CUSTOMER NOTIFICATION

SUD-DT-04-0093

PG-FP4

Operating Precautions

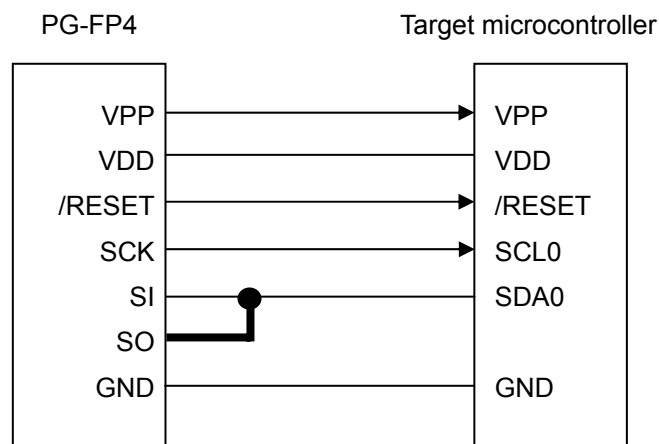
Connection example

No.2 IIC communication adapter board is not included

The IIC communication mode adapter board is not included.

When using IIC communication mode, short the SI and SO pins in the PG-FP4.

The IIC communication mode adapter board is included in products with control code C (firmware: V1.17, GUI: V2.00) or later.

Use the IIC communication mode adapter board for IIC communication.
