Microcomputer Technical Information

PG-FP4 Microcontroller Flash Memory Programmer Usage Restrictions		Document No.	ZBG-CD-04-0016	1/2
		Date issued	June 11, 2004	
		Issued by	Development Tool Group Multipurpose Microcomputer Systems Division 3rd Systems Operations Unit NEC Electronics Corporation	
Related documents	PG-FP4 User's Manual: U15260EJ4V0	Notification classification	√	Usage restriction
				Upgrade
				Document modification
				Other notification

PG-FP4 Microcontroller Flash Memory Programmer Usage Restrictions

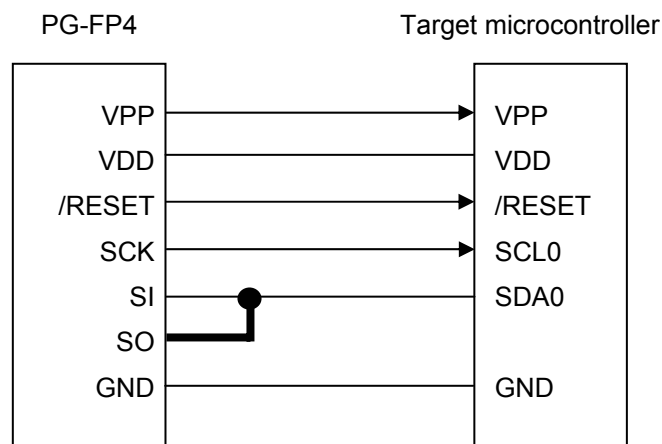
Connection example

No.2 IIC communication adapter board is not included

The IIC communication mode adapter board is not included.

When using IIC communication mode, short the SI and SO pins in the PG-FP4.

The IIC communication mode adapter board is included in products with control code C (firmware: V1.17, GUI: V2.00) or later.

Use the IIC communication mode adapter board for IIC communication.
