# RENESAS TECHNICAL UPDATE

Product Category	MPU/MCU		Document No.	TN-RA*-A0084A/E	Rev.	1.00
Title	Precaution regarding interrupt during successive bus access to peripherals sharing the same slave interfaces		Information Category	Technical Notification		
Applicable Product	RA6M1 Group, RA6M2 Group, RA6M3 Group, RA6T1 Group, RA4M1 Group, RA4W1 Group	Lot No.	Reference Document	Refer table at the end of this document		
		All

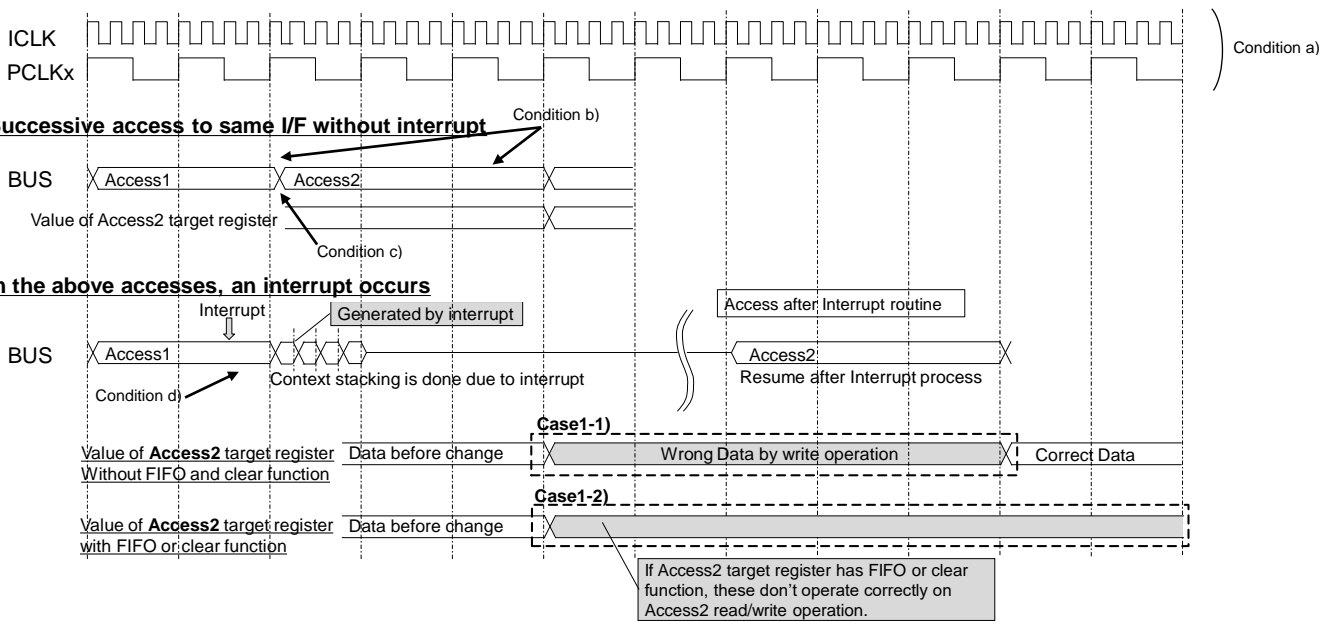
**Case1**

Case1 : A wrong access to Access2 target register might occur when all issue conditions meet.

- 1) When Access2 is write operation, wrong data is written to Access2 target register temporary, then a correct value is written after the CPU returning from interrupt.
- 2) If Access2 target register has FIFO or flag bit clear function, it causes unintentional value write to FIFO or unnecessary read from FIFO, or unintentional flag bit clear on the register.

- 1) In your system, set clock frequency as follows  
 ICLK = PCLKx (x=A,B) (RA4M1, RA4W1)  
 ICLK = PCLKx (x=A,B), ICLK>FCLK (RA6M1, RA6M2, RA6M3, RA6T1)
- 2) Identify in your code where successive Access1 and Access2 occurs relevant to the area where the unintended SW behavior was observed. Then insert DSB instruction between Access1 and Access2
- 3) Disable Interrupts during Access1 to Access2

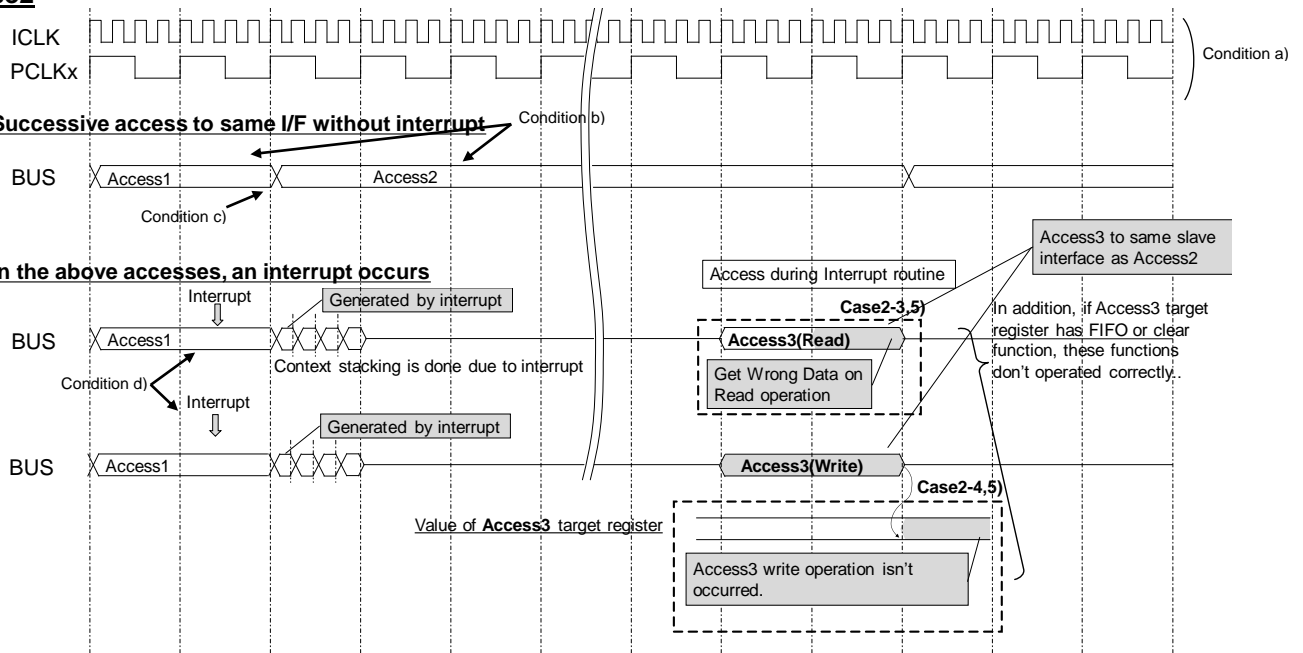
**Case2**

Case2 : A wrong access might occur in interrupt service routines when all issue conditions meet.

A register access to the same slave interface or external bus as Access2 in an interrupt service routine (referred to as Access3) causes an illegal operation

- 3) When Access3 is read operation, CPU might receive wrong data.
- 4) When Access3 is write operation, Access3 might not occurred in target register.
- 5) If Access3 target register has FIFO or flag bit clear function, these functions don't operated correctly.
