Microcomputer Technical Information

QB-V850ESSX2 In-Circuit Emulator for V850ES/SG1, V850ES/SG2,V850ES/SJ2, V850ES/SG3, V850ES/SJ3, V850ES/JG2, V850ES/JJ2 Usage Restrictions		Document No.	ZBG-CD-06-0026	1/1
		Date issued	April 5, 2006	
		Issued by	Development Tool Group Multipurpose Microcomputer Systems Division 4th Systems Operations Unit NEC Electronics Corporation	
Related documents	QB-V850ESSX2 User's Manual: U17091EJ2	Notification classification	√	Usage restriction
				Upgrade
				Document modification
				Other notification

QB-V850ESSX2, In-Circuit Emulator for V850ES/SG1, V850ES/SG2,V850ES/SJ2,
 V850ES/SG3, V850ES/SJ3, V850ES/JG2, V850ES/JJ2 - Usage Restrictions

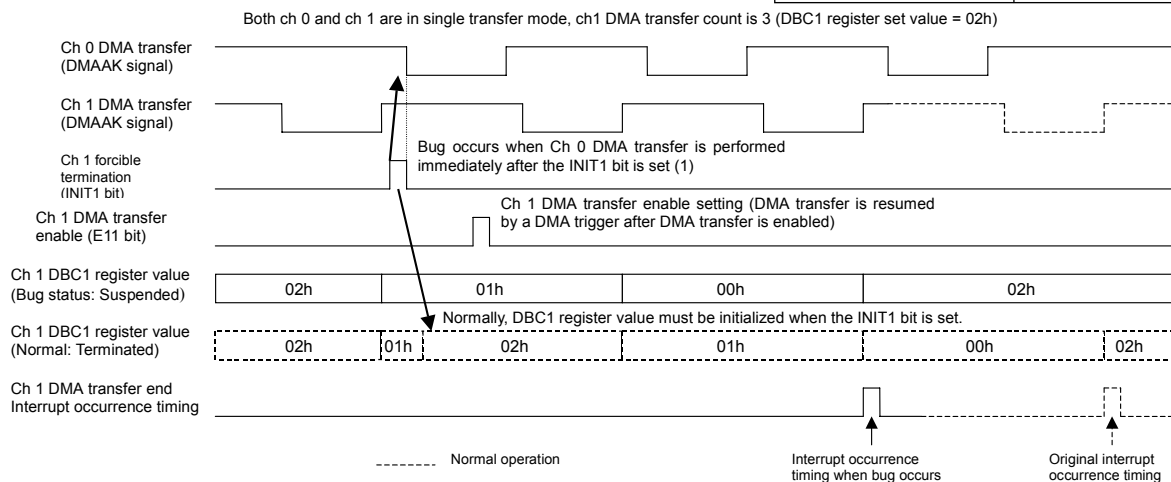
No. 10 Bug related to DMA transfer forcible termination

When terminating a DMA transfer by setting the INIT_n bit of the DCHC_n register, the transfer may not be terminated, but just suspended, even though the INIT_n bit is set (1). As a result, when the DMA transfer of a channel that should have been terminated is resumed, the DMA transfer will terminate after an unexpected number of transfers are completed and a DMA transfer completion interrupt may occur (n = 0 to 3). This bug occurs if a DMA transfer is executed immediately after a forcible termination is set (by setting the INIT_n bit) (see the figure below).

This bug does not depend on the number of transfer channels, transfer type (2-cycle or flyby), transfer target (between memory and memory, memory and I/O; including internal resources), transfer mode (single, single-step, or block), or trigger (external request, interrupt from internal peripheral I/O, or software), and can occur with any combination of the above elements that can be set under the specifications. In addition, another channel may affect the occurrence of this bug.

The following registers are buffer registers with a 2-stage FIFO configuration of master and slave. If these registers are overwritten during a DMA transfer or in the DMA-suspended status, the value is written to the master register, and reflected in the slave register when the DMA transfer of the overwritten channel is terminated.

The "initialization" in the above figure means that the contents of the master register are reflected in the slave register.

This bug can be avoided by implementing one of the following procedures using the software.

This bug has been corrected in control code D or later.

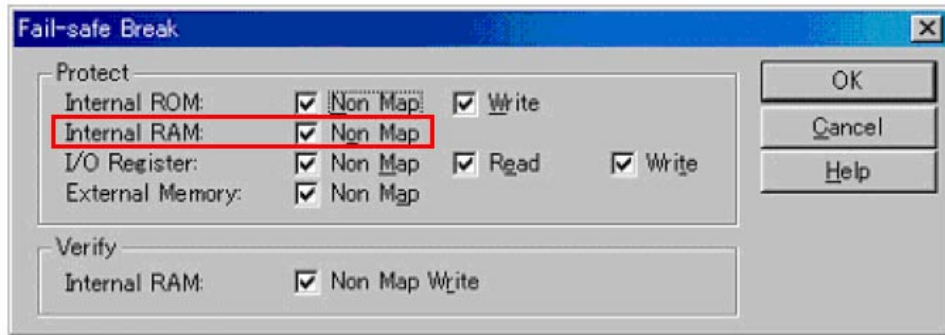
No. 17 Illegal break occurs during program execution in internal RAM (1)

An illegal break may occur when a peripheral I/O register is accessed during program execution in the internal RAM.

Cancel the fail-safe break setting for the internal RAM in the debugger.

Click the [Detail] button in the Fail-safe Break field in the Configuration window and clear the check box for “Internal RAM”.

Cancel the fail-safe break for “ramgrd” and “ramgrdv” using the Target flsf command. Please regard this item as a permanent restriction.

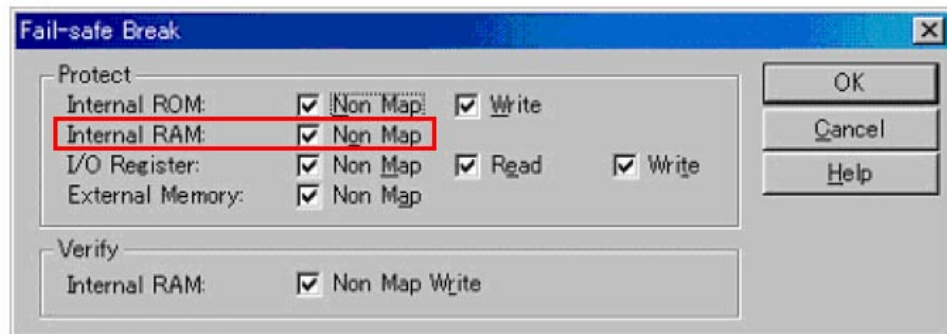
A non-map break occurs if all of the following conditions are satisfied, even if the program itself is correct.

- Cancel the fail-safe break setting for the internal RAM in the debugger.

Click the [Detail] button in the Fail-safe Break field in the Configuration window and clear the check box for "Internal RAM".

Cancel the fail-safe break for "ramgrd" and "ramgrdv" using the Target flsf command.
