RENESAS TECHNICAL UPDATE

Product Category	MPU/MCU		Document No.	TN-RH8-B0584A/E	Rev.	1.00
Title	RH850/U2Bx, U2Bx-E Clock Monitor Backup Clock Limitation		Information Category	Technical Notification		
Applicable Product	RH850/U2B-FCC, U2B6, U2B10, U2B24-E EVA, U2B24-E, U2B16-E, U2B12-E, U2B6-E	Lot No.	Reference Document	R01UH1046EJ0110 (RH850/U2B-E Group User's Manual: Hardware) R01UH0923EJ0120 (RH850/U2B Group User's Manual: Hardware)		
		All

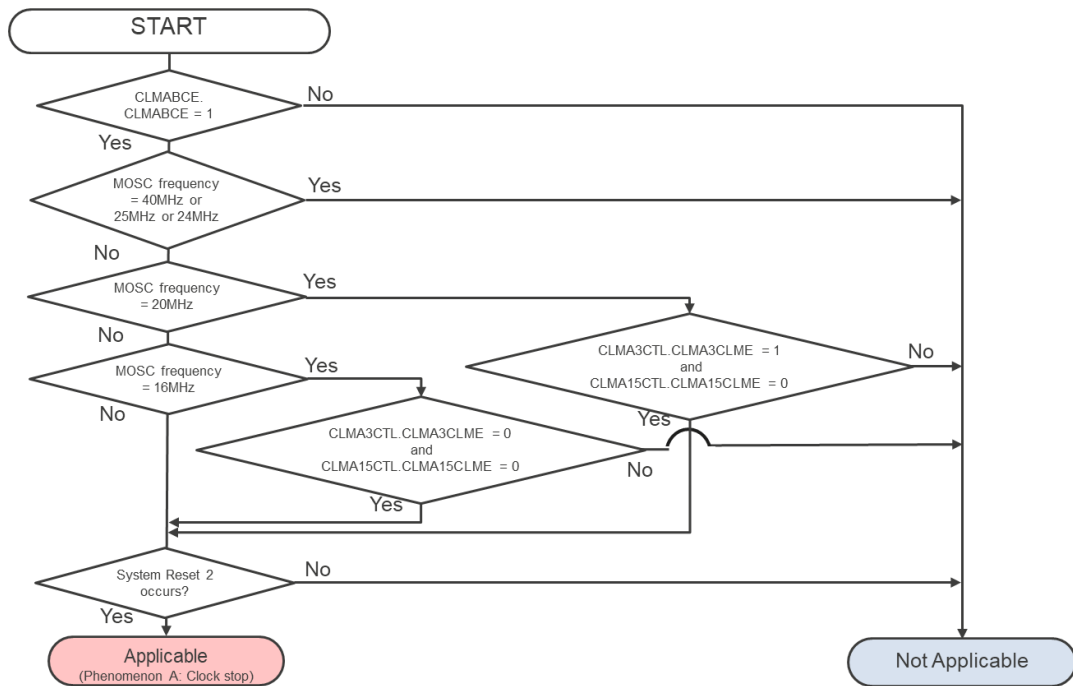
[Judgement Flow]

CLMA backup clock function	MOSC frequency	CLMA3 setting	CLMA15 setting	Phenomenon A
Disable	X	X	X	Not Applicable
Enable	40MHz, 25MHz, 24MHz	X	X	Not Applicable
		20MHz	Disable	X
	Enable		Disable	Applicable
			Enable	Not Applicable
	16MHz	Disable	Disable	Not Applicable
			Enable	Applicable
Enable		X	Applicable

- Using MOSC = 20MHz case:

- Set the CLMA15 to enable (CLMA15CTL.CKMA15CLME=1) or

- Set the Backup clock to disable (CLMABCE. CLMABCE = 0).

- Using MOSC = 16MHz case:
