MSC TECHNICAL NEWS

No. M7700-20-9311

7700 Series Note for Serial I/O Error Flag

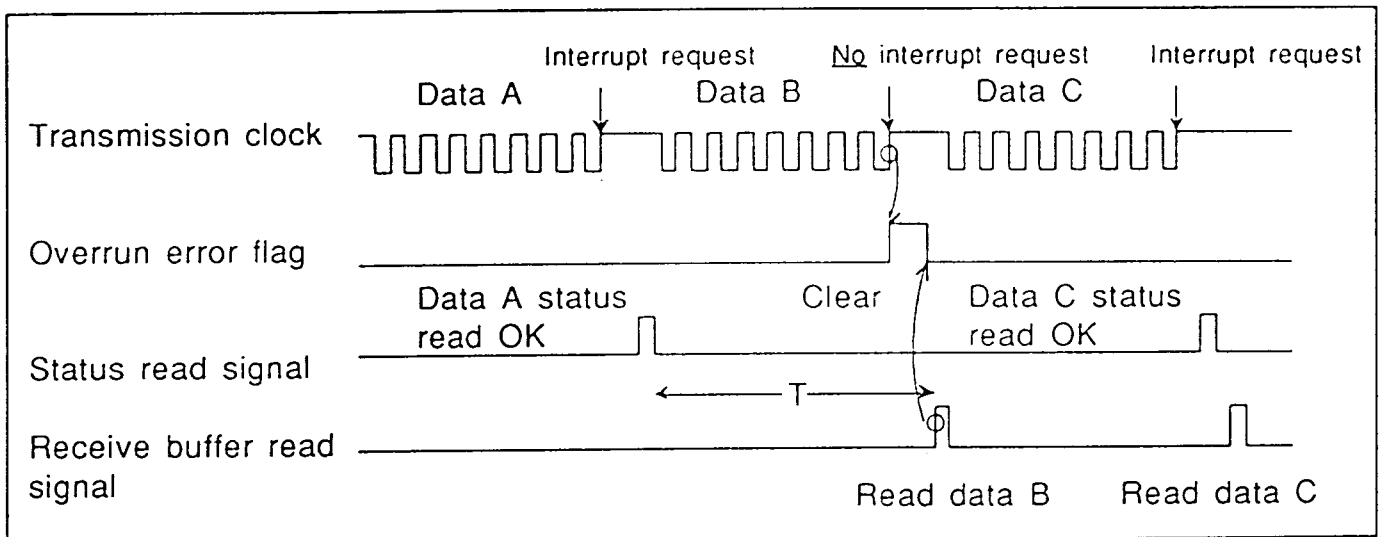
During receiving data in clock synchronous serial I/O and UART, receive status flag*¹ is cleared by reading the contents of the receive buffer register.

Thus, when receiving data continuously, errors happens not to be found in the following situation which occurs errors; after completing to receive one data (Data A), when receiving the next data (Data B) is completed from checking the receive status flag to reading the receive buffer register (Period T).

Especially, it may happen to deal with the previous data (Data A) as the next data (Data B) by reason of not to find overrun error (in this case the interrupt request is not occurred).

Therefore, receive the next data after reading the receive data from the receive buffer register when receiving data continuously.
