# MESC TECHNICAL NEWS

No.M740-20-0008

## Attention for programming using 7532/7536 Group USB function

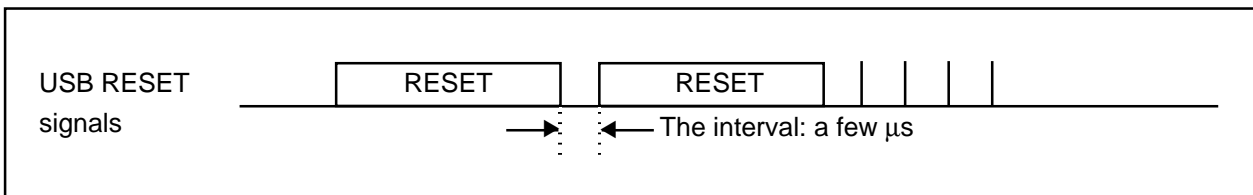
Fig. 1 Example of the short interval between USB RESET signals

When the interval between USB RESET signals (a few  $\mu\text{s}$ ) shown in Fig.1, the initialization of request flags in the first USB RESET must be finished before the second USB RESET detection.

Therefore, initialize the USB interrupt source discrimination register 2 and USB interrupt control register in the close subsequence after the end of USB RESET signal\*. The sample procedure is listed in Fig. 2.

(\*when RSTRQ (USB RESET request flag) is cleared)

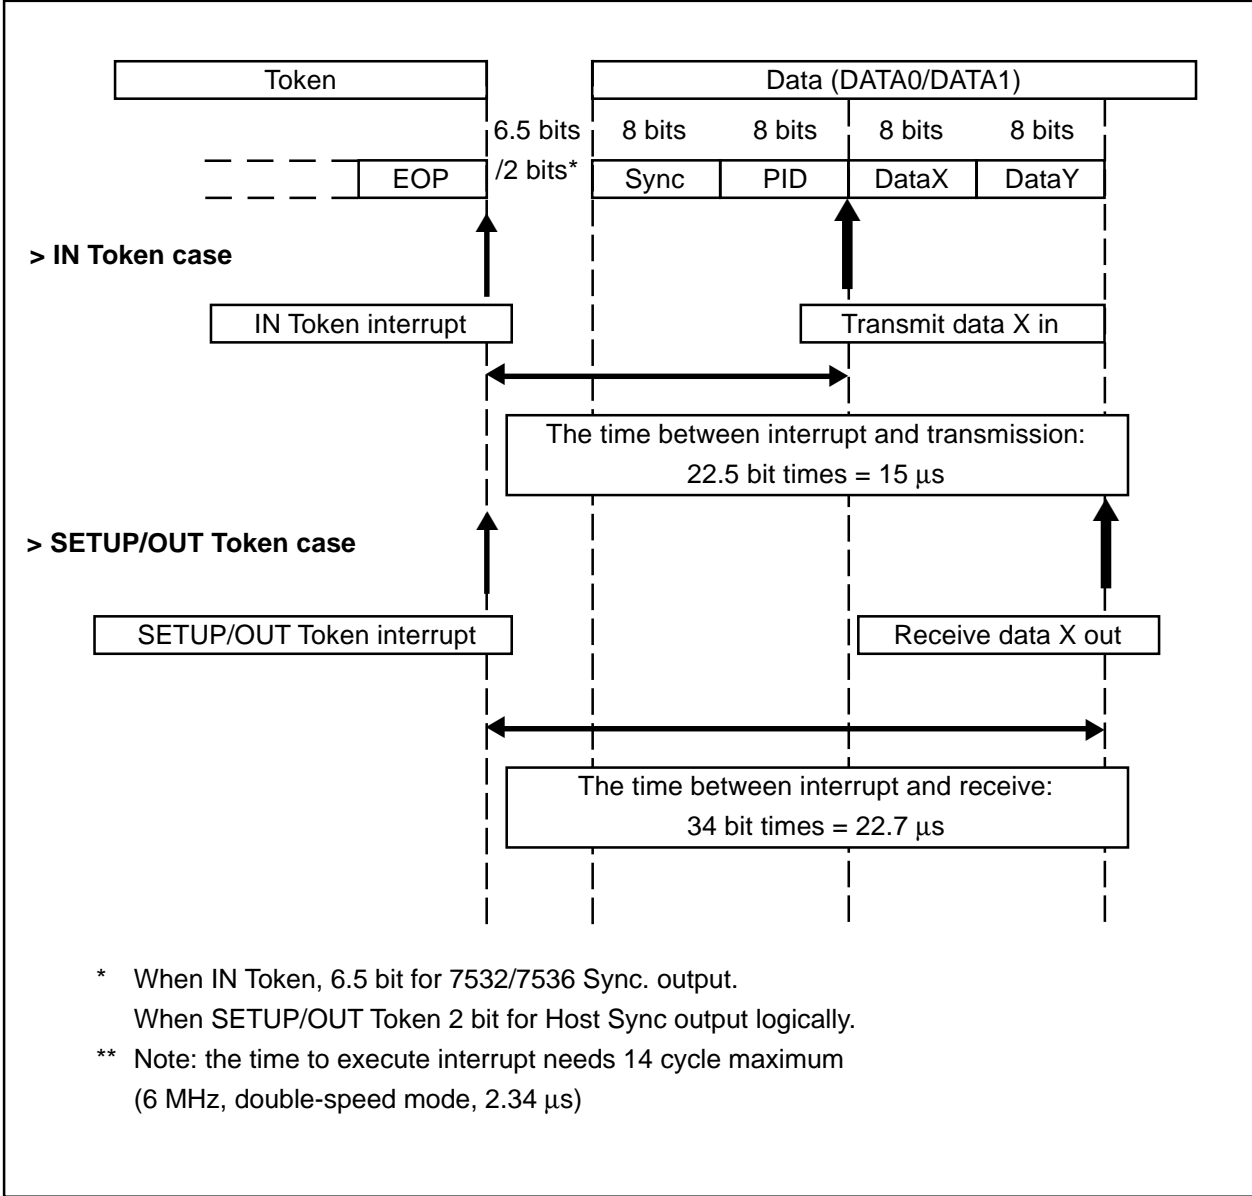
Fig. 3 USB Token transmit/receive interrupt execution timing chart

The transmission/receive of data in 7532/7536 Group is processed by the software. Therefore, the following transmission/receive buffering is needed for USB transactions.

The software should be coded according to the buffering timing shown below in order to design the Token interrupt routine.
