MESC TECHNICAL NEWS

No.M740-15-9910

Attention of USB MCU software for Apple PC

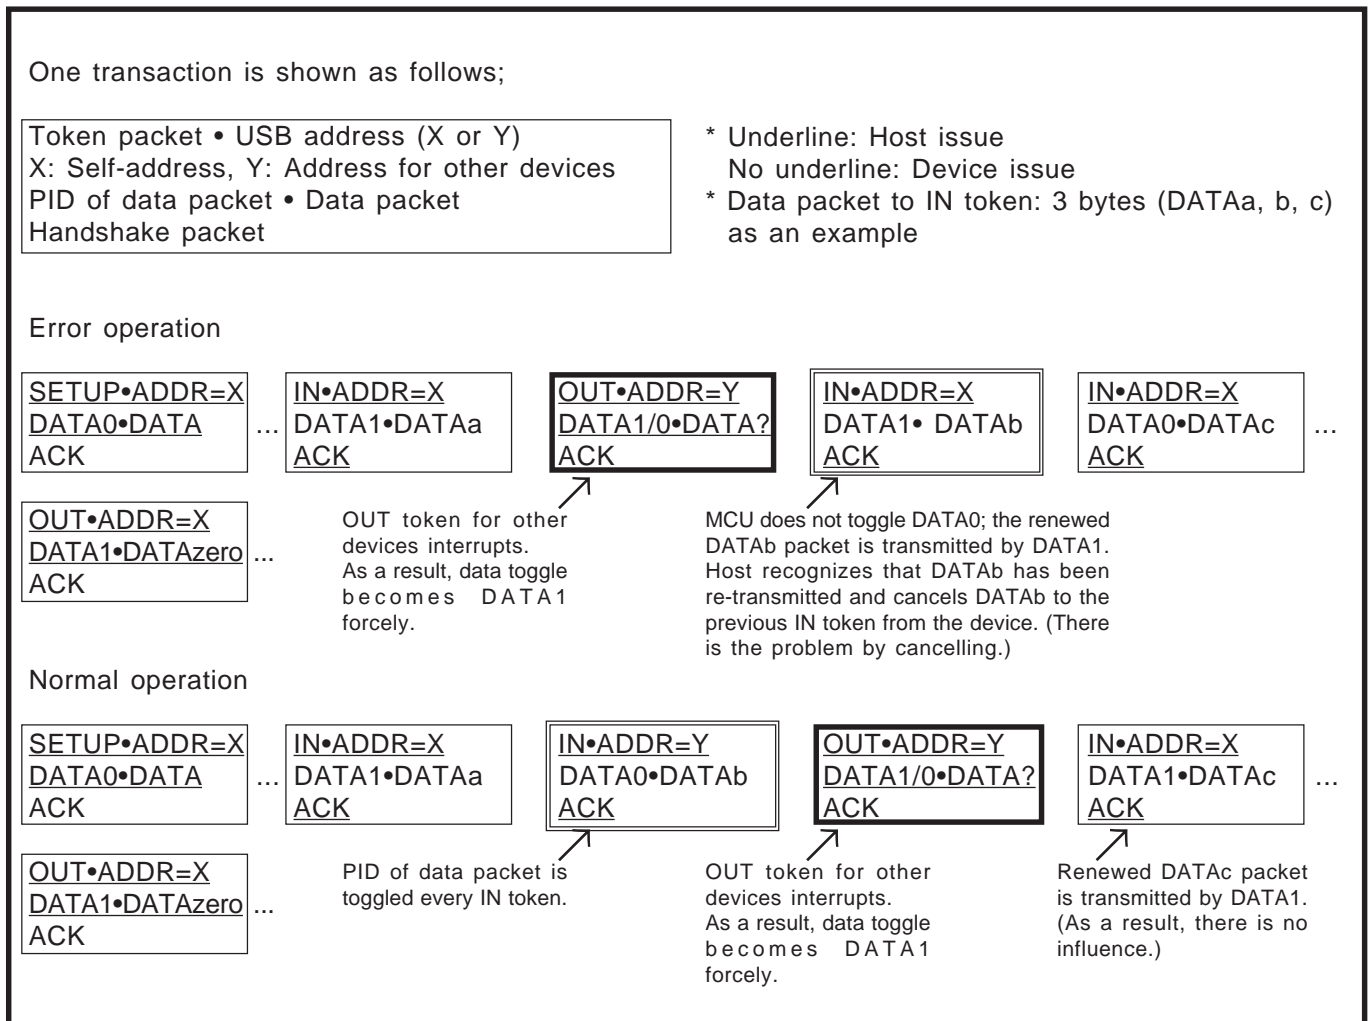
When the USB MCU is connected to Apple PC (PC with MacOS), in the Control transfer of Endpoint 0, the case in which the transaction is handled in order shown by Figure 1 might happen. In this case, the toggle function of the USB function in the 7532/7536 Group may be failed. (Enumerate may be failed in Enumerate.)

Fig. 1 Description of error operation at Control transfer

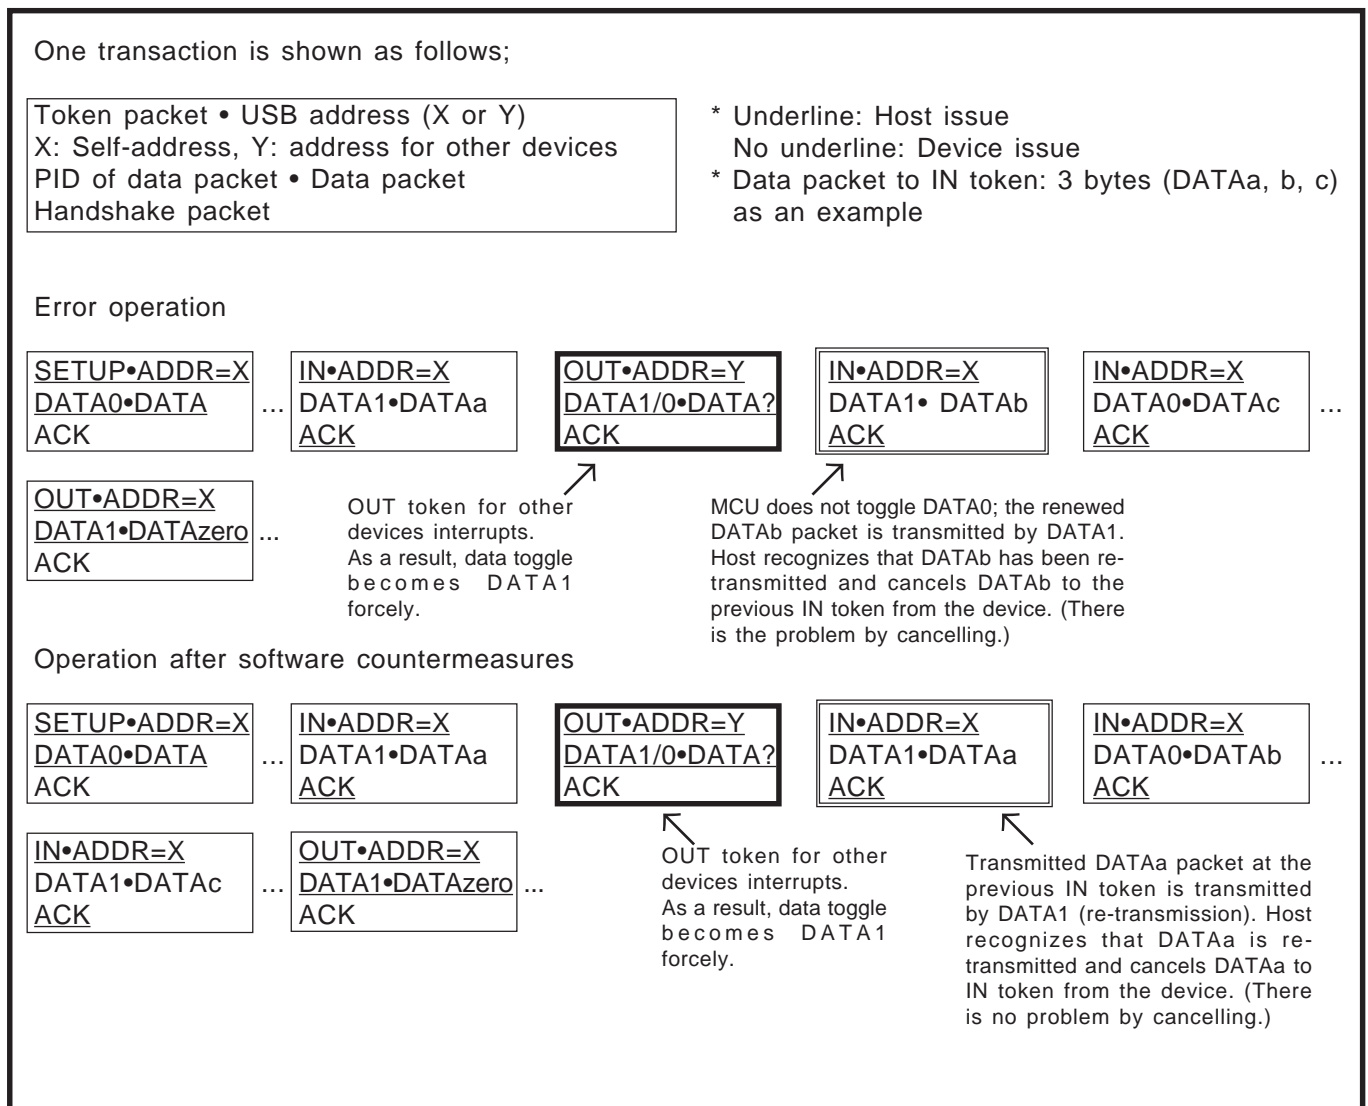
Fig. 4 Comparing the error operation at Control transfer with the operation after software countermeasures
