MESC TECHNICAL NEWS

No. M7700-54-9911

Note on Executing 32-Bit Operation Instructions in 7900 Series MCUs

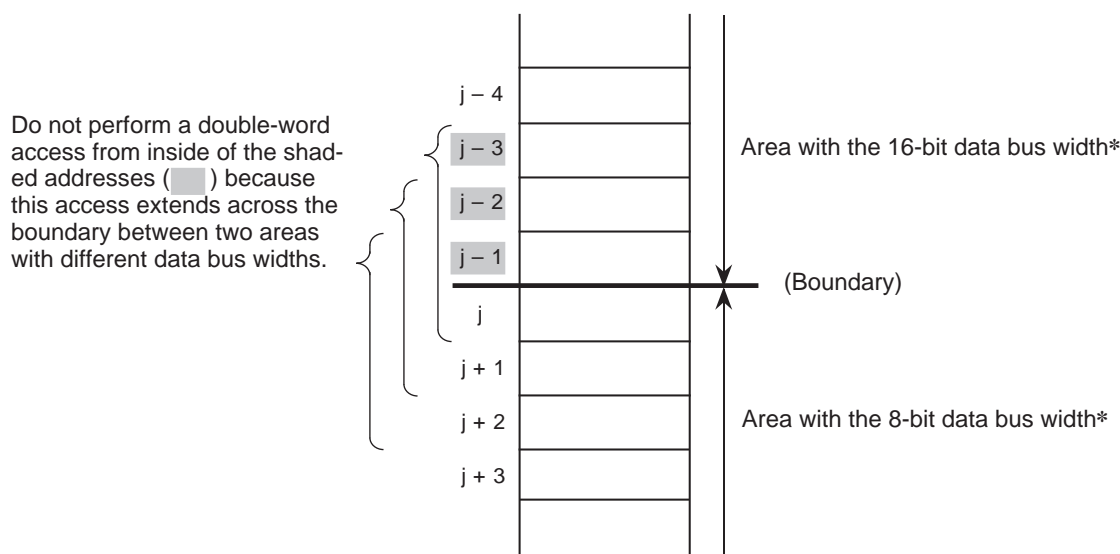
When performing memory access with one of the 32-bit operation instructions shown above, make sure that this access does not extend across the boundary between two areas with different data bus widths; that is, when an area with the 16-bit data bus width (including an internal area) is immediately followed by another area with the 8-bit one, do not perform a double-word (32-bit) access from inside of three bytes preceding the boundary.

* : If an area with the 8-bit data bus width is allocated to the low-order addresses and an area with the 16-bit one is allocated to the high-order addresses, the above caution is also applied.

A double-word access that extends across the boundary between two areas with different data bus widths may result in the following symptoms:

- (1) Incorrect accesses before and after the boundary may occur.
- (2) The CPU may run away.
