RENESAS TECHNICAL UPDATE

Product Category	System LSI		Document No.	TN-RZ*-A0081A/E	Rev.	1.00
Title	UART DE signal HW control issue		Information Category	Technical Notification		
Applicable Product	See below	Lot No.	Reference Document	RZ/N1 Series User's Manual (See below for details)		
		All lots

We would like to inform about UART DE (Data Enable) signal HW control issue.

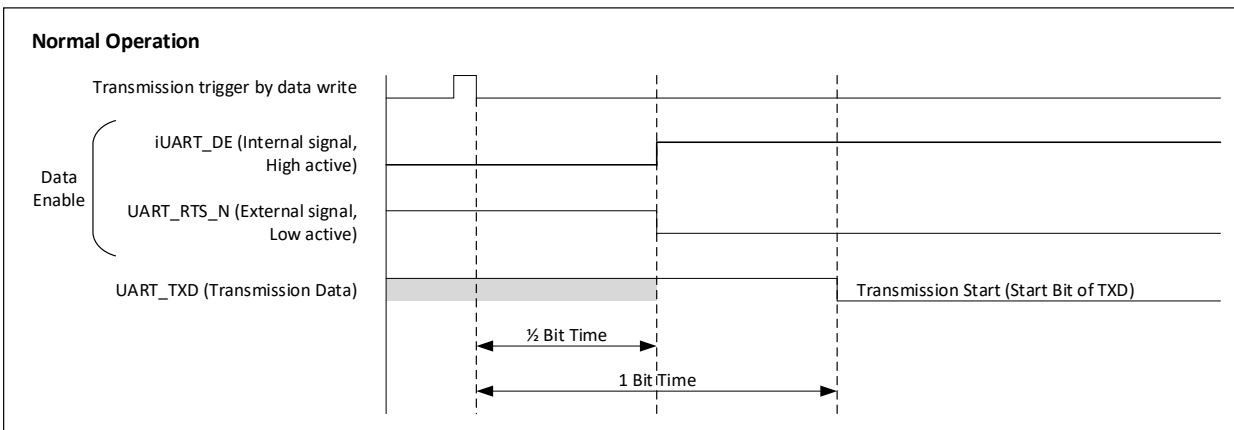
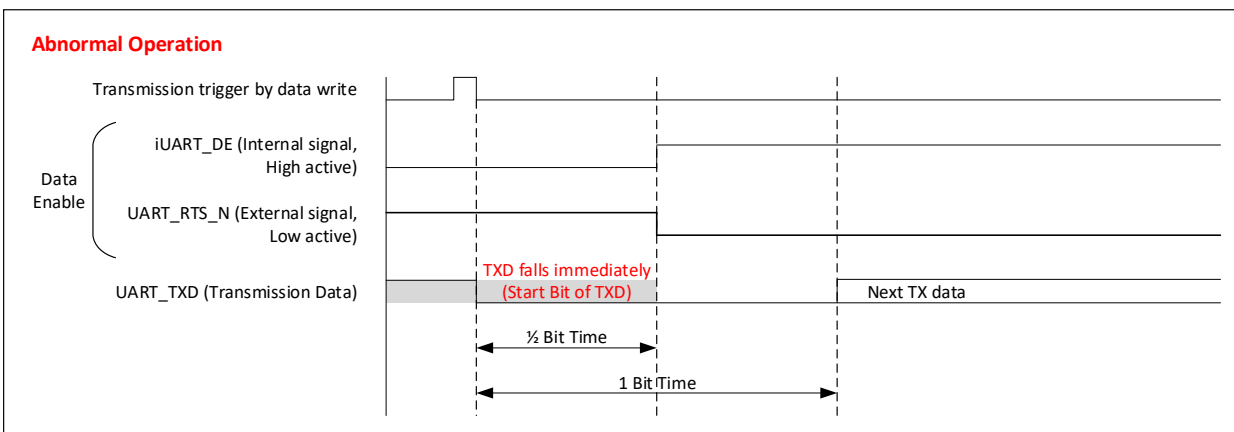
When UART DE signal by HW control (rUart_CTRLTO.bUart_EnableDE=1) is used, transmission of TXD might start before DE is asserted.

In the case of the issue, start bit of UART_TXD is asserted first, and DE signal is asserted 1/2 bit time later. Therefore receive side might not be able to detect start bit correctly.

The issue happens randomly, its probability is below.

Serial Clock (UART[m]_SCLK)	Baud Rate	Baud Rate Divisor (bUart_DLH,bUART_DLL)	Probability
48 MHz	9600	313	0.02%
48 MHz	19200	156	0.04%
48 MHz	115200	26	0.24%
83.3 MHz	9600	543	0.01%
83.3 MHz	19200	271	0.02%
83.3 MHz	115200	45	0.14%

Use of DE signal control by HW (rUart_CTRLTO.bUart_EnableDE=1) is prohibited.

Control DE signal by SW through GPIO or rUart_MCR.bUart_RTS with rUart_MCR.bUart_AFCE=0.
