Microcomputer Technical Information

<p>μPD789046 Subseries</p> <p>Usage Restrictions</p>	Document No.	SBG-DT-03-0187-E	1/2
	Date issued	July 18, 2003	
	Issued by	Microcomputer Group 2nd Solutions Division Solutions Operations Unit NEC Electronics Corporation	
<p>Related documents</p> <p>μPD789046 Subseries User's manual: U13600EJ2V0UMJ1</p> <p>μPD789046 Data sheet: U13380EJ1V1DS00</p> <p>μPD78F9046 Data sheet: U13546EJ1V0DS00</p>	Notification classification	<input checked="" type="checkbox"/>	Usage restriction
		<input type="checkbox"/>	Upgrade
		<input checked="" type="checkbox"/>	Document modification
		<input type="checkbox"/>	Other notification

***μ*PD789046 Subseries Usage Restrictions**

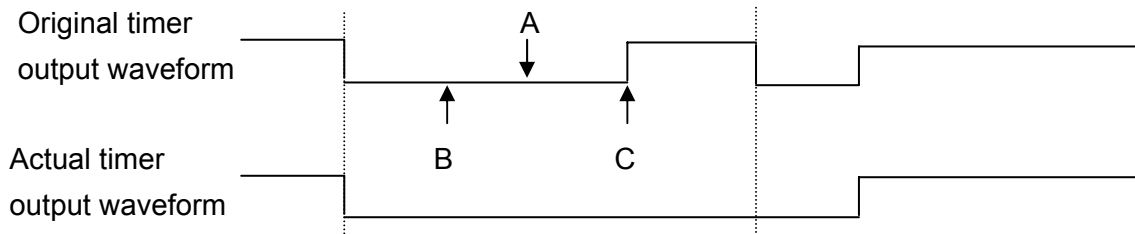
<Phenomenon>

The 8-bit timer does not have a compare register reload function. When the 8-bit timer is used in PWM mode, therefore, the following phenomenon may occur if the value of the compare register (CR80) is overwritten while the timer is operating.

If the value of the compare register is set to "B" while the count value is "A" ($A < C$, $A > B$) where B is the overwritten values of the compare register (CR80) and C is the original value of the compare register (CR80), no pulse is output during this period.

When the 8-bit timer is used in the interval timer mode, the value of the compare register (CR80) should be overwritten while the timer operation is disabled.

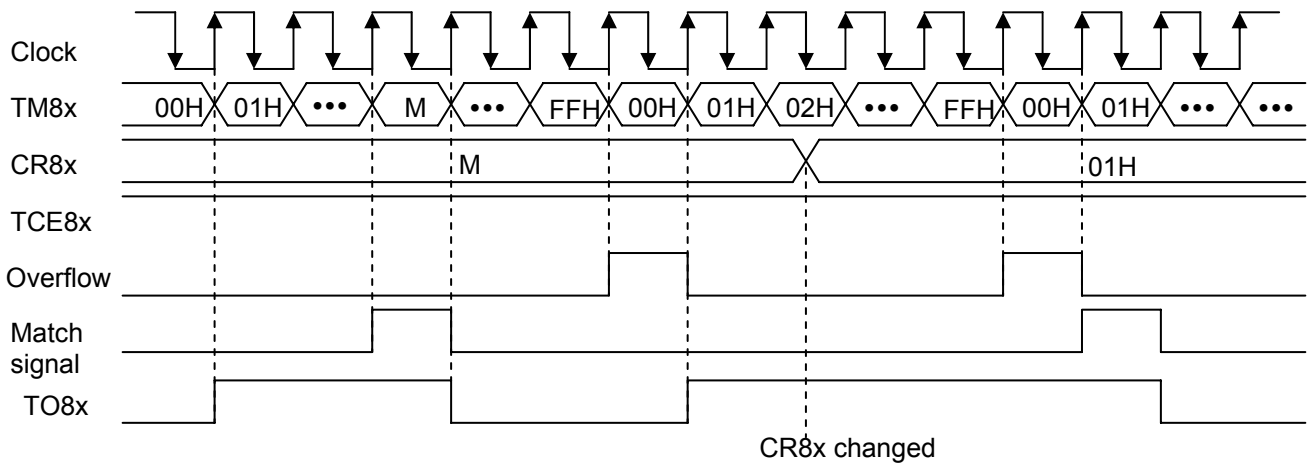
While the timer is operating (during PWM output), if a value is written to the compare register (CR8x), a high level may be output for the next cycle (count pulse \times 256). This phenomenon occurs if a value smaller than the value of TM8x is written to CR8x.

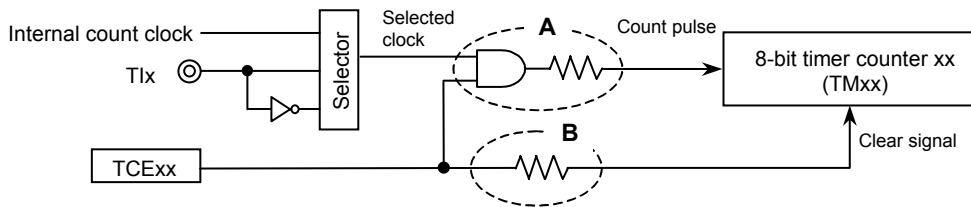
Basic Timer Configuration

When the 8-bit timer/event counter is used, an error of up to 1.5 clocks is generated after the timer has been started until a match signal is generated. This is because a rising edge is detected when the timer is started while the selected clock is high, which results in the count value getting incremented.

- The selected clock and the count operation flag (TCExx) are ANDed, and the result is supplied to the counter
- The TMxx counter value is cleared when the count operation flag (TCExx) is set

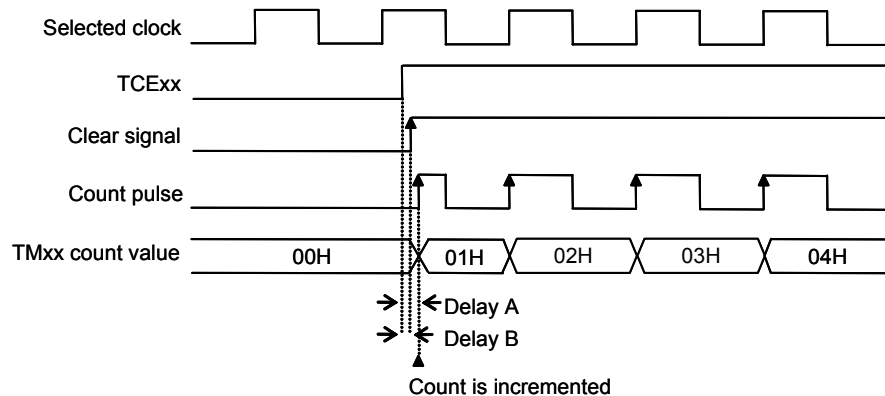
Case when an error of up to 1.5 clocks is generated

If a count pulse is delayed for the clear signal (“delay A > delay B”) as the result of setting the count operation flag (TCExx) while the selected clock is high, the TMxx count value is incremented. An error of up to 1.5 clocks is generated.

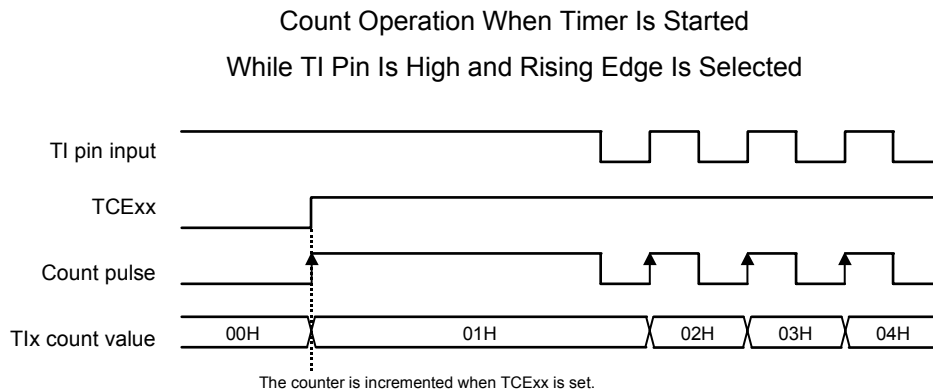
In the case of “delay A > delay B” as described in (1), the TMxx count value is incremented if any of the following conditions is satisfied.

- The count operation flag (TCExx) is set while the TI pin is high and the rising edge is selected.
- The count operation flag (TCExx) is set while the TI pin is low and the falling edge is selected.

Make allowances for 1-count error in the counter, or implement one of workarounds (1) and (2) below.

- Always start the timer while the TI pin is low if the rising edge is selected.
- Always start the timer while the TI pin is high if the falling edge is selected.

- Save the count value upon timer start in the control register. When reading the count value, subtract this value from the count value saved in the control register and use the result as a true count value.
