# Microcomputer Technical Information

<p><math>\mu</math>PD789860, 789861 Subseries</p> <p>Usage Restrictions</p>	Document No.	SBG-DT-03-0195-E	1/2
	Date issued	July 18, 2003	
	Issued by	Microcomputer Group 2nd Solutions Division Solutions Operations Unit NEC Electronics Corporation	
Related documents $\mu$ PD789860, 789861 Subseries User's Manual: U14826EJ3V0UM00 $\mu$ PD789860, 789861 Data Sheet: U13917EJ1V1DS00 $\mu$ PD78E9860, 78E9861 Data Sheet: U16524EJ1V0DS00	Notification classification	√	Usage restriction
			Upgrade
		√	Document modification
			Other notification

$\mu$ PD789860, 789861, 78E9860, 78E9861

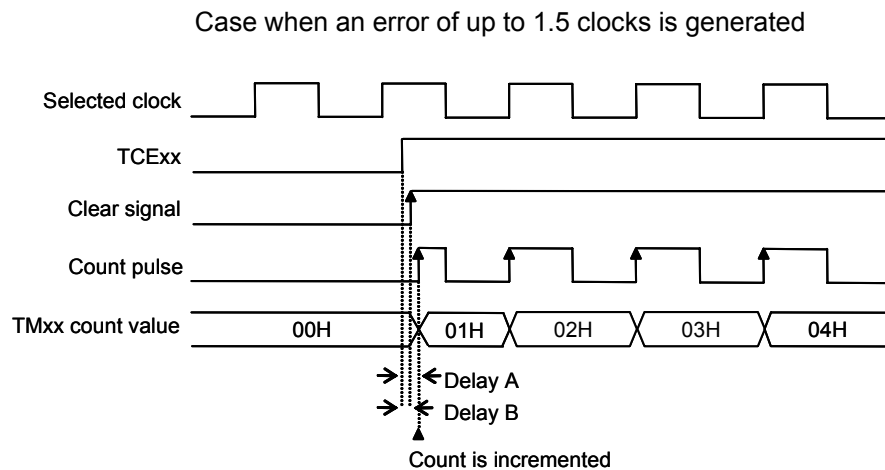
When the 8-bit timer/event counter is used, an error of up to 1.5 clocks is generated after the timer has been started until a match signal is generated. This is because a rising edge is detected when the timer is started while the selected clock is high, which results in the count value getting incremented.

If a count pulse is delayed for the clear signal (“delay A > delay B”) as the result of setting the count operation flag (TCExx) while the selected clock is high, the TMxx count value is incremented. An error of up to 1.5 clocks is generated.

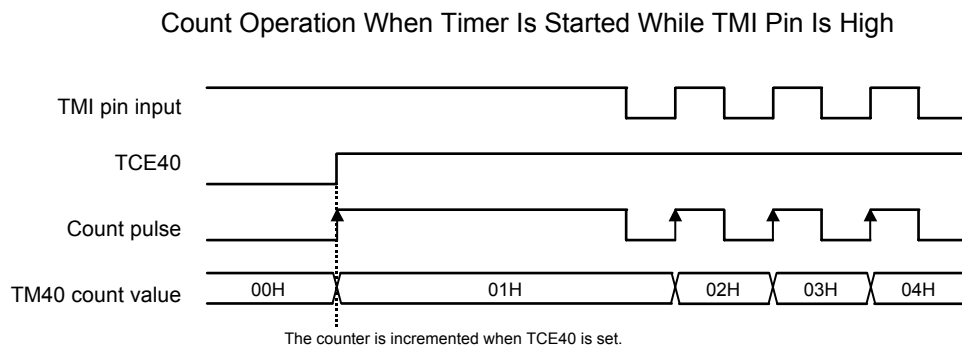
If an external event (TMI pin input) is selected for the timer count clock when 8-bit timer 40 is used, the count may be incremented after the count operation flag (TCE40) is set, depending on the status of the valid edge and TMI pin.

In the case of “delay A > delay B” as described in (1), the TM40 count value is incremented if the following condition is satisfied.

- The count operation flag (TCE40) is set while the TMI pin is high.

Make allowances for 1-count error in the counter, or implement one of workarounds (1) and (2) below.

- Always start the timer while the TMI pin is low.

- Save the count value upon timer start in the control register. When reading the count value, subtract this value from the count value saved in the control register and use the result as a true count value.
