RENESAS TECHNICAL UPDATE

Product Category	MPU/MCU	Document No.	TN-SH7-A820A/E	Rev.	1.00
Title	Usage notes regarding internal reset		Information Category	Technical Notification	
Applicable Product	SH7450 Group, SH7451 Group SH7455 Group, SH7456 Group	Lot No.	Reference Document	SH7450 Group, SH7451 Group Hardware Manual REV.1.00	
				SH7455 Group, SH7456 Group User's Manual REV.0.50

We would like to inform you of the usage notes regarding internal reset.

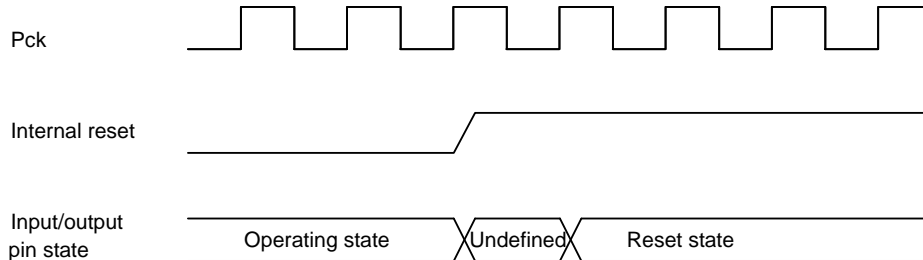
When the microcontroller is changing to reset status caused by an internal reset, there will be a period of one peripheral clock (Pck), where I/O ports will be undefined. Undefined state could be either high level output or low level output or high impedance states.

The microcontroller, including I/O ports, will correctly transfer to reset status after this period.

All I/O ports have this phenomenon; with the exception of input dedicated or output dedicated ports.
