Customer Notification

V850E/Dx3

32-Bit Single-Chip Microcontrollers

Operating Precautions

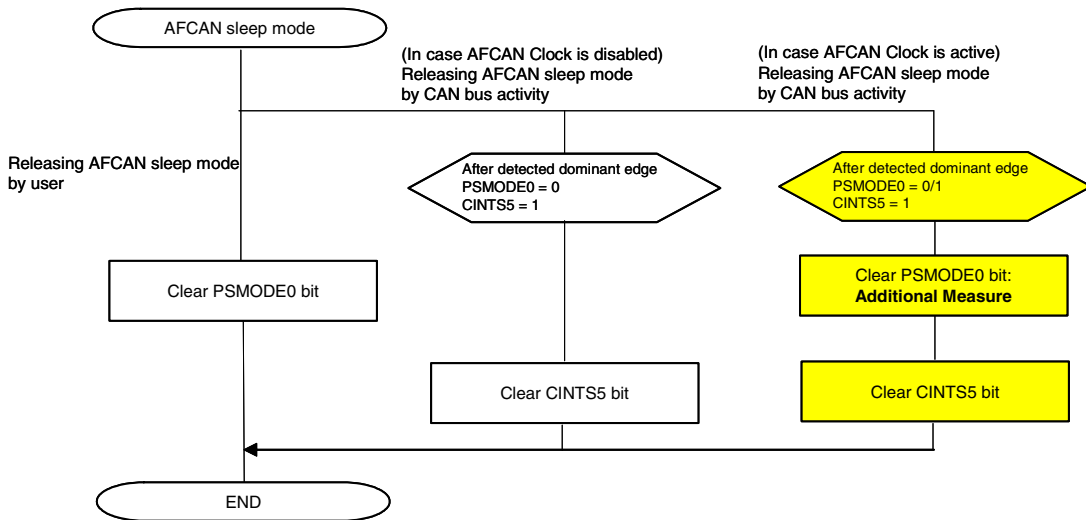
Figure: Additional Measures in case AFCAN clock is active when waking up

The following flowchart illustrates, how and whether additional measures have to be taken in software, to avoid the *wakeup dead time*.
