## **Customer Notification**

# **V850E/PH2**

## **Operating Precautions**

**μPD70F3187**

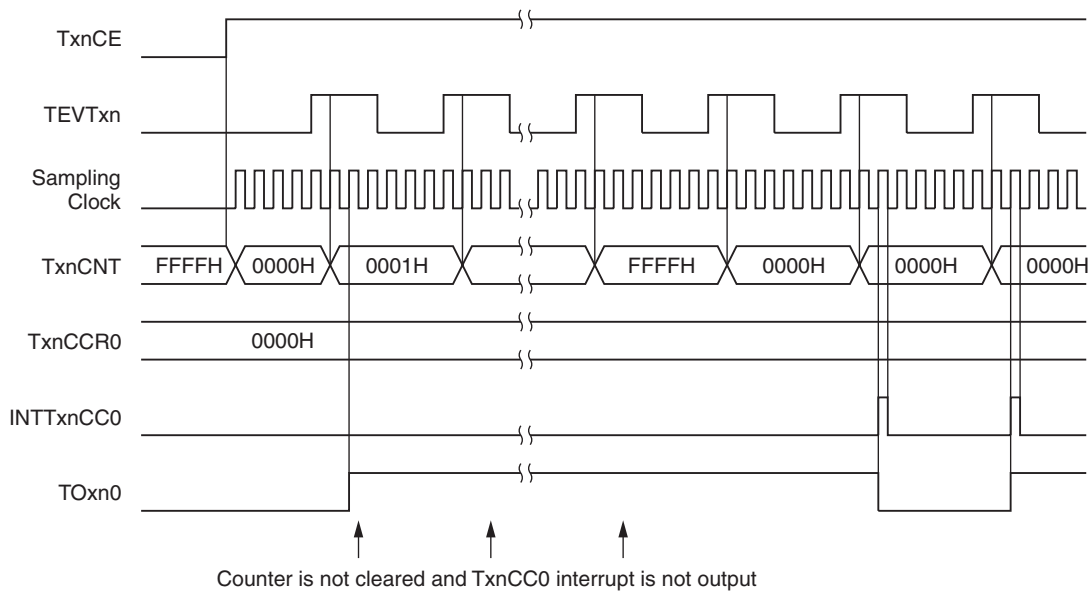
No. 3	TMP/TMT/TMR: External event counter mode does not work correctly when compare register value is 0000H (Specification change notice)
-------	--

In the external event count mode (TxnMD3 to TxnMD0 bits = 0001B) the counter (TxnCNT) is not compared with the compare register value (TxnCCR0) during first count up timing. Therefore, when TxnCCR0 is set to 0000H, the counter cannot be cleared and the compare match interrupt signal (INTTxnCC0) is not output. In this case the timer counts up until FFFFH in the first period, and not until then the compare match works as expected.

TxnMD3 to TxnMD0 bits = 0001B (External event count mode), TxnCCR0 = 0000H

Do not set TxnCCR0 = 0000H in external event counter mode.

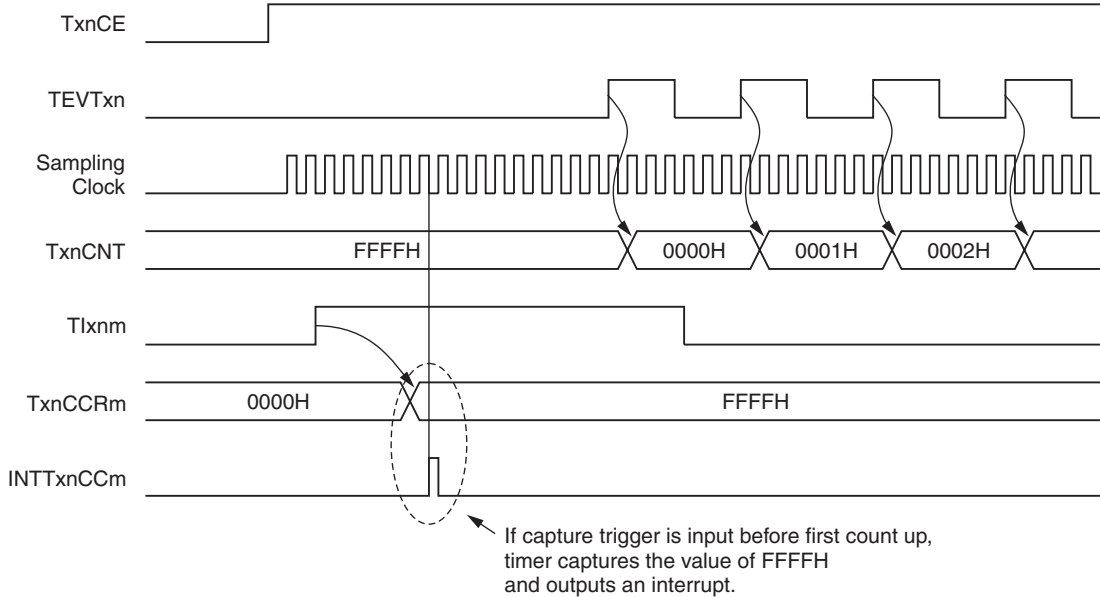
No. 4	TMP/TMT/TMR: Capture operation of illegal data before first counting up (Specification change notice)
<p><u>Details</u></p> <p>In free-running mode (TxnMD3 to TxnMD0 bits = 0101B), pulse width measurement mode (TxnMD3 to TxnMD0 bits = 0110B), and offset trigger generation mode (TxnMD3 to TxnMD0 bits = 1100B, TMT only), when a lower count clock (TxnEEE = 0, TxnCKS2 to TxnCKS0 = 011B to 111B) or an external clock (TxnEEE = 1) is selected, the timer captures the value of FFFFH and outputs a capture interrupt signal (INTTxnCCm), if a capture trigger signal (Tlxnm) is enabled and input before first counting up. This captured data and the corresponding interrupt might be useless.</p> <p><u>Example</u></p>

<p>If capture trigger is input before first count up, timer captures the value of FFFFH and outputs an interrupt.</p> <p><b>Remarks:</b></p> <ol style="list-style-type: none"> <li>1. x = P, R or T</li> <li>2. n = 0 to 7, if x = P = 0 or 1, if x = R or T</li> <li>3. m = 1, if x = P or T = 1 to 4, if x = R</li> </ol> <p><u>Workaround</u></p> <p>None.</p>

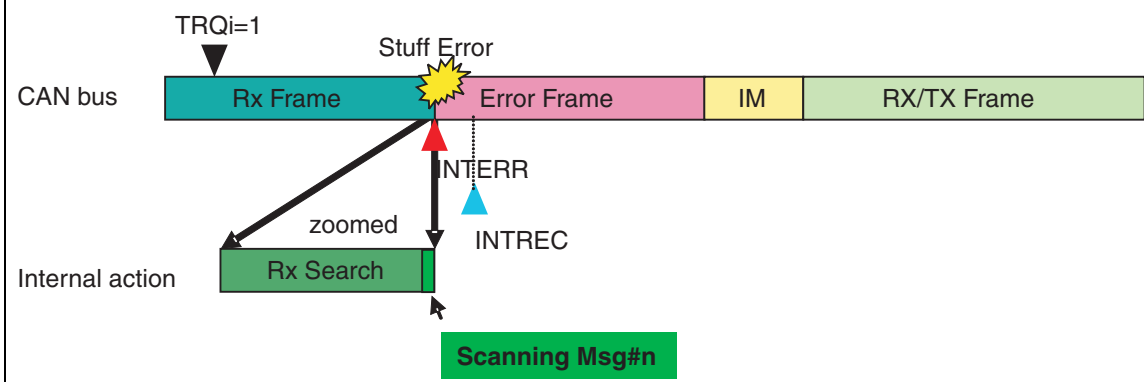
<p>No. 7</p>	<p>AFCAN: Rx limitation (Technical limitation)</p>
<p><u>Details</u></p> <p>The aFCAN macro may store an incoming message although this message was interrupted by a bus error frame. Thus, the incomplete reception causes that a message buffer is updated with old or incorrect data or that the message is even stored at an incorrect location.</p> <p>This unexpected behaviour affords that the bus error occurs in a certain relation to the currently present message on the bus. The critical time window starts at the sample point of the LSB of the DLC-field and lasts for the duration of an internal process in the aFCAN macro (RX-search). This time window usually lasts for a few bit times only. The actual length depends on the clock supply for the AFCAN, the CPU accesses during this period, the baud rate and the number of message buffers of the particular AFCAN macro.</p> <p>In this time window the RX-search evaluates the received identifier of the current message. When the bus error is detected within this window and when the RX-search has just scanned buffer #n for reception and found it is matching, the message will unexpectedly be treated as a received message. As the time window is limited as described above, only a stuff bit error occurring right in this window can cause this behaviour.</p> <p>There are two types of unexpected behavior for the RX limitation depending on the presence of pending transmission request (TRQ) for any other message buffer.</p> <p><u>1. Behavior at pending TRQ (TRQi = 1)</u></p> <p>When the host processor has already submitted a transmit request (TRQ) for at least one buffer, the unexpected reception of the message will take place into the message buffer found by internal RX-search. This is the correct location to store the message i.e. the acceptance filter criteria are correctly fulfilled. However the data part will be updated with the contents of the shift register of the CAN protocol core. As this register is immediately stopped at detection of the bus error, the data provided to the message buffer can not be interpreted by the host processor.</p>

<p>As during a regular reception, the RX-interrupt (if enabled) is generated and the application processes the message object.</p>

NEC will update the affected products.

NEC does not recommend a S/W workaround as first choice as it is fairly complex. On the one hand it is based on the control of workmitting transmission requests only when the bus is idle. On the other hand a less complex algorithm can be used which does not prevent the unexpected reception but detects it safely and discards the unexpected reception in the CAN S/W driver. Any of these algorithms require that message buffer #0 is not used or that a 'dummy' TRQ in an unused buffer is set. This prevents behaviors as described in 2.

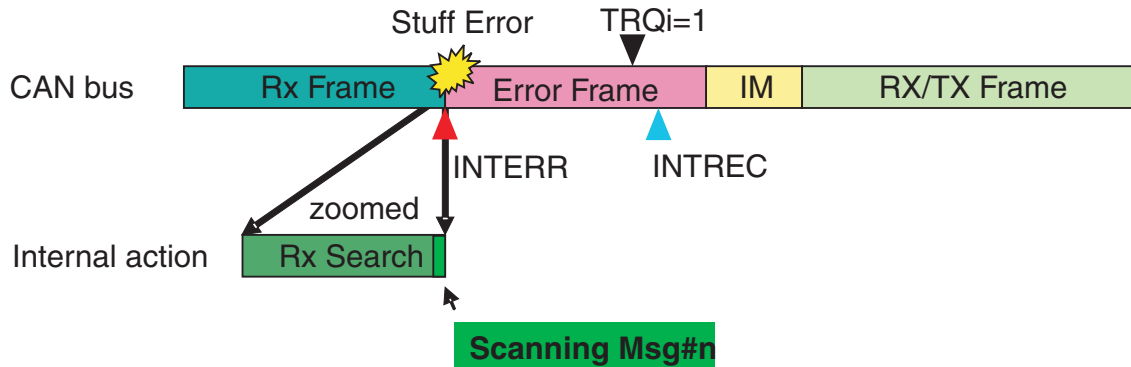
2. Behavior without pending TRQ (TRQi = 0)

In case the host processor has not submitted a transmit request (TRQ) for any buffer before the detection of the bus error but submits TRQ = 1 after that point in time (see figure below) before the re-transmission of the message interrupted by the stuff bit error started, the unexpected reception of the message will take place.

The unexpected storage of the message is issued in the particular message buffer that matches the acceptance filter criteria at the time where the bus error is detected (as described in 1.) or the message buffer #0 is overwritten independently of its configuration.

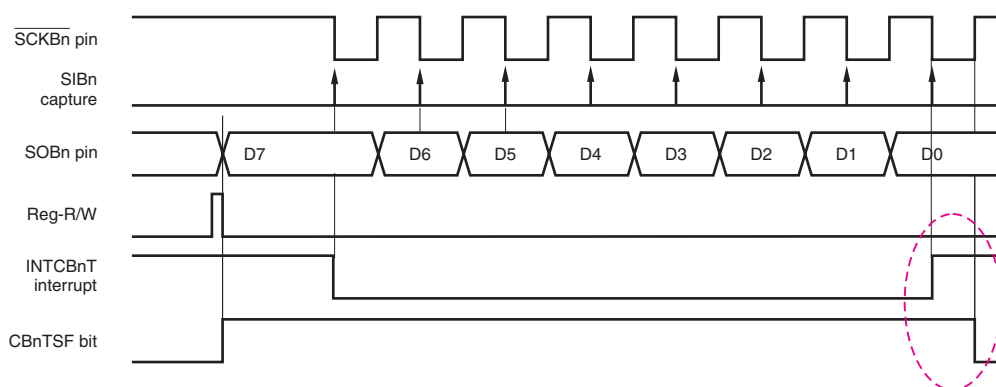
Transfer operation in case of single transfer mode and CBnCKP=0, CBn0DAP=1

In the case single transfer mode and CBnDAP=1, transmission enable interrupt (INTCBnT) occurs at the sampling timing of the final data bit.

When CBnTSF = 1 after transmission enable interrupt (INTCBnT) occurred, writing next data to CBnTX register for a subsequent transfer may not start next transfer.

Therefore, if DMA is used, depending on transfer clock and access speed on the special function registers, the transfer operation may fail.

In single transfer mode, when CBnDAP=1, check whether the CBnTSF flag is cleared (0) or not. If CBnTSF flag = 0, write next transfer data to CBnTX register.

If DMA transfer function is used, only transfer modes with CBnDAP=0 should be used.

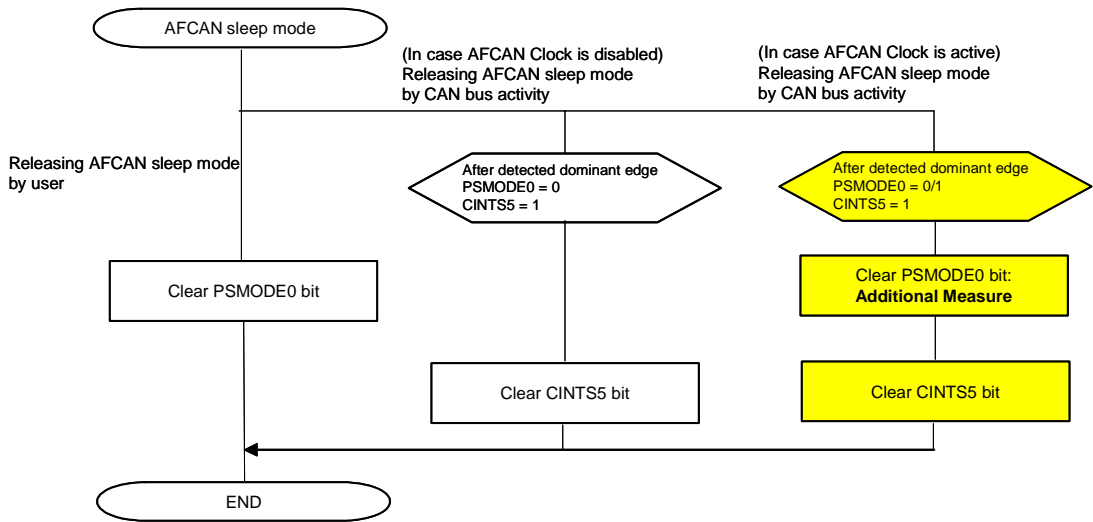
Figure: Additional Measures in case AFCAN clock is active when waking up

The following flowchart illustrates, how and whether additional measures have to be taken in software, to avoid the *wakeup dead time*.
