# NEC Microcomputer Technical Information

<p>V853 32-Bit Microcontrollers Usage Restrictions</p>	Document No.	ZBG-CC-05-0074	1/1
	Date issued	December 15, 2005	
	Issued by	Solution Development Group Multipurpose Microcomputer Systems Division 4th Systems Operations Unit NEC Electronics Corporation	
<p>Related documents</p> <p>Hardware User's Manual: U10913EJ6V0UM00 (6th edition)            Architecture User's Manual: U10243EJ7V0UM00 (7th edition)            Data Sheet (mask ROM): U13188EJ6V1DS00 (6th edition)            Data Sheet (flash memory): U13189EJ5V1DS00 (5th edition)</p>	Notification classification	√	Usage restriction
			Upgrade
			Document modification
			Other notification

## List of Usage Restrictions in V853

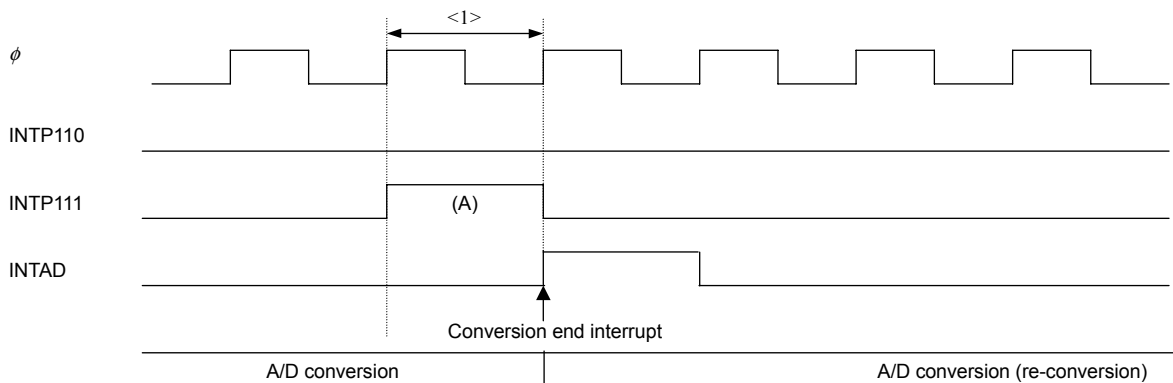
**Example of Timing at Which This Restriction Applies**

If a timer match interrupt (INTCC111, INTCC112, or INTCC113) or an external pin interrupt (INTP111, INTP112, or INTP113) occurs when the 1-trigger mode of the timer trigger mode or external trigger mode is used, A/D conversion may be re-started after A/D conversion ends.

Originally, only INTCC110 can be the trigger to start the A/D converter in the 1-trigger mode, and ADTRG pin input in the external trigger mode, therefore the interrupt sources listed below should be ignored. However, if one of the interrupt sources listed below occurs immediately before the end of A/D conversion (<1> in the figure below; 1 internal system clock), it is mistakenly judged as the A/D conversion start trigger. As a result, A/D conversion is started again after the A/D conversion end interrupt (INTAD) is issued. The first A/D conversion ends correctly and the result is stored in the ADCRn register (this value can be read during the second conversion).

**Caution** The external interrupt signal that functions alternately as the external capture trigger input of timer 1 can also be a trigger for re-conversion. In the case of an external interrupt input, this restriction applies when a valid edge is input before the timing of (A) in the above figure by the noise eliminator (digital noise elimination (2 to 3 internal system clocks)).

- (1) Start A/D conversion in the A/D trigger mode by setting the ADCE bit of the ADM0 register to 1 in the interrupt service routine of the timer match interrupt or external pin interrupt.
- (2) Do not use the compare match interrupt (INTCC111/112/113) and external interrupt signal (INTP111/112/113) during A/D conversion.
