R20TS0733ES0100

CS+ Code Generator for RX,
e² studio Code Generator Plug-in,
AP4 Coding Assistance Tool for RX

1. When using RSPI2 as resource in SPI operation (four-wire method) or in Clock synchronous operation (three-wire method)

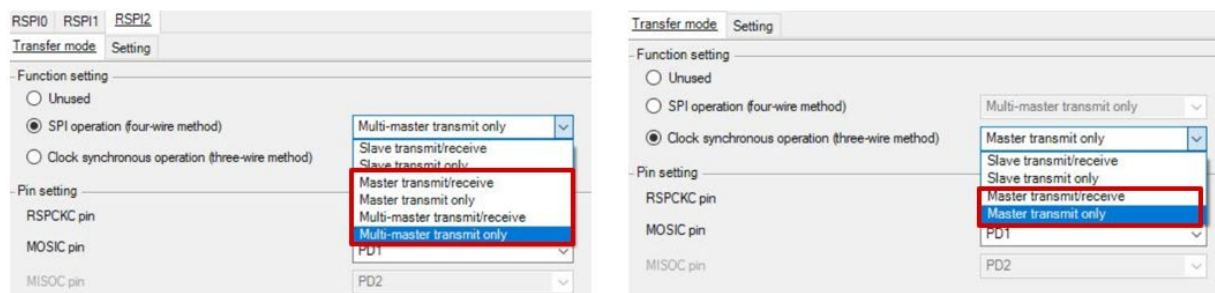
Figure 1: Affected function setting and operation mode

1.3.1 The generated code for enabling SPI2 idle interrupt (SPII2) is wrong

The generated code for enabling SPII2 interrupt should be “ICU.GENAL0.BIT.EN20 = 1U” in the “void R_RSPI2_Create(void)” initialization API, but the actual generated code is “ICU.GENAL0.BIT.EN20 = 0U” instead, thus SPII2 interrupt will not be triggered and r_rspi2_callback_transmitend function will not be executed after data transfer completion even it is configured to be used on the settings GUI tab.

- Affected function setting: SPI Operation (four-wire method) or Clock synchronous operation (three-wire method).
- Affected Operation mode: All Master mode with transmit function.

The development of CS+ Code Generator for RX is completed. Kindly switch to the new tools Smart Configurator for your development.

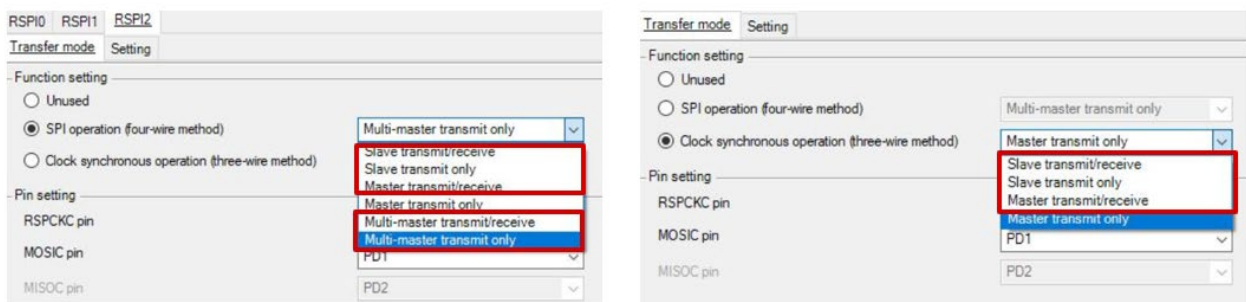
Figure 2: Affected function setting and operation mode

1.3.2 The generated code for enabling SPI2 error interrupt (SPEI2) is wrong

The generated code for enabling SPEI2 interrupt should be "ICU.GENAL0.BIT.EN21 = 1U" in the "void R_RSPI2_Create(void)" initialization API, but the actual generated code is "ICU.GENAL0.BIT.EN21 = 0U" instead, thus SPEI2 interrupt will not be triggered and r_rspi2_callback_error function will not be executed when error occurs during data transmission even they are configured to be used on the settings GUI tab.

- Affected function setting: SPI Operation (four-wire method) or in Clock synchronous operation (three-wire method).
- Affected Operation Mode: All operation mode except Master transmit mode only.
