Renesas Flash Programmer

R20TS0330EJ0100 Rev.1.00 Jul. 16, 2018

Outline

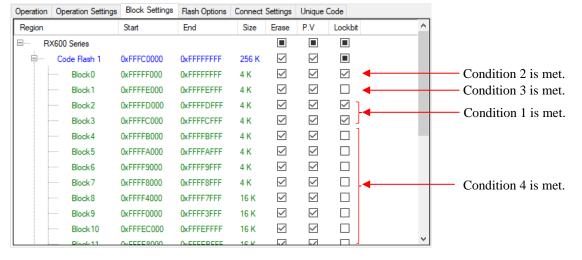
2.3.2 Lock Bit Write Error

If all the following lock bit setting conditions are met and lock bits are written by the flash option programming command, RFP displays the following error message, and then stops flash operation.

Error (E1000011): A write error occurred in the device. (Response 77:53)

Condition 4: A block whose block number is larger than those in condition 1 is not selected.

Example case: When only Block0, Block2, and Block3 are selected for lock bit setting

The error message indicated above is displayed, and then RFP flash operation stops.

4. Schedule for Fixing the Problem

This problem will be fixed in V3.05.00. This program will be available from July 20, 2018.

Lock bits that are written incorrectly can be corrected by running commands in V3.05.00.

Execute the following command in sequence for the blocks containing the lock bits to be corrected.

- (1) Block Erase command
- (2) Program command and Program Flash Options command
