[Notes]

R20TS0679EC0100

## Smart Configurator for RH850

### Outline

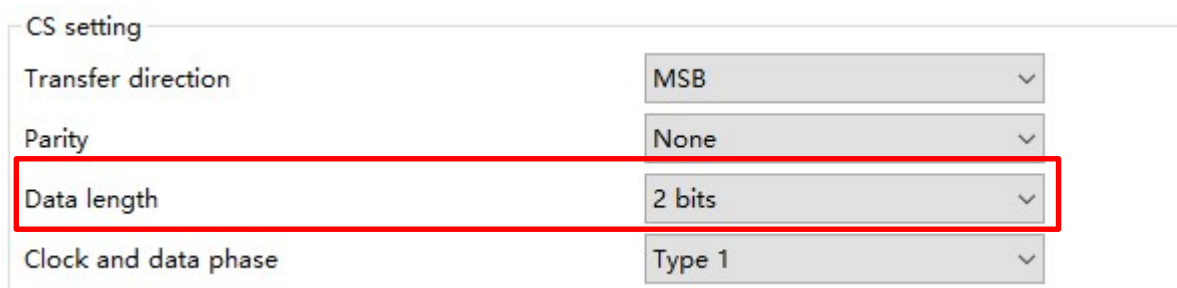
When using CSI master mode and CSI Slave mode on the following peripherals, data transmission occurs error when data length are selected as "2 bits", "3 bits", "4 bits", "5 bits" and "6 bits" on GUI (refer to Figure 1-1 Setting of CSI Master Data length and Figure 1-2 Setting of CSI Slave Data length).

Please don't select data length as "2 bits", "3 bits", "4 bits", "5 bits" and "6 bits" on CSI Master and CSI slave GUI when using CSIG.

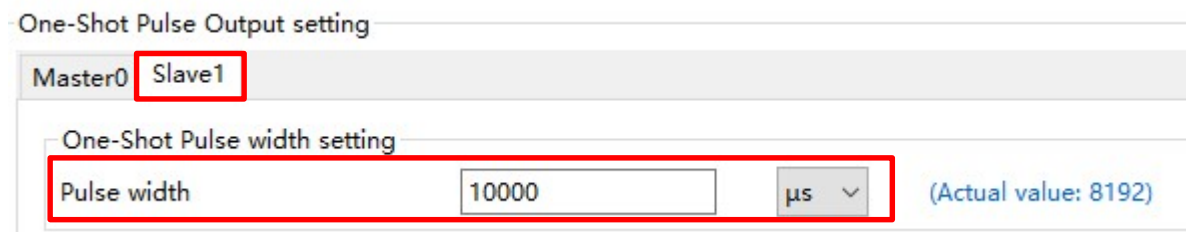
Figure 4-1 Setting of One-shot pulse width

When using One-Pulse Output and One-Shot Pulse Output on the following peripherals, the actual output pulse width has one count clock cycle error due to wrong value is set to timer data register.

Step2: Click “Generate Code” and check the following macro value in “Config\_TAUB0.h” file, the value in red need to be confirmed.

Step3: If user find the actual One-shot pulse width output in his own system is not as expected 10000 us, user can increase this macro value by “1”, as the following value in blue.
