# 1 Purpose of Document

This document summarizes the changes between the previous SAP5 silicon revision C and the current silicon revision D. These include requested UART design changes. The purpose of the redesign was to correct reported timing errors by the UART in the following modes: Master, Monitor, and Repeater. A problem with slave communication in special network constellations was also fixed.

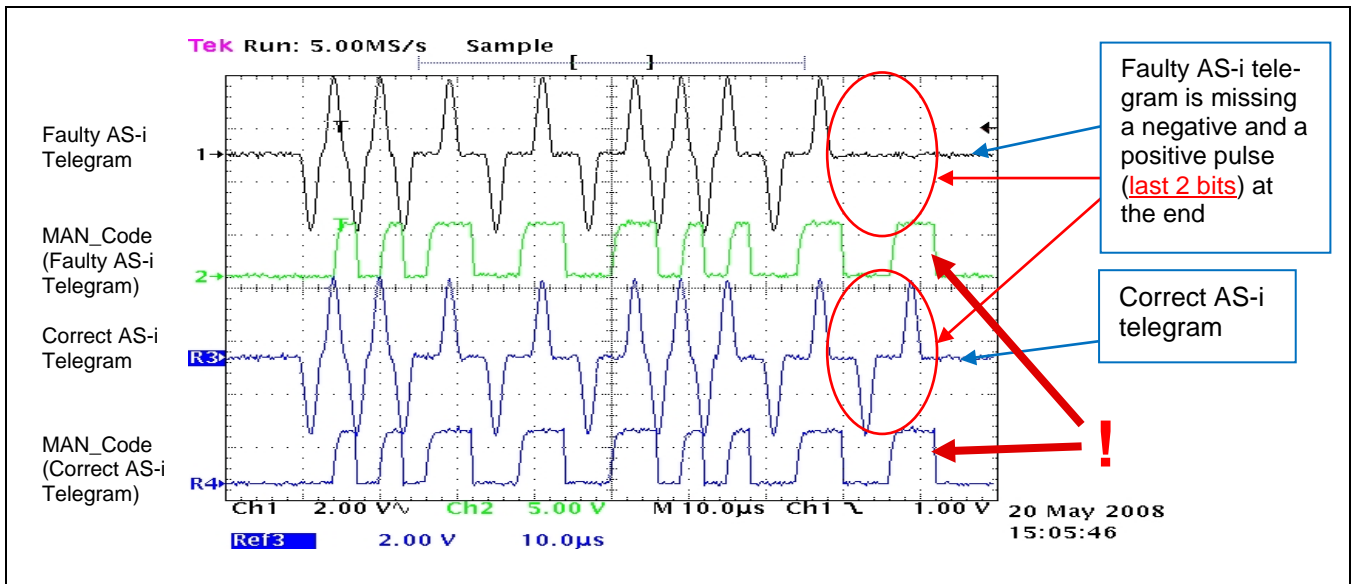
**Figure 2.1 Comparison of Valid MAN-Code Signal to Faulty MAN-Code Signal**

If the SAP5 revision C operates in Master Mode or in Repeater Mode, the error signaling for an *End\_Bit\_Error* does not work correctly. In some special cases, the generated MAN-Code of a signal with an *End\_Bit\_Error* looks similar to the MAN-Code of a signal without any errors as demonstrated in Figure 2.1.

This malfunction of the SAP5 revision C results in an MAN coded output signal that does not allow distinction between correct AS-I pulse sequences and pulse sequences that are shortened (missing one negative and one positive pulse). It occurs only under the following conditions:

- The parity of the signal is even.
- The last bit of the corrupt telegram is equal to binary 1.
- The *Stop\_Bit* and the *Parity\_Bit* or the *Start\_Bit* and the *Control\_Bit* are missing.
- If the *Start\_Bit* and the *Control\_Bit* are missing, the first pulse must have a negative polarity.

The following changes in the UART block were implemented in SAP5 silicon revision D:

1. A new principle for ASI-telegram pause detection was implemented. The previous method caused erroneous pause detection in some cases; e.g., a telegram starting with a wrong Start bit (SB=1) and second bit = 0.
2. A new *Endbit\_error* detection principle was implemented to comply with the *AS-I Complete Specification V3.0*. The new principle ensures that an *Endbit\_error* is detected only if the polarity of the pulse at time (36µs/78µs ± tolerance) is negative.
3. The internal computation of *No\_info\_error*, *Timing\_error*, and *Length\_error* was reviewed and corrected to comply with the *AS-I Complete Specification V3.0*.

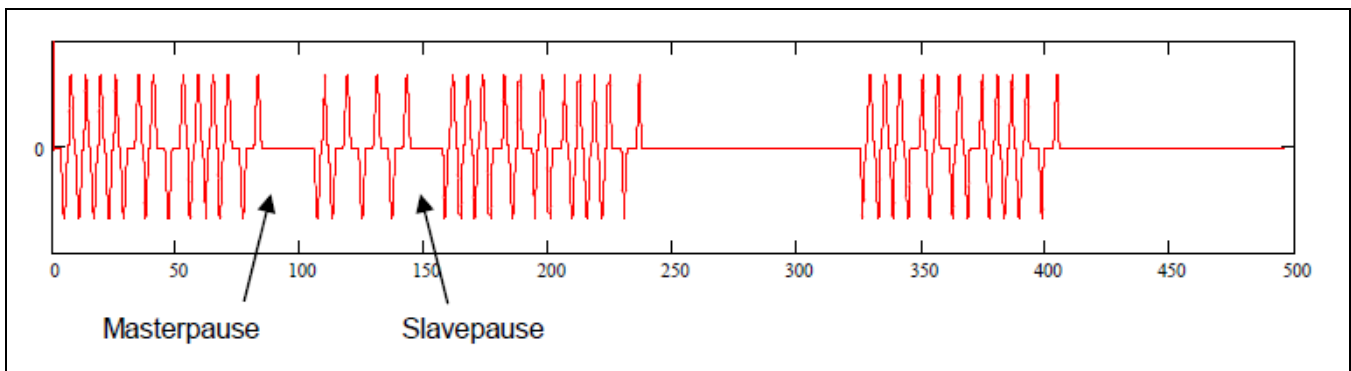
**Figure 3.1 Test for SAP5 Revision C Error in Master Pause Detection**

If the previous SAP5 revision C is operated in Slave Mode, the UART Master Pause detection does not always function correctly when the UART must listen to slave responses from a different slave. Depending on the actual AS-I line pulse timing, a slave response from a different slave is sometimes not recognized correctly, which results in a UART communication error. This prevents the Slave from understanding the next Master telegram correctly. If the Master telegram addresses the Slave itself, the error leads to a missing slave response and the Slave replies on a second repetition of the Master Call to its own address in asynchronous mode.

This behavior was mostly observed in mixed networks that used modules with the ASI4U, SAP5, and SAP4.1.

Figure 3.1 shows a telegram test case to reproduce the error. The AS-I signals shown in Figure 3.1 were generated by a signal generator that allowed sweeping the Master Pause and Slave Pause duration over the allowed specification limit. The first Master Call contains a different slave address than the tested slave. The second and third master calls address the tested slave. The tested slave replied with the erroneous behavior for certain Master pause and Slave pause scenarios only. The majority of the test cases were passed without error.

A new principle of AS-i telegram pause detection was implemented in SAP5 silicon revision D that is more precise and able to cover all valid timing scenarios for Master and Slave pauses. The new principle is now independent of the internal timing constraints of the UART state machine.
