RENESAS TECHNICAL UPDATE

Product Category	MPU/MCU		Document No.	TN-H8*-A426A/E	Rev.	1.00
Title	Additional Usage Notes on Interrupts		Information Category	Technical Notification		
Applicable Product	H8SX Group	Lot No.	Reference Document	Refer to the "Reference Documents" section below		
		All lots

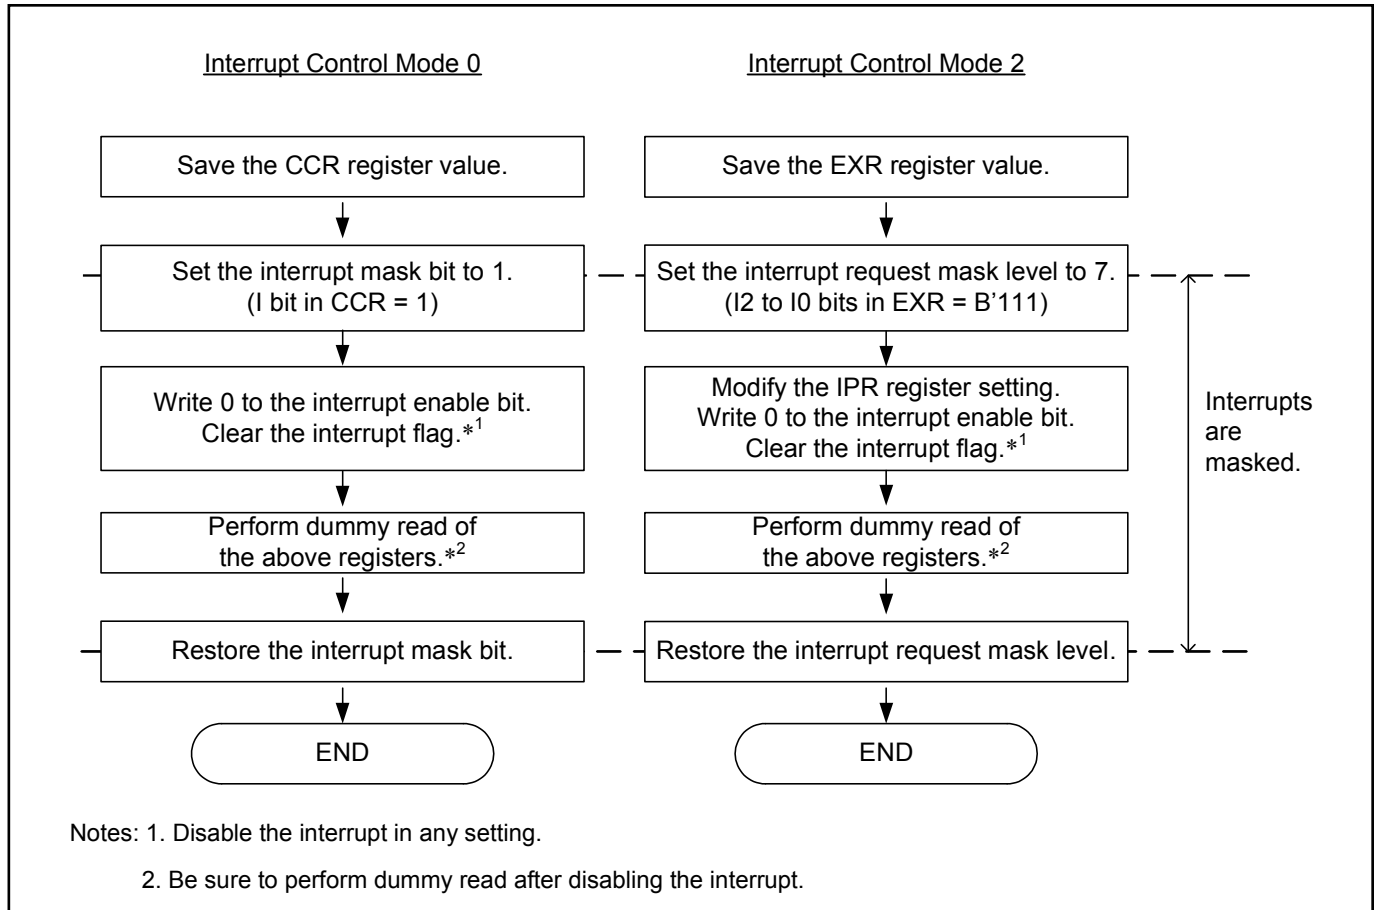
Figure 1 Interrupt Masking Procedure to Avoid Conflict between Interrupt Generation and Disabling

As described in the Usage Notes of the interrupt controller in the hardware manual, when there is a conflict between interrupt generation and interrupt disabling by clearing the interrupt enable bit or interrupt source flag, the interrupt exception handling for that interrupt may be executed on completion of the interrupt disabling instruction. For this note, we found additional applicable behavior and register setting.

If this conflict occurs in interrupt control mode 2, the interrupt exception handling with priority equal to or lower than the interrupt mask level (I2 to I0 setting in EXR) may be executed on completion of the interrupt disabling instruction.

In addition, note that the interrupt priority register (IPR) may generate this conflict.

When a conflict between interrupt generation and disabling may occur in your system, avoid it by masking interrupts as shown in figure 1. There is no additional note about interrupt control mode 0, but if a conflict may occur in this mode, it should also be avoided through the procedure shown in figure 1.
