# RENESAS TECHNICAL UPDATE

Product Category	MPU/MCU		Document No.	TN-RX*-A023A/E	Rev.	1.00
Title	Note on Using Multi-Function Timer Pulse Unit 3 (MTU3) Interrupts		Information Category	Technical Notification		
Applicable Product	RX 62T Group, RX 62G Group, and RX 63T Group	Lot No.	Reference Document	RX62T Group User's Manual: Hardware		
		All lots		RX62G Group User's Manual: Hardware RX63T Group User's Manual: Hardware

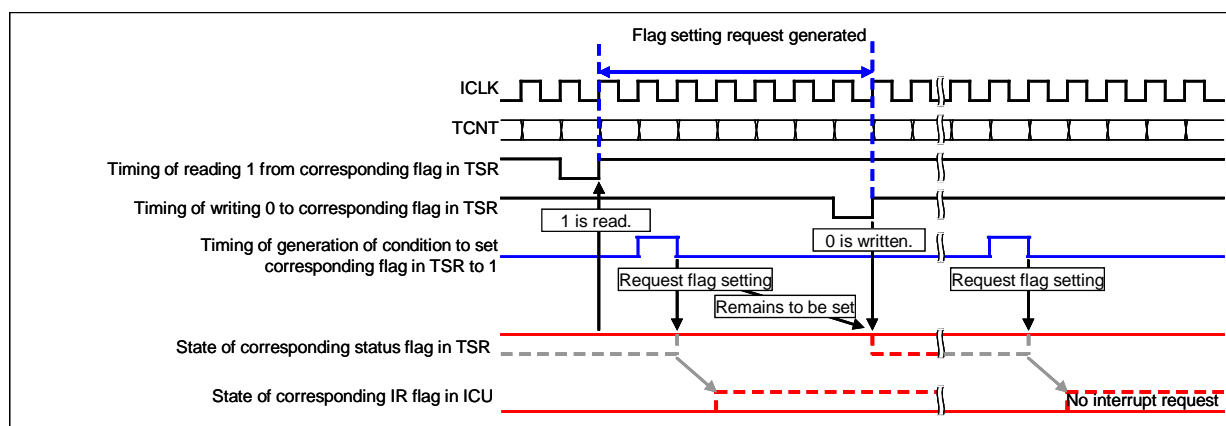
If a status flag (\*1, \*2, and \*3) in the timer status register (TSR) is cleared to 0 at a certain timing, no MTU3 interrupts may be issued to the CPU after that. The following gives the details.

The specified procedure for clearing a flag is reading 1 from the flag and then writing 0 to the flag as described in the manual (\*4). However, if the interrupt is generated after 1 is read from the corresponding flag before the flag is cleared to 0, the corresponding flag is not cleared but remains 1, thus disabling the clear-to-0 instruction as shown in the figure below. Once this condition occurs, if the interrupt is generated while the status flag is 1, the interrupt status flag in the ICU (IR bit in the IR register) is not set to 1 and thus any interrupt to the CPU is ignored (\*5). Consequently, if an interrupt is generated during the above period or after that before the status flag is reset next time, the interrupt is not processed. To prevent this, use the procedure that is given in section 1.2 to clear a status flag.
