RENESAS TECHNICAL UPDATE

Product Category	MPU/MCU		Document No.	TN-RZ*-A021A/E	Rev.	1.00
Title	Ethernet MAC reception issue in case TCPIP accelerator enabled		Information Category	Technical Notification		
Applicable Product	RZ/T1 GROUP	Lot No.	Reference Document	RZ/T1 Group User's Manual: Hardware Rev1.2 R01UH0483EJ0120		
		All lots

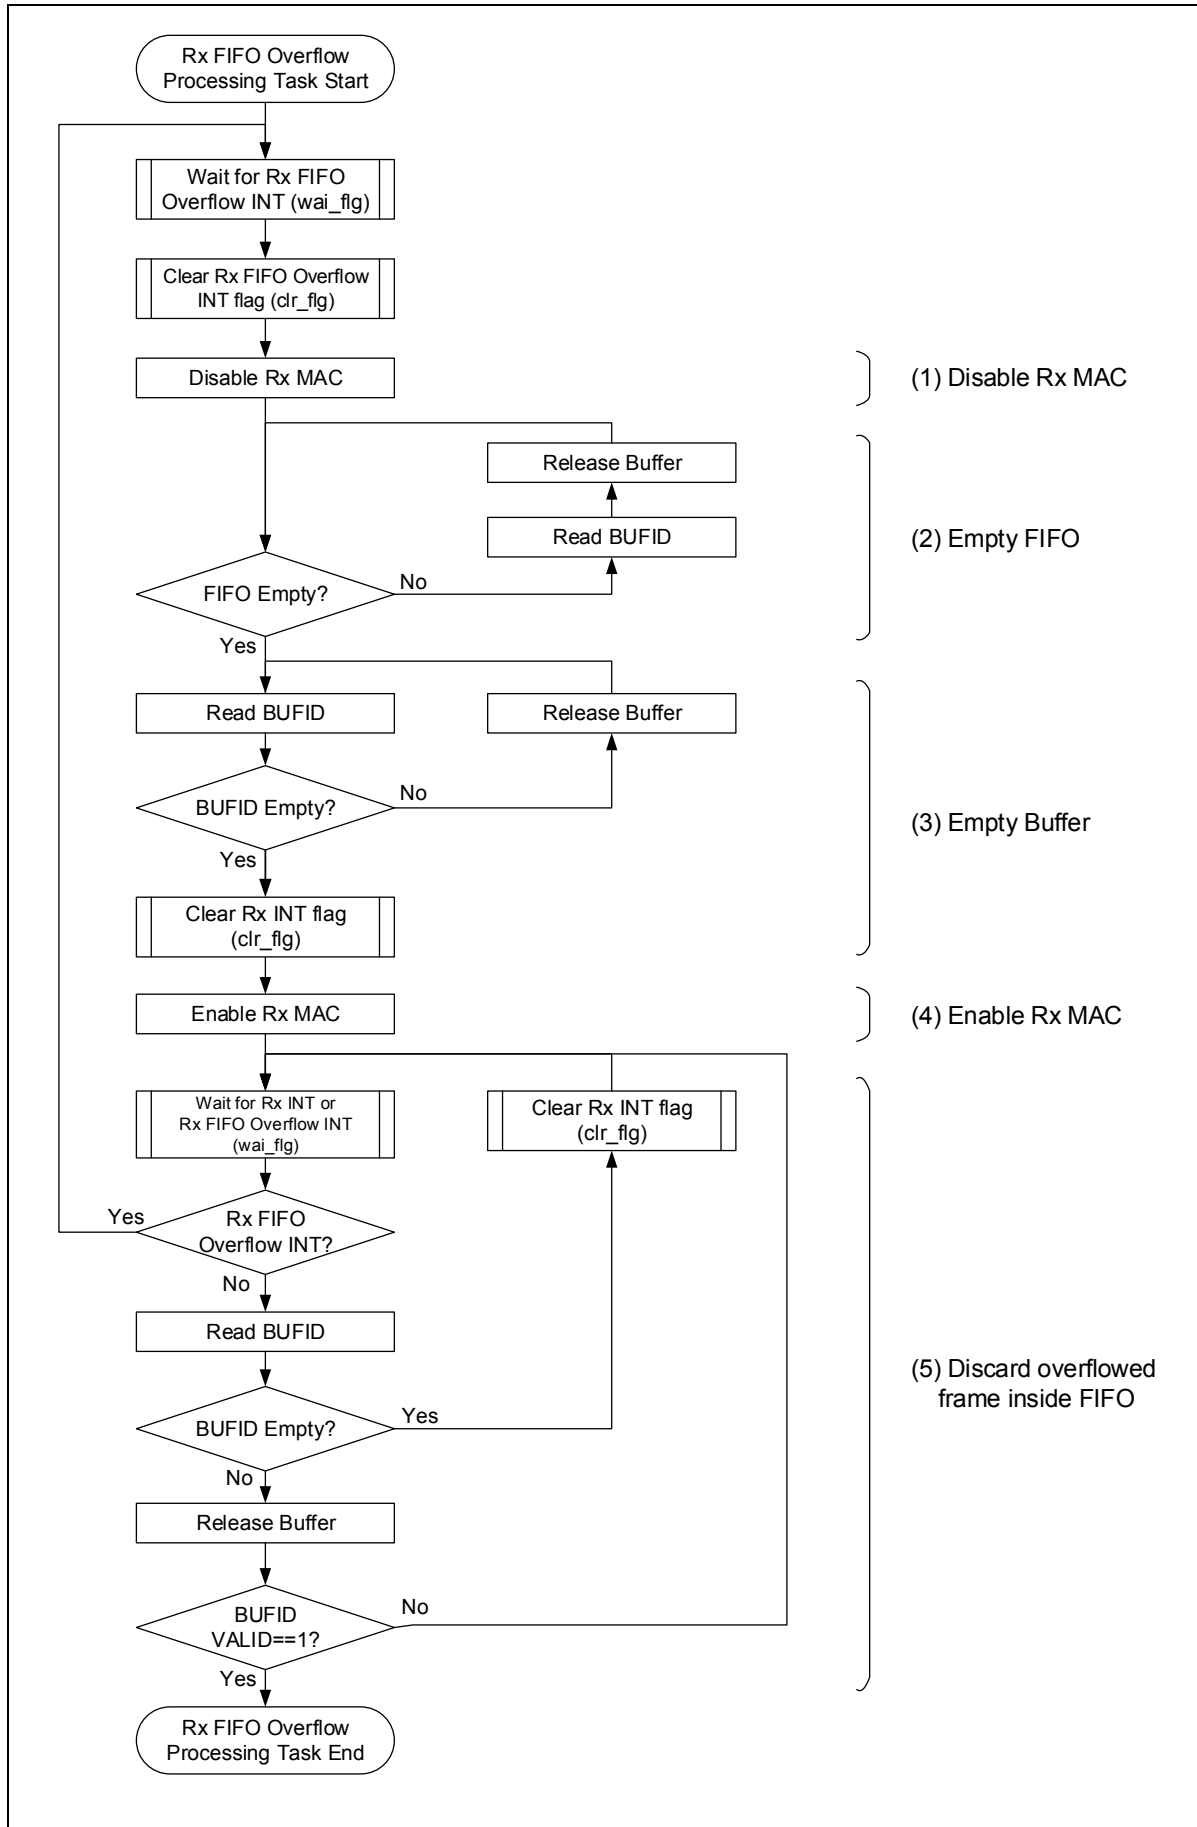
Fig1: Flowchart of RX FIFO overflow processing task (In case of using HW-RTOS)

- It is possible that error information which is related to the previous error frame is included in frame information of normal reception frame.
- It is possible that abnormal frame which caused Rx FIFO overflow is regarded as normal frame because of illegal value is included in frame information

In case Rx FIFO overflow is occurred when Rx TCPIP accelerator is enabled.

(B) When Rx FIFO is overflowed, discard all frames left in Rx FIFO and Buffer RAM. Specifically, apply the following procedure;

(1) Disable Rx MAC.

(2) Discard all frames left in Rx FIFO.

(3) Discard all frames left in Buffer RAM.

(4) Enable Rx MAC.

(5) Discard at least one frame with BUFID VALID bit = 1. This is because FIFO empty state can be read even if the frame which caused FIFO overflow remains in the FIFO. Receive normal frame once and discard remained abnormal frame with it.

- ✓ Create overflow processing task with higher priority than one of reception processing task
- ✓ Start overflow task by HWISR combined with FIFO overflow interrupt
- ✓ Discard the abnormal frame remained in the FIFO by HWISR combined with reception interrupt

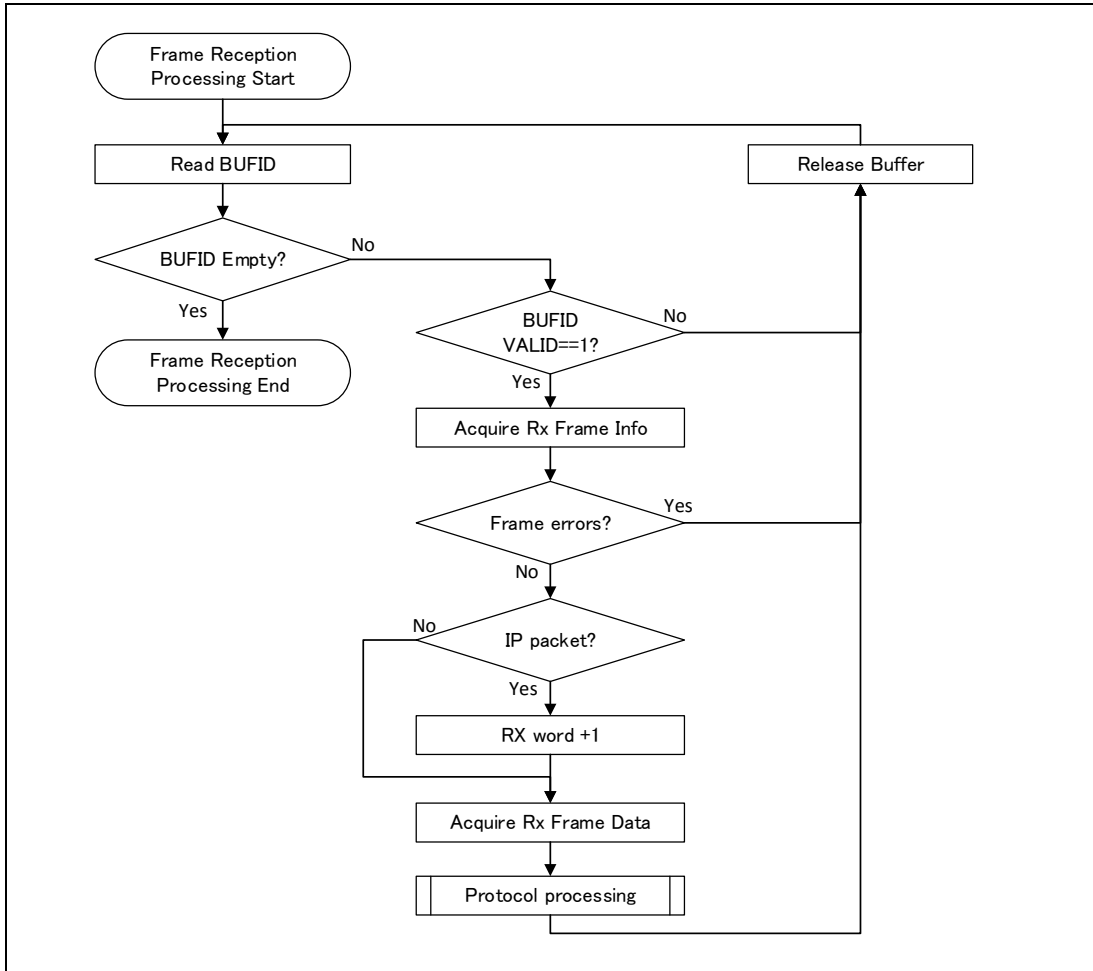
Fig 5: Flowchart of Reception processing

It is possible that reception word size (RX_WORD[12:0]) in the frame information increases by 1 word (4 bytes) or decreases by 1 word compared with correct size. In case of decrease by 1 word, it is possible that RX_WORD indicates the size which causes lack of IP packet. IP packet itself is NOT lacked.

- (A) RX TCPIP accelerator enabled
- (B) Reception frame meets all the following conditions;
 - (1) Frame size including FCS is more than 64 bytes.
 - (2) TCP/IP or UDP/IP packet is included.
 - (3) Padding (Trailer) is included between IP packet and FCS.

- (B) In order to avoid lack of the IP packet, increase reception word size by 1 and transfer the size to protocol stack.

In the protocol stack, payload data should be extracted based on size of Total Length field in IP header and the rest data should be discarded. Fig 5 is the flowchart of this workaround.
