Errata Sheet

SLG46108

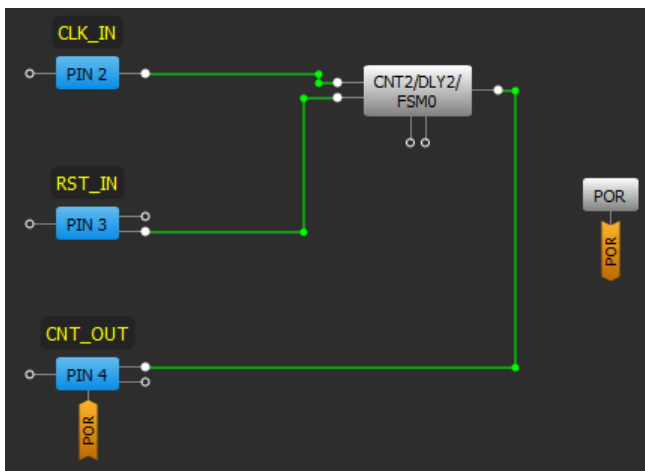
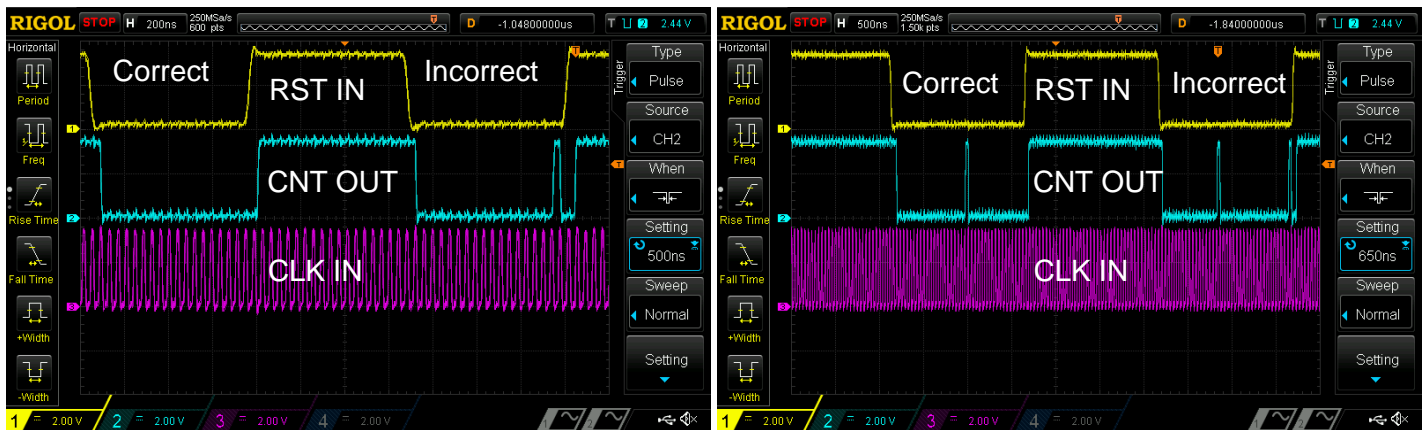
ISSUE 1: Incorrect Counter Operation after the Reset

If the Counter Reset is asserted at the same time as a rising clock edge, it is possible that the Counter Data will be reset incorrectly and the counter output may appear faster than expected, it doesn't depend on Edge select option. This phenomenon appears more often as the clock frequency increases.

- Synchronize the RESET input of the Counter with its CLK using 2 DFF cells as shown in the image below.

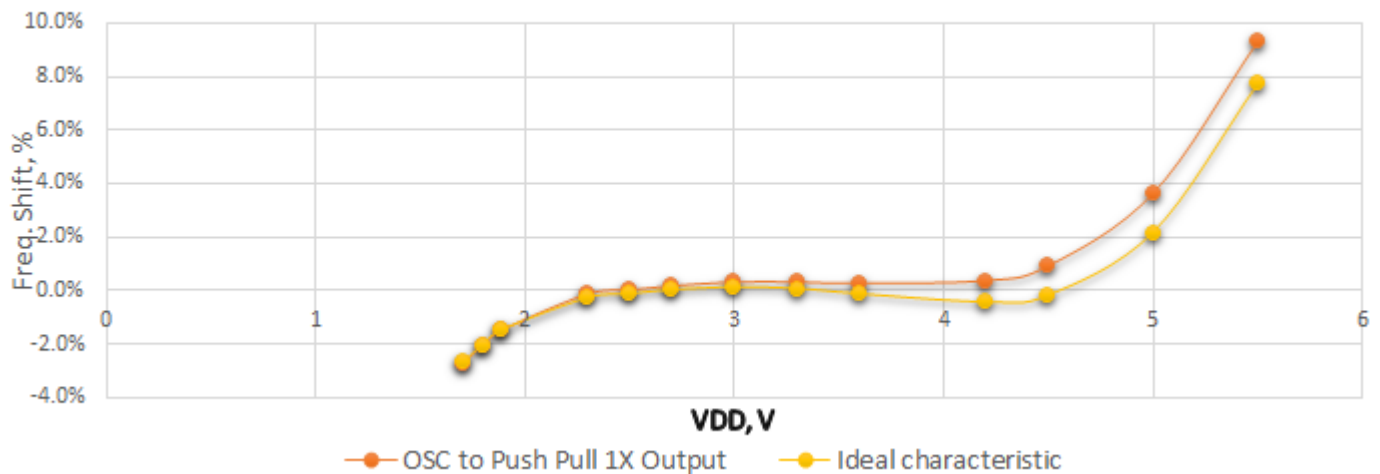
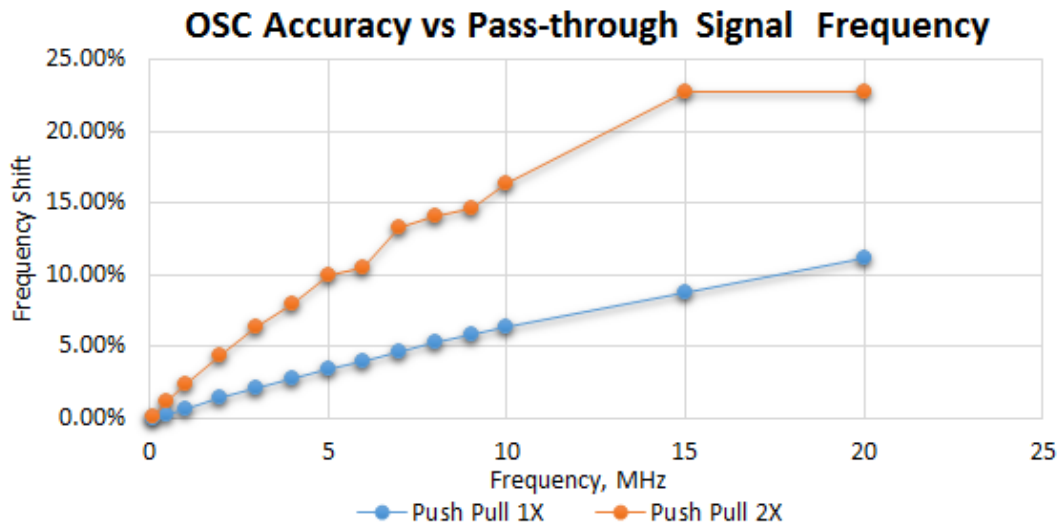
OSC Accuracy vs VDD

ISSUE 2: VDD Noise Influences OSC Variation Functional Blocks Affected: OSC, Counter/Delay

White applying some high frequency noise to the VDD, OSC inaccuracy may increase. The same behavior is also present in cases where high frequency switches are outputted from the chip using the Push Pull type driver. See, test results below.

VDD =5 V Trim VDD = 3.3 V	Push Pull 1X	Push Pull 2X	Push Pull 1X	Push Pull 2X
OUT PIN #	f shifted, %	f shifted, %	average	average
4	1.42 %	3.63 %	1.52 %	3.81 %
6	1.67 %	4.03 %		
7	1.62 %	3.98 %		
8	1.38 %	3.59 %		
4 ... 8	6.73 %	11.98 %

Currently there are no viable workarounds for this issue.

However, the issue can be minimized by doing the following:

- Only use frequencies lower than 2 MHz when switching the output.
- Do not use parallel PIN connections to output high speed switching signals.

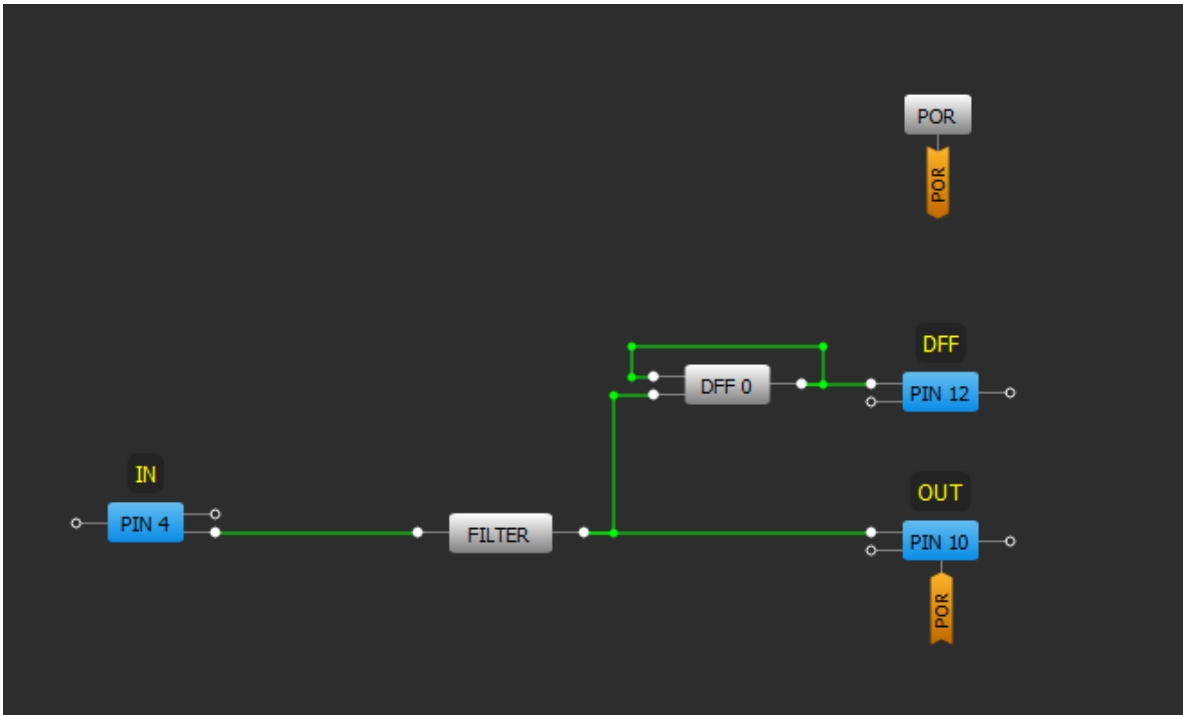
Channel 1 (yellow/top line) – PIN#4 (IN).
 Channel 2 (light blue/2nd line) – PIN#10 (OUT).
 Channel 3 (magenta /3rd line) – PIN#12 (DFF).

1. Period is 60 ns. Pulse width is 10 ns, DC = 16.7 % (correct functionality).

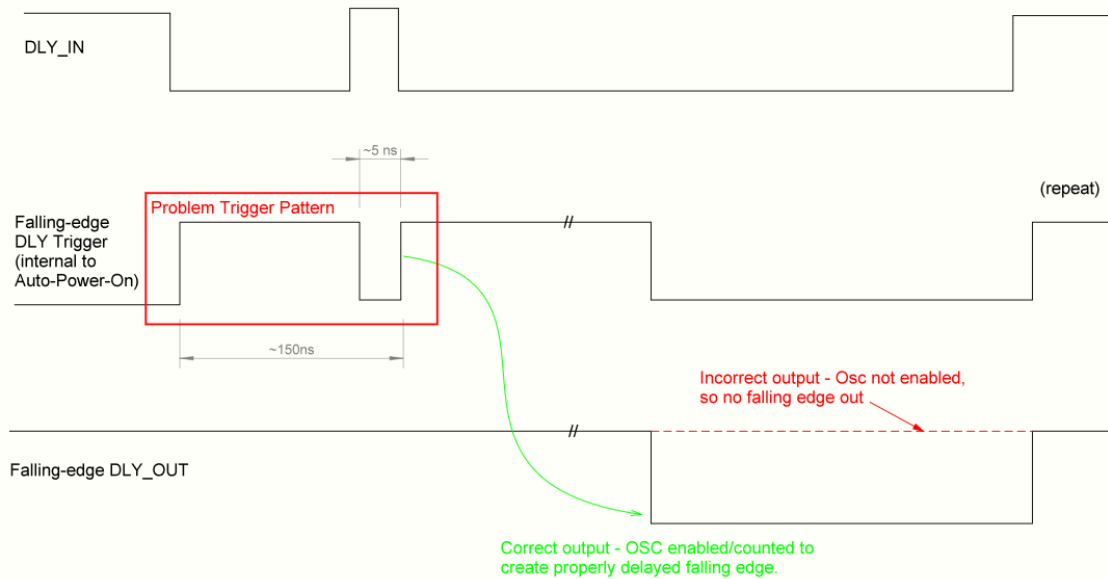
Figure 1

For this chip, the Auto Power On circuitry of the 25 kHz/2 MHz generators contains a circuit errata, which can potentially fail to power on the OSC for a specific pattern and timing of the OR of all related DLY trigger signals. The pattern is shown in [Figure 1](#) (boxed in red) and consists of a relatively longer pulse (~145 ns) followed by a shorter (~5 ns) glitch of opposite polarity.

1. Use signal conditioning circuits to prevent glitch on DLY inputs < 200 ns. Examples:
 - a. ACMP with Hysteresis
 - b. External RC in front of Digital Input with Schmitt Trigger
 - c. Filter cell.
2. Set OSC power mode to Force Power On mode instead of Auto Power On.
3. Use different oscillator, such as 25 MHz Ring OSC, which does not have Auto Power On issue.

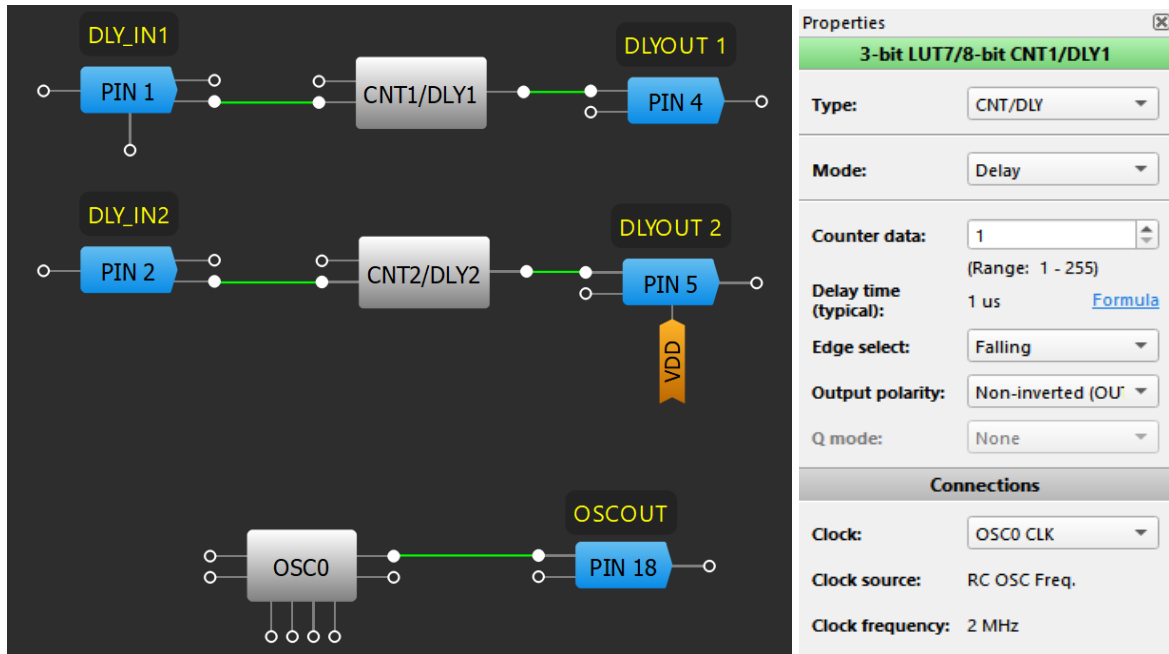
Figure 2: Test Circuit

The error is difficult to capture as the timing must be exact within ns, and short (ns) pulses are difficult to generate glitch precise enough to induce the problem. GPIO naturally filter out ns pulses, so for purposes of errata capture, two simultaneous falling-edge DLY circuits (as shown in [Figure 2](#)) were used. By lining up two delays precisely at a particular timing relationship, we can use the internal Auto Power On (OR logic) to generate the glitch pattern necessary to cause the error.

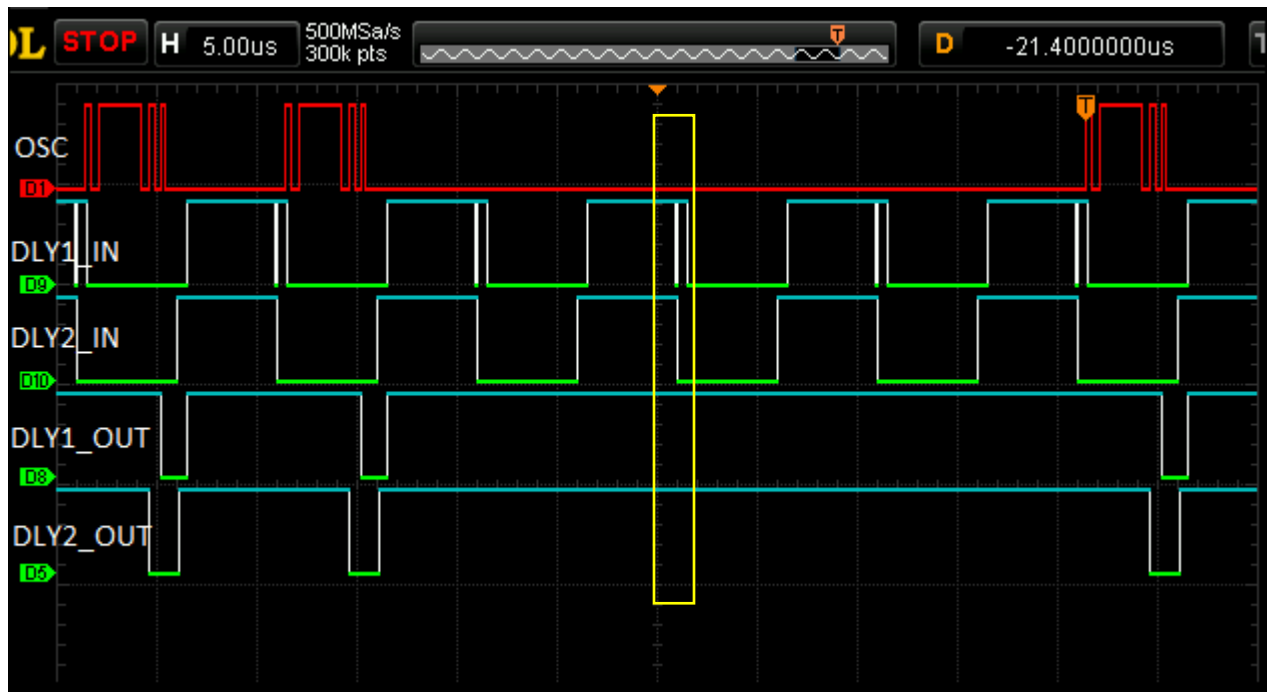
Figure 3: Errata Capture (Zoom Out)

Figure 3 shows a series of DLY output events are missing, where the OSC is correspondingly not triggering when it was supposed to. Figure 4 is a zoom in of the boxed region from Figure 3. The total glitch/chatter time was measured in this case at 152 ns. By using the composite OR of the two delay channels, we can asynchronously strobe with tiny frequency variations, and so tune the timing to induce this errata. Note that the error is not persistent – the system is recovered when all DLYs are returned to inactive state, such as when input of falling edge DLY goes high, thus canceling delay, or after DLY out finishes.

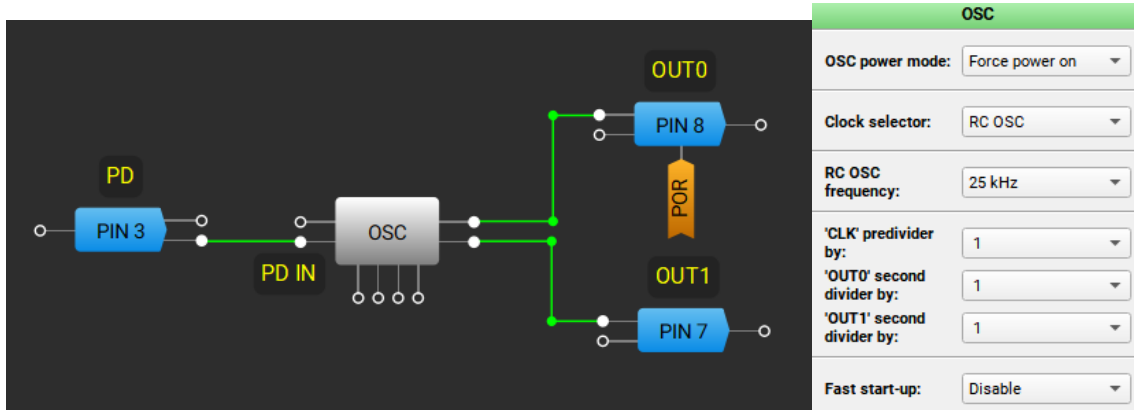
Figure 5: Test Design

When a short pulse is applied to the PWR DOWN input, the oscillator exhibits a long start-up time.

When a short pulse of less than ~40 ns is applied to the PWR DOWN input.

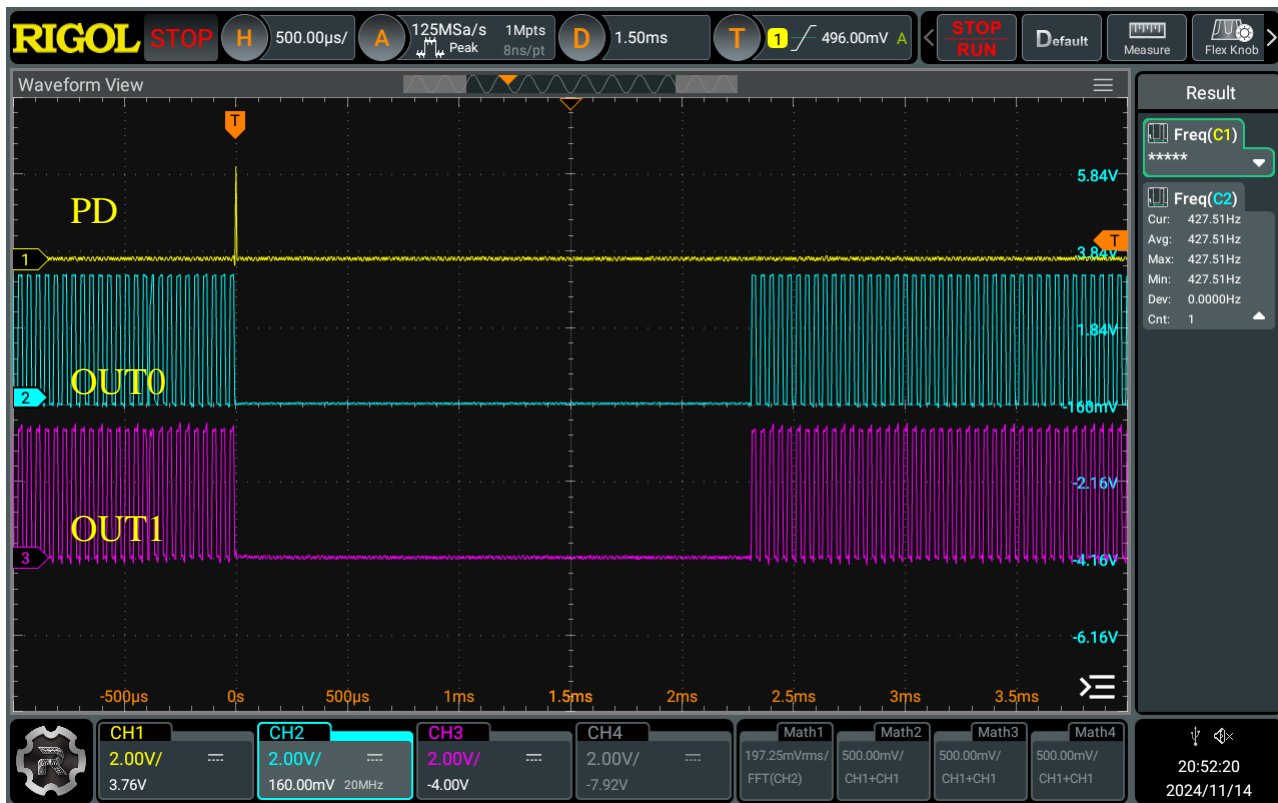
Figure 6: 25 kHz OSC Long Start-Up

If a pulse with a duration of less than ~40 ns is applied to the PWR DOWN input of the oscillator, the oscillator outputs remain stuck for milliseconds, as shown in figures below. This issue is observed for both 25 kHz and 2 MHz oscillators.

Change the Fast Start-up setting to "Enable" (see Figure 8) or avoid applying glitches to the PWR DOWN input of the oscillator.
