Errata

SLG46117

CE-GP-012

This document contains the known errata for SLG46117 and the recommended workarounds.

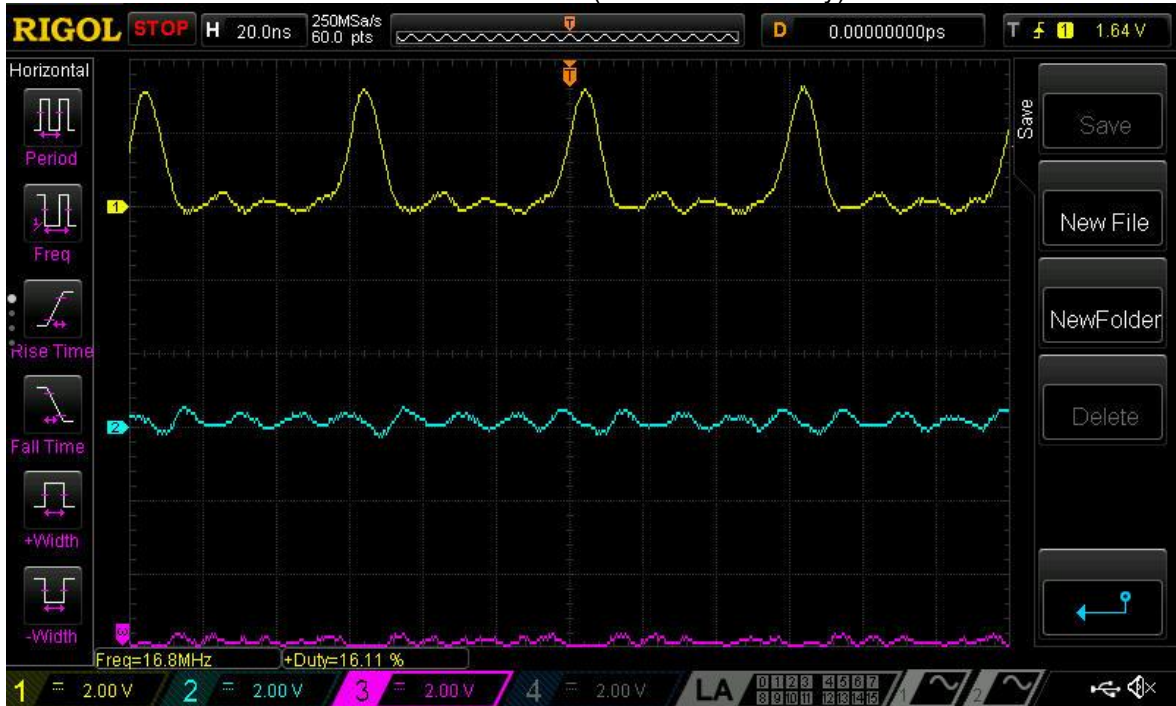
1. Period is 60ns. Pulse width is 10ns DC=16.7% (Correct functionality)

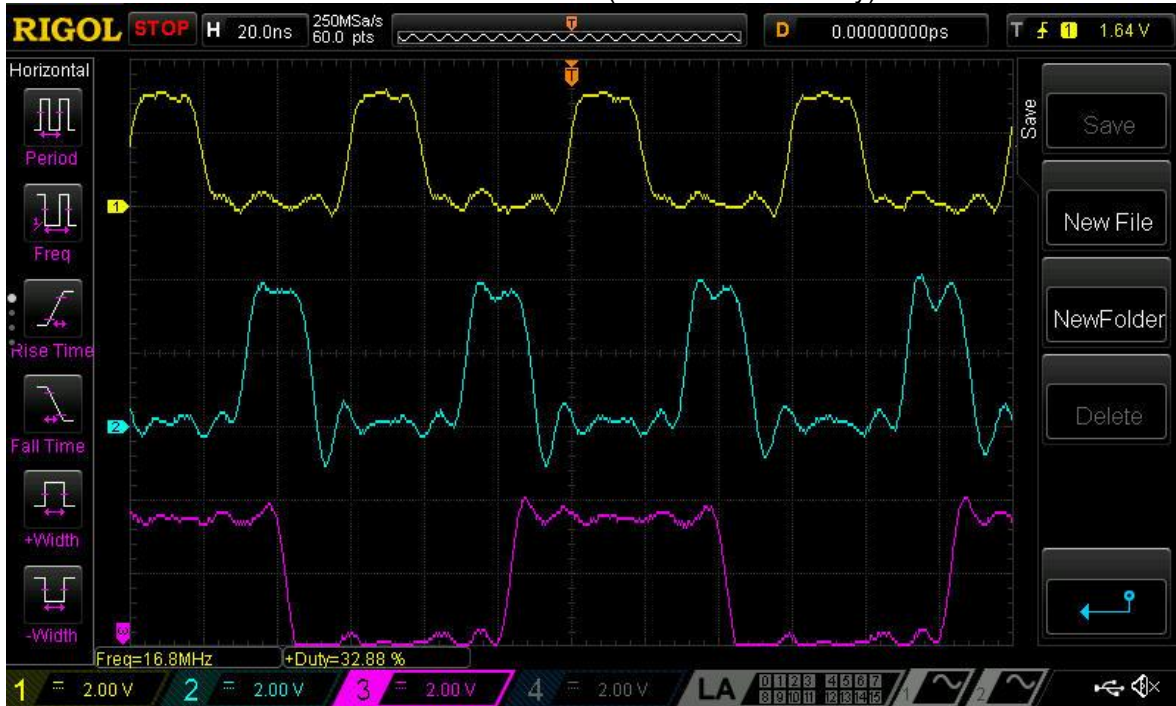
2. Period is 60ns. Pulse width is 20ns DC = 33.3% (Incorrect functionality)

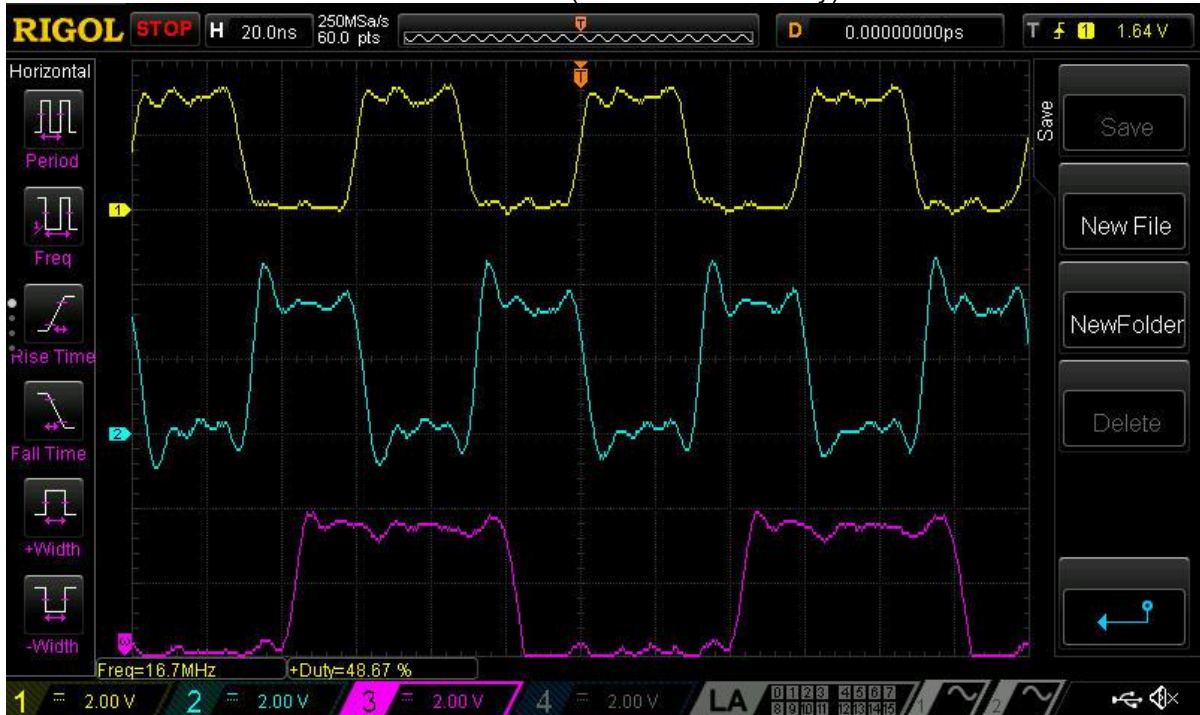
3. Period is 60ns. Pulse width is 30ns DC=50% (Incorrect functionality)

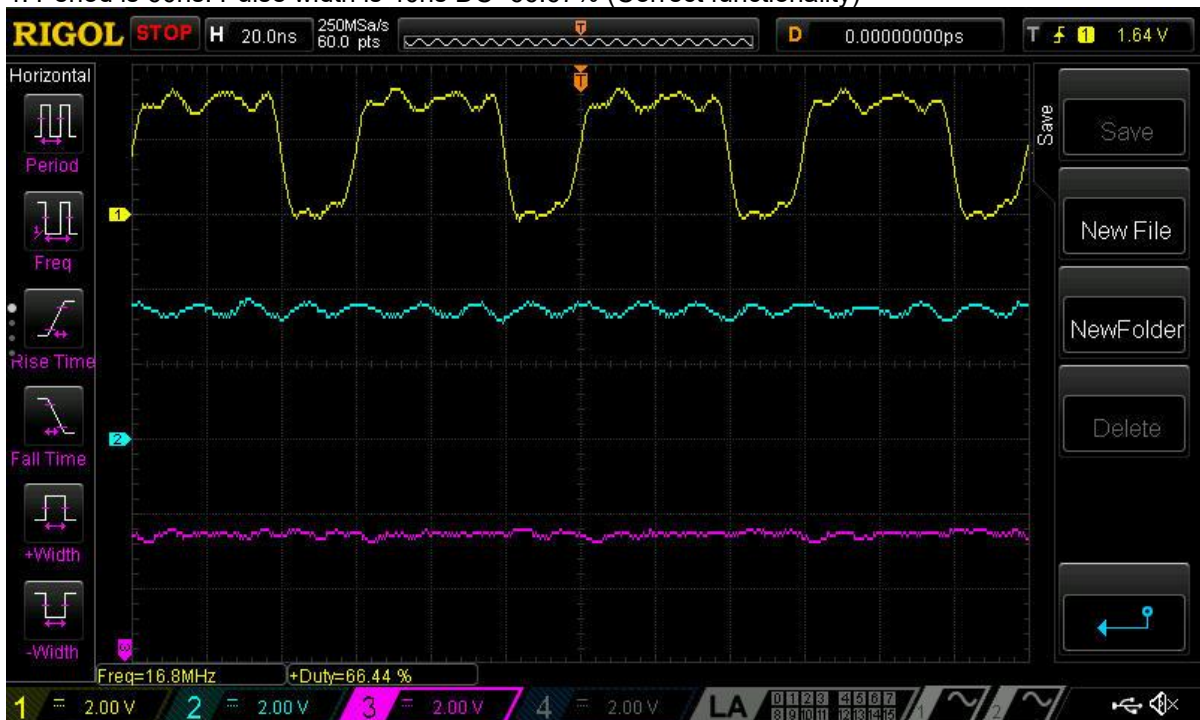
4. Period is 60ns. Pulse width is 40ns DC=66.67% (Correct functionality)

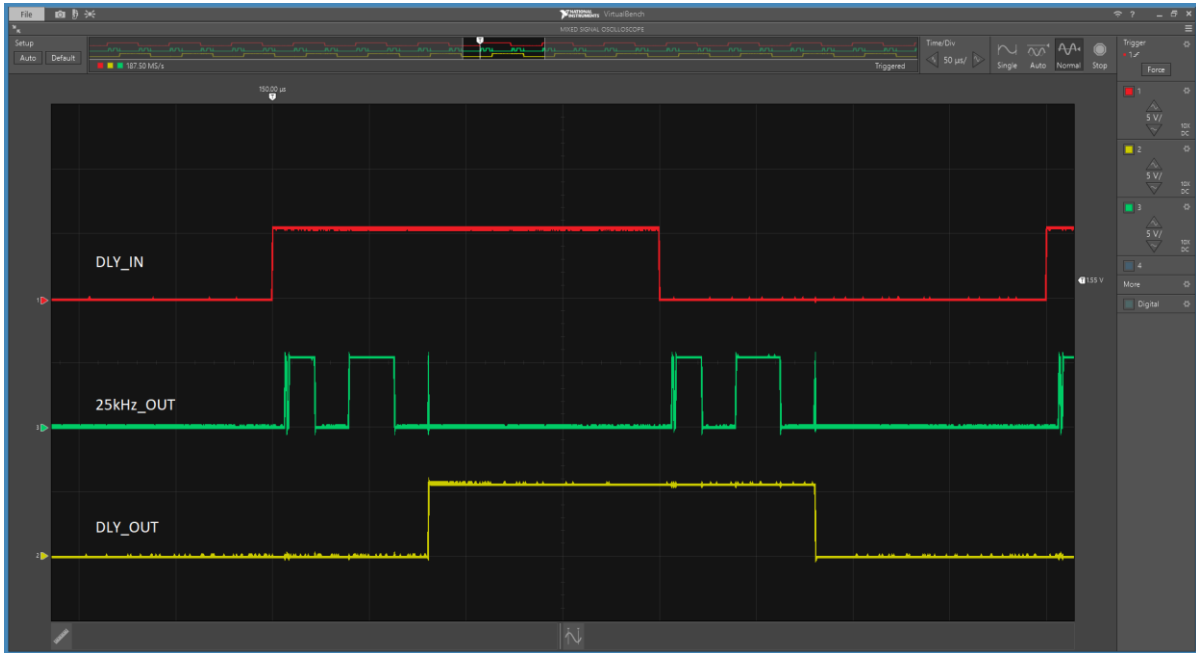
The first period of the RC OSC can be very short when OSC configured as 25 kHz with Auto Power On in the designs. This can be occurred when V_{DD} is above 4.0 V. Critical for CNT/DLY with a low counter data (less than 10) or if it is necessary to use the frequency of the OSC to clock external elements.

Abnormal oscillator behavior.

- Avoid V_{DD} higher than 4 V
- Force ON OSC

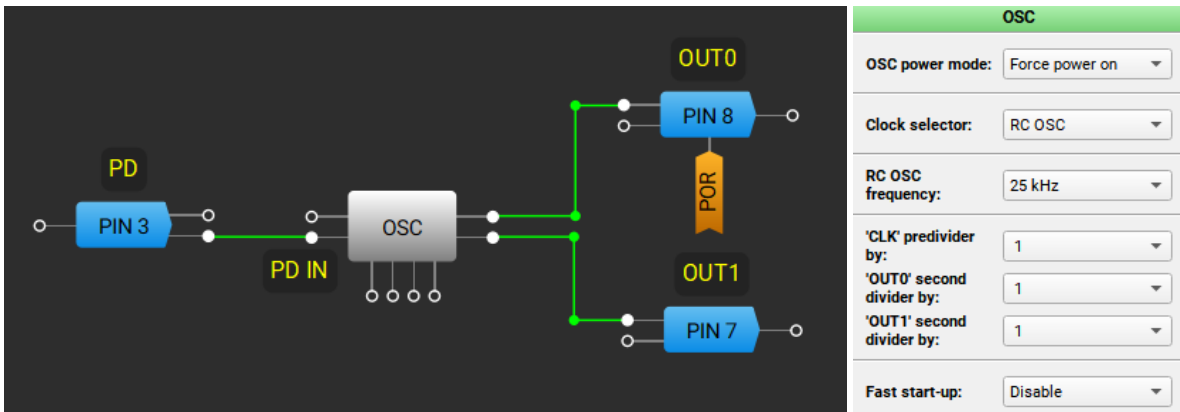
When a short pulse of less than ~40 ns is applied to the PWR DOWN input.

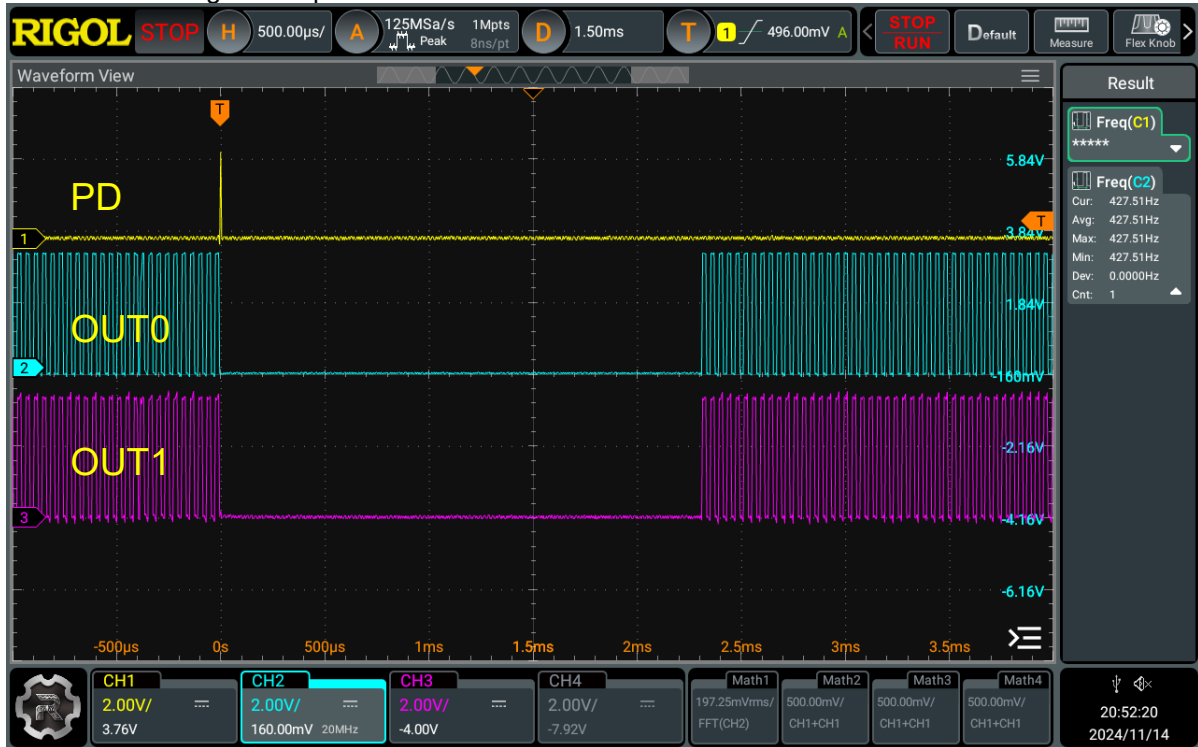
25 kHz OSC Long Start-Up:

If a pulse with a duration of less than ~40 ns is applied to the PWR DOWN input of the oscillator, the oscillator outputs remain stuck for milliseconds, as shown in figures below. This issue is observed for both 25 kHz and 2 MHz oscillators.

Change the Fast Start-up setting to "Enable" (see figure below) or avoid applying glitches to the PWR DOWN input of the oscillator.
