## SLG4653x Errata

**CE-GP-002**

*This document contains the known errata for SLG46533, SLG46534, SLG46535, SLG46536, SLG46537, SLG46538 and the recommended workarounds.*

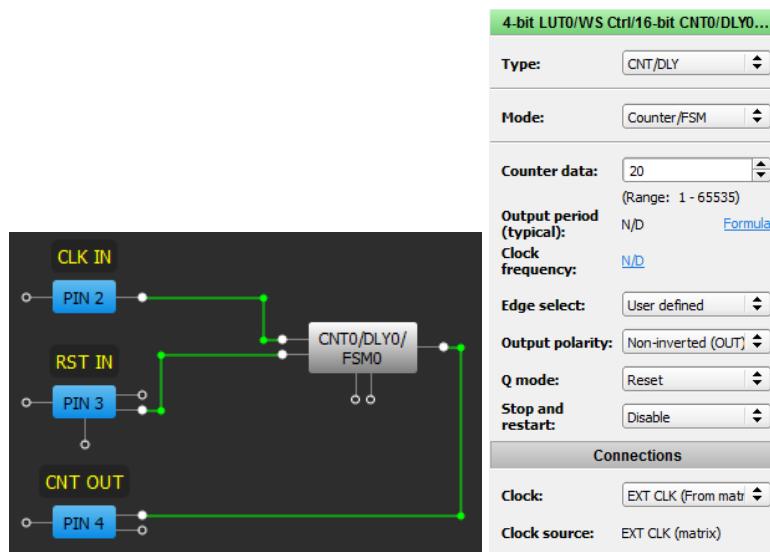
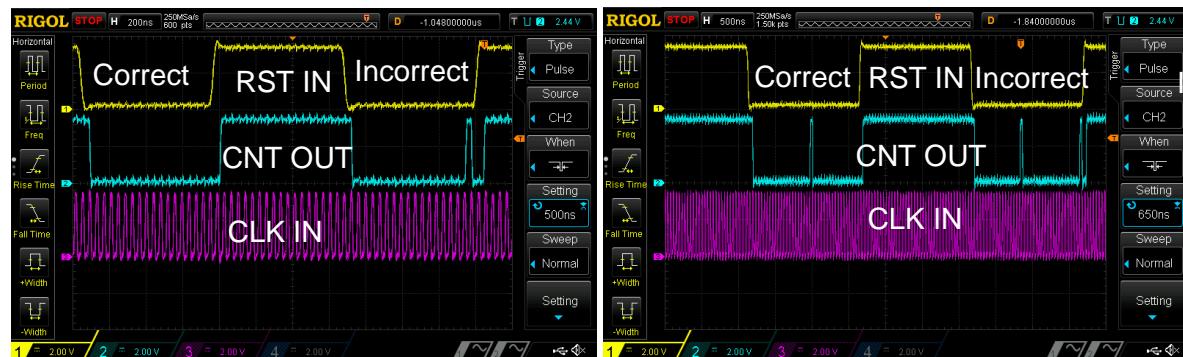
If the Counter Reset is asserted at the same time as a rising clock edge, it is possible that the Counter Data will be reset incorrectly and the counter output may appear faster than expected. This phenomenon appears more often as the clock frequency increases.

Synchronize RESET input of the Counter with its CLK using 2 DFF cells as shown on [Figure 3](#).

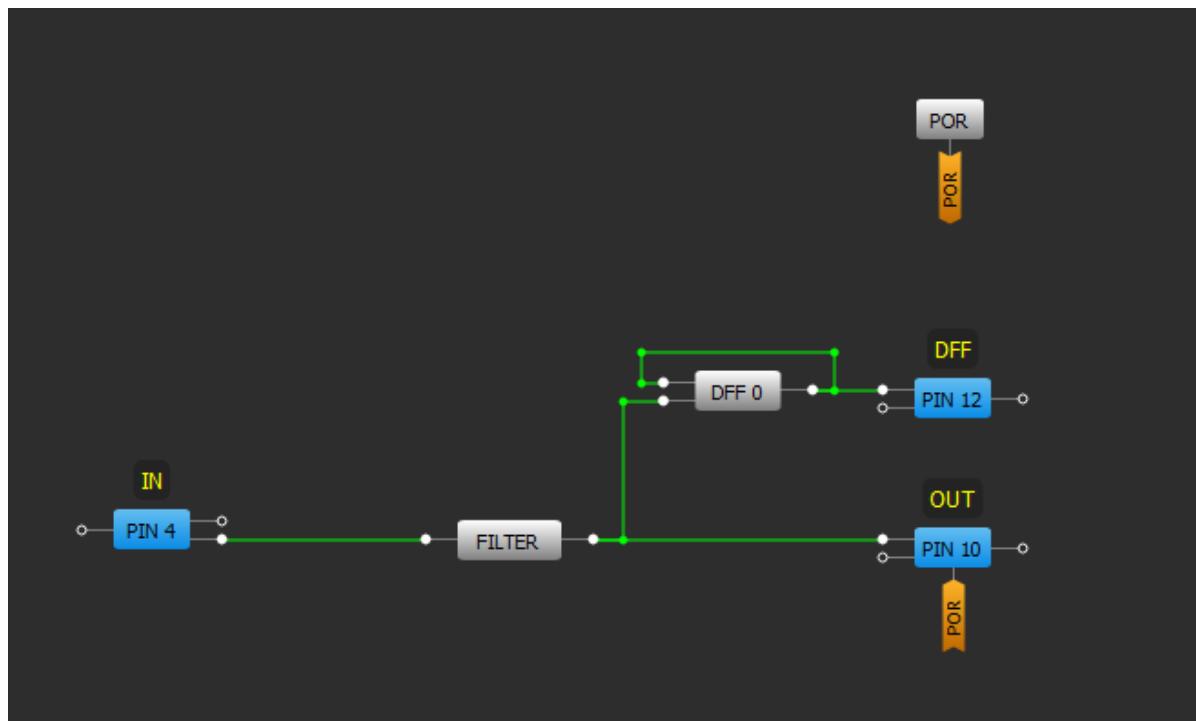
Figure 4

If clock type high frequency input comes in, the FILTER cell may not filter out it. There are several factors like input frequency, duty cycle, and LOW duration in such signal that may lead to its passing through FILTER block.

Currently there is no workaround for this issue. Filter block is good at filtering short spontaneous glitches. It is intended to be used in series connection before the delay cell to avoid its latching.

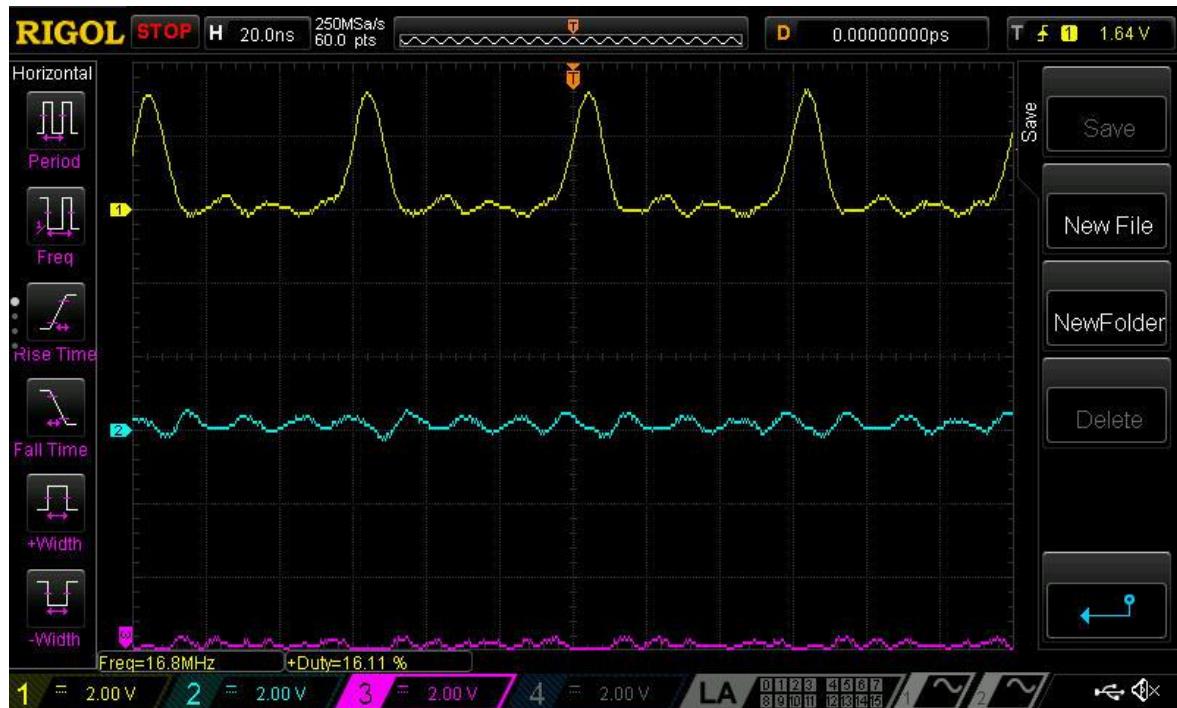
Figure 5

1. Period is 60 ns. Pulse width is 10 ns, DC = 16.7 % (correct functionality).

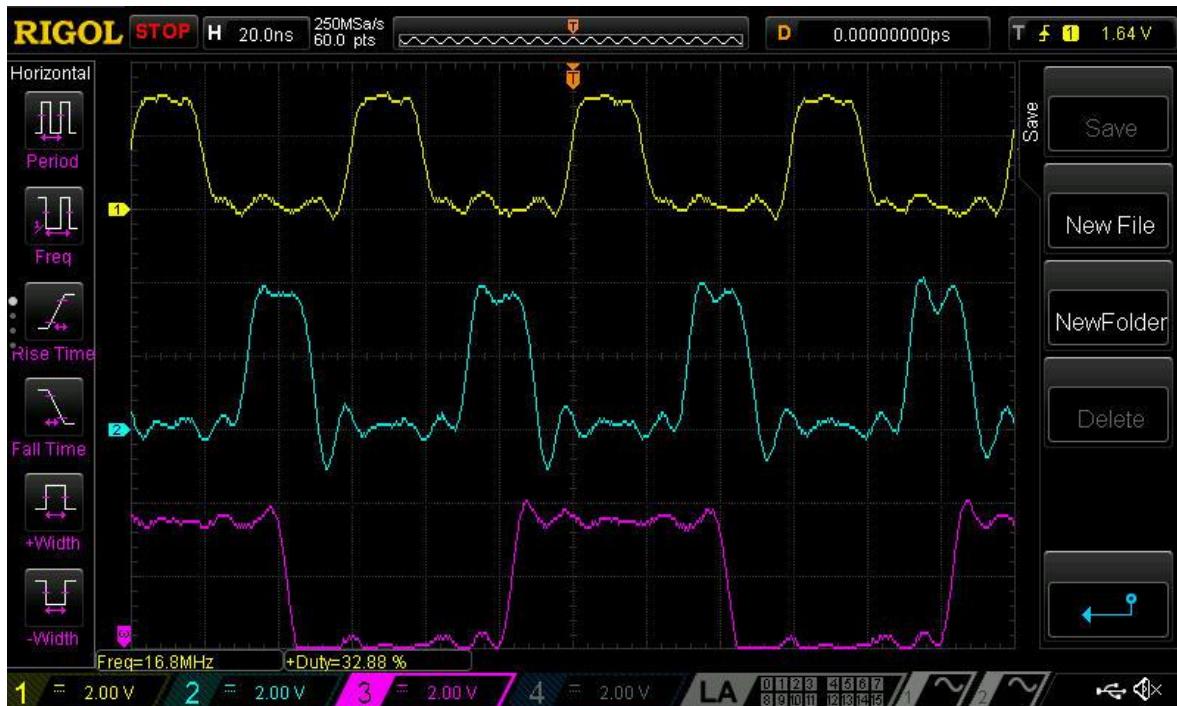
Figure 6

2. Period is 60 ns. Pulse width is 20 ns, DC = 33.3 % (incorrect functionality).

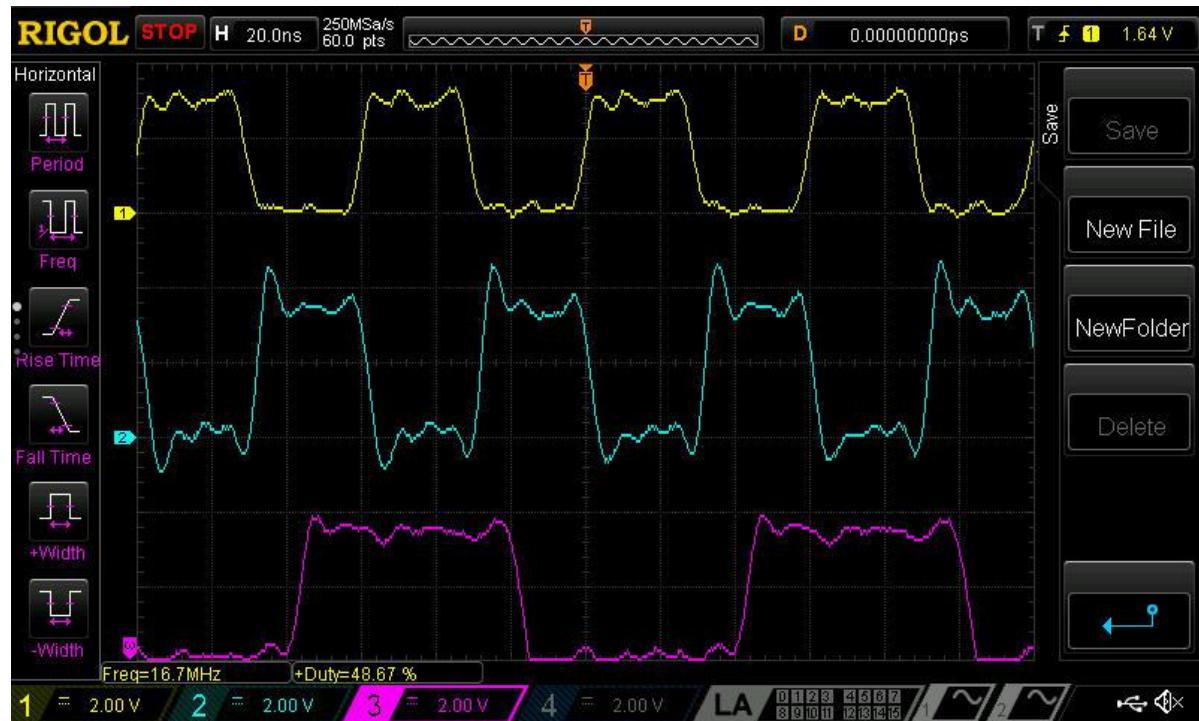
Figure 7

3. Period is 60 ns. Pulse width is 30 ns, DC = 50 % (incorrect functionality).

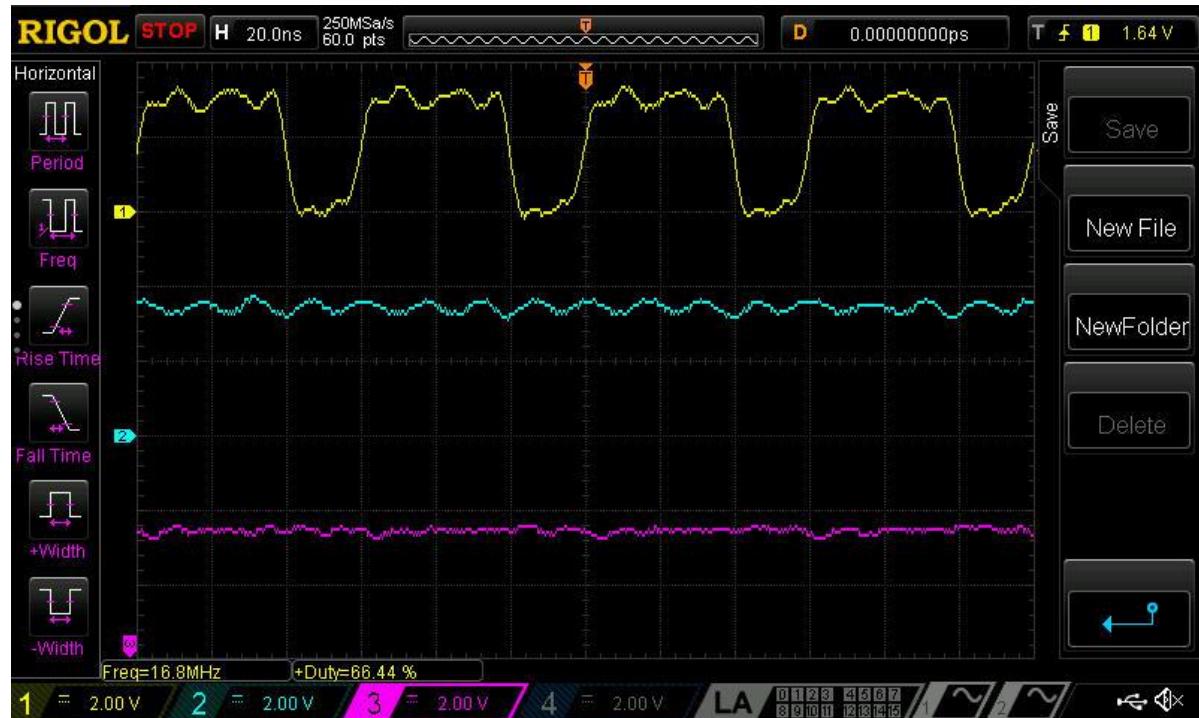
Figure 8

4. Period is 60 ns. Pulse width is 40 ns, DC = 66.67 % (correct functionality).

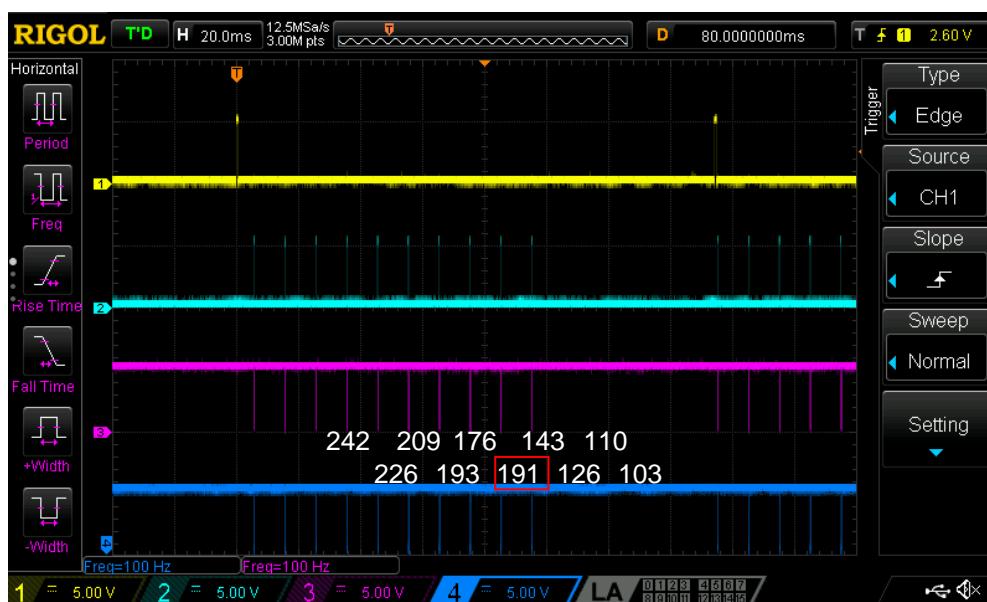
Asynchronous interaction between the CNT/DLY clock input and the I2C latch signal (generated by an I2C read command of the CNT/DLY block's count value) can result in an incorrect I2C data read. The CNT/DLY block will count accurately, but the count value transferred into the block's I2C read register might be loaded incompletely if the I2C latch signal and the clock input occur at about the same time.

The example data capture below shows ten periodic I2C reads of CNT2/DLY2 configured to count down at about 16 clocks per read. The sixth read sample erroneously shows a value greater than that of the fifth. The seventh sample reads as if the previous I2C error never occurred - the difference from the fifth sample (176) to the seventh (143) is 33 clocks or 16 clocks + 17 clocks as expected.

If the possibility of incorrect I2C data reads can't be accommodated for by external software checks, one can guarantee proper operation by stopping the CNT/DLY block's clock during I2C reads through one of the following methods: by disabling the oscillator block, by reconfiguring the CNT/DLY block's clock source, or by gating an external clock using a LUT (Look-up Table) in the signal matrix. After disabling the CNT/DLY block's clock, the count registers can be read without error. Please note that this workaround will add the I2C read and processing time to the counter's overall clock period.

The best workaround depends on the resource constraints of the application. If the oscillator block doesn't clock other logic elements within the design, a matrix output can be used to manually power down the oscillators for the I2C read. When the CNT/DLY block's clock source is routed internally from the oscillator block, I2C commands can temporarily reconfigure the CNT/DLY block's clock source registers to select "Ext. CLK. (From Matrix)." This action will disable the clock by connecting it to ground. If the CNT/DLY block is clocked from the signal matrix, a LUT can be used to gate the clock during an I2C read.

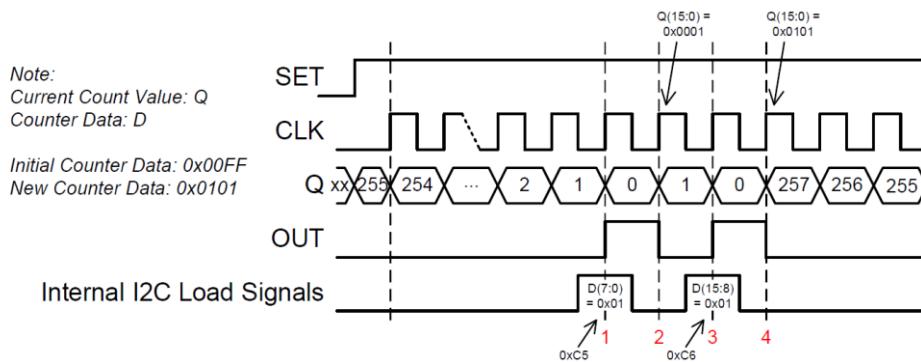
Figure 10: I2C Write of 16-Bit Counter Data Example

The timing diagram in [Figure 10](#) sets up a case where an improper output will be seen on the counter. In this example, the initial Counter Data value (D) is set up as 0x00FF. As you can see, the Current Count Value (Q) decrements from 255 down to 0 with rising edges on CLK. At time "1"

denoted by a red number 1, an I2C command (not shown) has just been sent to the GreenPAK device to reconfigure the Counter Data value to 0x0101.

As previously mentioned, the 16-bit value is loaded from the I2C buffers to the Counter Data registers in 8-bit chunks. Right at time “1”, the LSB byte (0x01) is loaded into the Counter Data registers. This makes the Counter Data value temporarily equal to 0x0001. At time “2” between the internal I2C load signals, the counter receives a rising edge on its clock input. This causes the Current Count Value to underflow and to be loaded with the Counter Data value which is 0x0001. At time “3”, the MSB byte (0x01) is loaded into the Counter Data registers setting the Counter Data value to 0x0101. At time “4”, the Current Count Value underflows again and is set to the Counter Data value of 0x0101.

This behavior results in two output pulses on OUT when only one pulse is expected. Observing this behavior depends upon the asynchronous timing between the counter's clock and the I2C write command to the Counter Data registers. For some applications, the extra pulse on OUT can be ignored and the counter will self-correct after underflowing, overflowing, or being SET/RESET through the GreenPAK connection matrix.

For applications where the application processor needs to read the Current Count Value while the counter is clocking, disable the "Stop and Restart Bit." When this bit is disabled, the counter's clock will not be gated internally which avoids the loss of count values during Tstop. In order to guarantee the current count value after an I2C write to the Counter Data registers, the clock should be manually stopped for the I2C write or a SET/RESET command should be generated after the I2C write. (Case 1)

I2C Write of Counter Data: Accommodate for the double pulse described in Case 1.

Disable the counter's clock during the I2C write.

Manually SET/RESET the counter after the I2C write is complete.

Disregard the first set of pulses on the counter output after an I2C write by waiting for one counter cycle to complete. This allows the counter's DFF chain to be loaded with the new Counter Data value after the counter overflows/underflows.

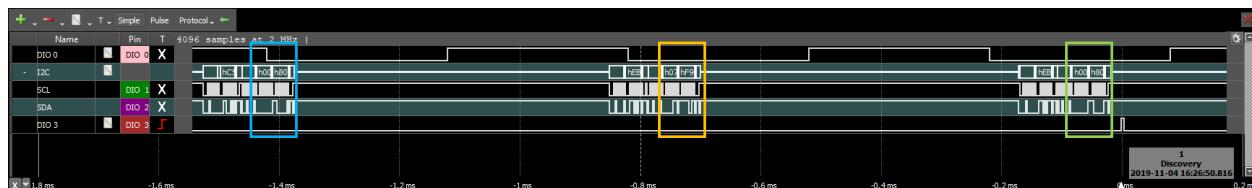
**Figure 12: Counter Behavior**

For the following condition, the Counter Data register contents are unexpectedly loaded into the counter's DFF chain. This behavior occurs when there is a falling edge on the counter block's clock input during the data return portion of an I2C read of the Counter Data registers. [Figure 12](#) shows this falling edge boxed in light blue followed by two I2C reads of the Current Count Value registers.

As you can see by the MCU data log below, the Current Count Value gradually increases from 0xF904 to 0xF907 but is unexpectedly reset to 0x8000. Please note that the colored HEX values in the MCU Log correspond to the boxed I2C read commands shown in the waveform above. As previously described, this reset occurs because there is a falling edge on the counter's clock input while the GreenPAK device is responding to an I2C read request to 0xC5 and 0xC6. (Note that 0xC5/0xC6 are the Counter Data registers and 0xEB/0xEC are the Current Count Value registers for CNT0.)

The reason that the counter isn't set to 0x8000 on the I2C read immediately following the Counter Data query is because the counter requires two rising edges on its clock input to load the data from the Counter Data registers into the DFF chain. Note that all rising edges during Tstop will be gated internally by the "Stop and Restart" feature.

I2C Read of Counter Data: Avoid reading Counter Data via I2C while the counter is being clocked.

Within the MCU, we recommend saving the Counter Data register configuration as a software variable so that the Counter Data register does not need to be read during counter operation.

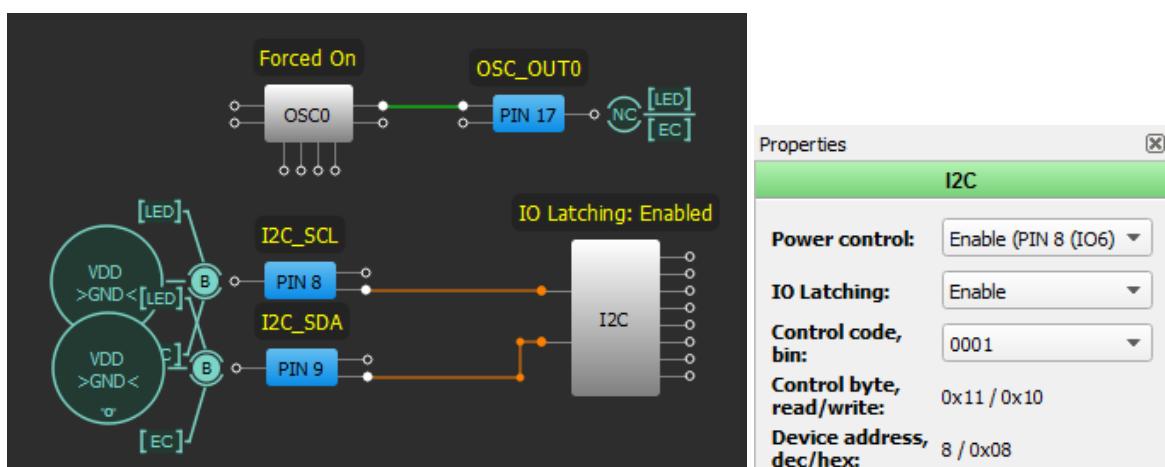
**Figure 13**

The GreenPAK device does not check for a matching I2C Target address condition before triggering 'IO Latching'. A Start bit on the I2C bus will trigger IO Latching. A Start bit is when I2C\_SDA goes low first followed by I2C\_SCL going low after.

In the example below, we will be monitoring the OSC output, which is measured by a scope on Channel 3 via PIN17 ("OSC\_OUT0"). The I2C bus will be forced low to create a START bit.

Disable IO Latching in programmed OTP. This register is I2C-write locked during normal operation and therefore should be disabled in configuration file.

Do not share I2C bus with other devices and make sure the I2C bus is not powered down while the GreenPAK is still powered through VDD.

If the above cannot be satisfied, then consider using the SLG4658x devices, where this errata has been fixed.

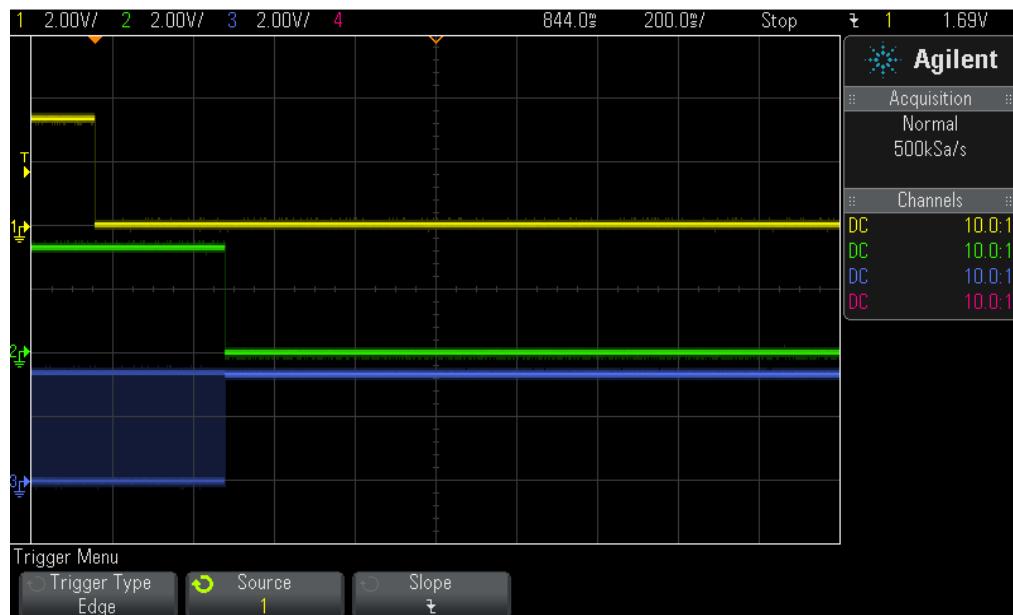
**Figure 14**

By toggling I2C\_SDA low and then I2C\_SCL low, the GreenPAK registers this as a start bit and latches all General Purpose Outputs such as PIN#17 (“OSC\_OUT0”). In the [Figure 14](#), notice that PIN#17 (OSC\_OUT0) stops toggling.

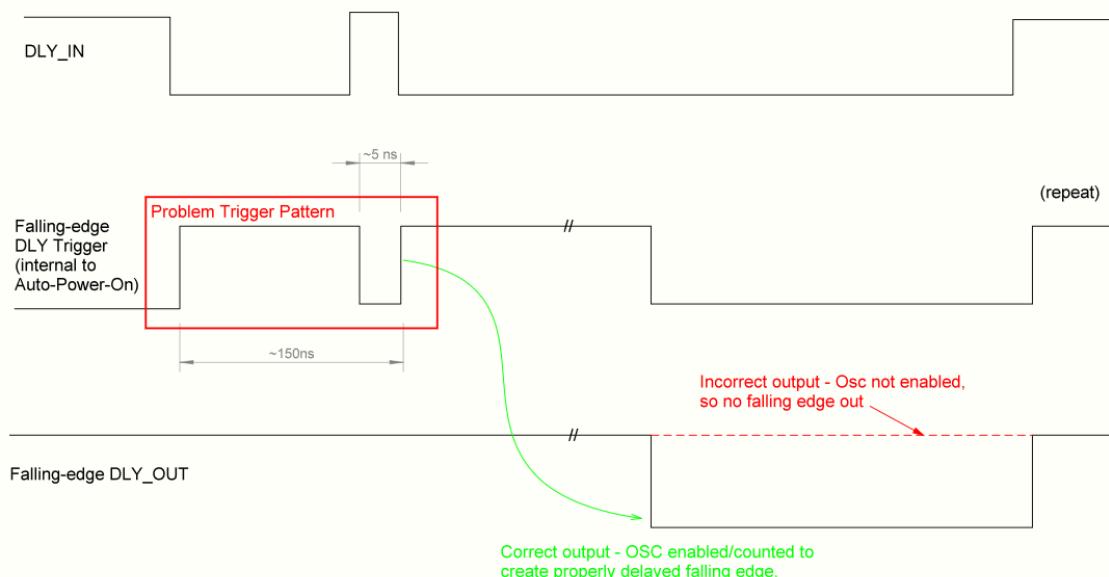
**Figure 15: Problem Trigger Pattern**

For this chip, the Auto Power On circuitry of the 25 kHz/2 MHz generators contains a circuit errata, which can potentially fail to power on the OSC for a specific pattern and timing of the OR of all related DLY trigger signals. The pattern is shown in [Figure 15](#) (boxed in red) and consists of a relatively longer pulse (~145 ns) followed by a shorter (~5 ns) glitch of opposite polarity.

1. Use signal conditioning circuits to prevent glitch on DLY inputs < 200 ns. Examples:
  - a. ACMP with Hysteresis
  - b. External RC in front of Digital Input with Schmitt Trigger
  - c. Filter cell.
2. Set OSC power mode to Force Power On mode instead of Auto Power On.
3. Use different oscillator, such as 25 MHz Ring OSC, which does not have Auto Power On issue.

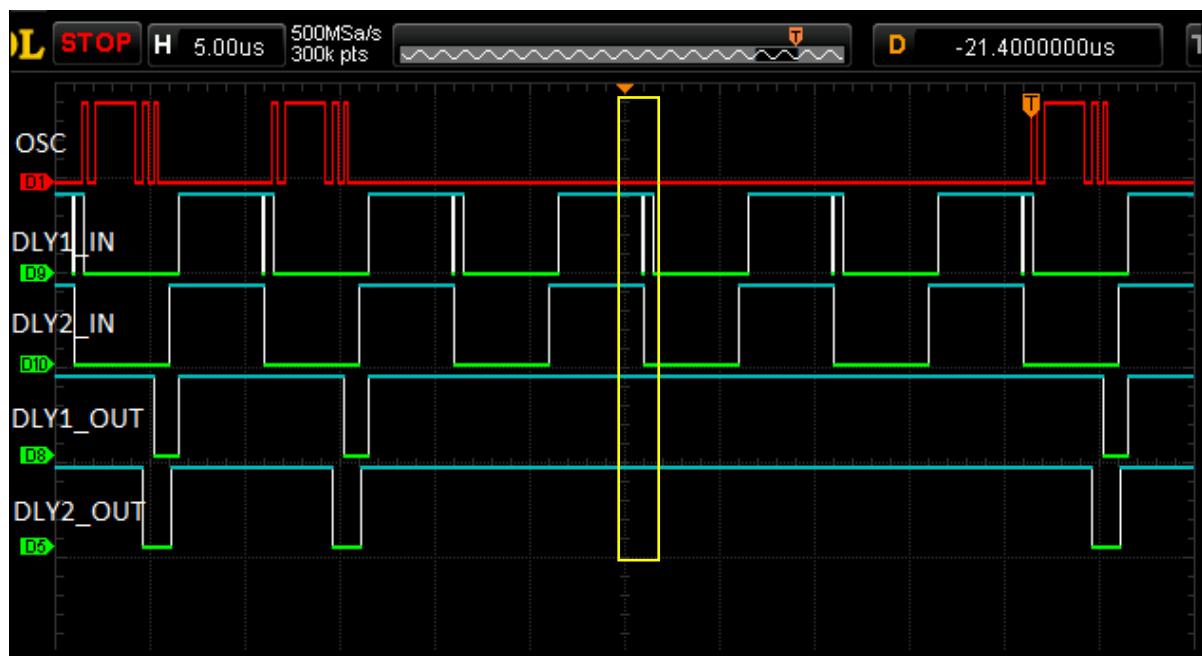
Figure 17: Errata Capture (Zoom Out)

Figure 17 shows a series of DLY output events are missing, where the OSC is correspondingly not triggering when it was supposed to. Figure 18 is a zoom in of the boxed region from Figure 17. The total glitch/chatter time was measured in this case at 152 ns. By using the composite OR of the two delay channels, we can asynchronously strobe with tiny frequency variations, and so tune the timing to induce this errata. Note that the error is not persistent – the system is recovered when all DLYs are returned to inactive state, such as when input of falling edge DLY goes high, thus canceling delay, or after DLY out finishes.

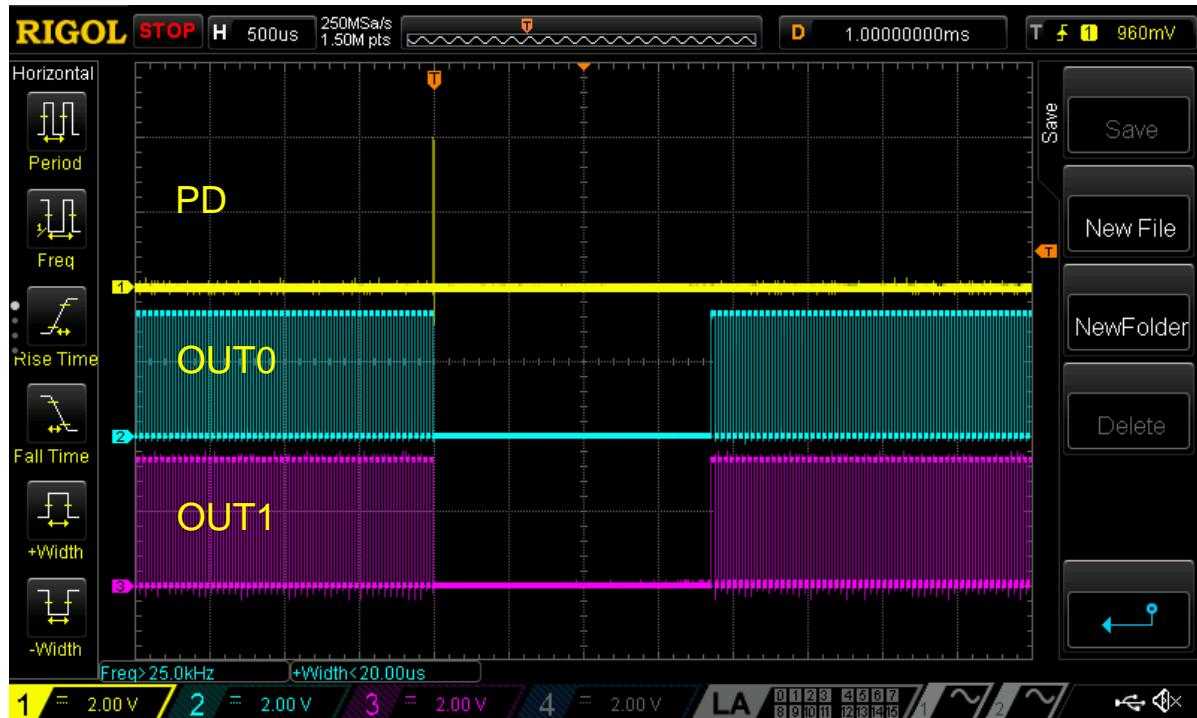
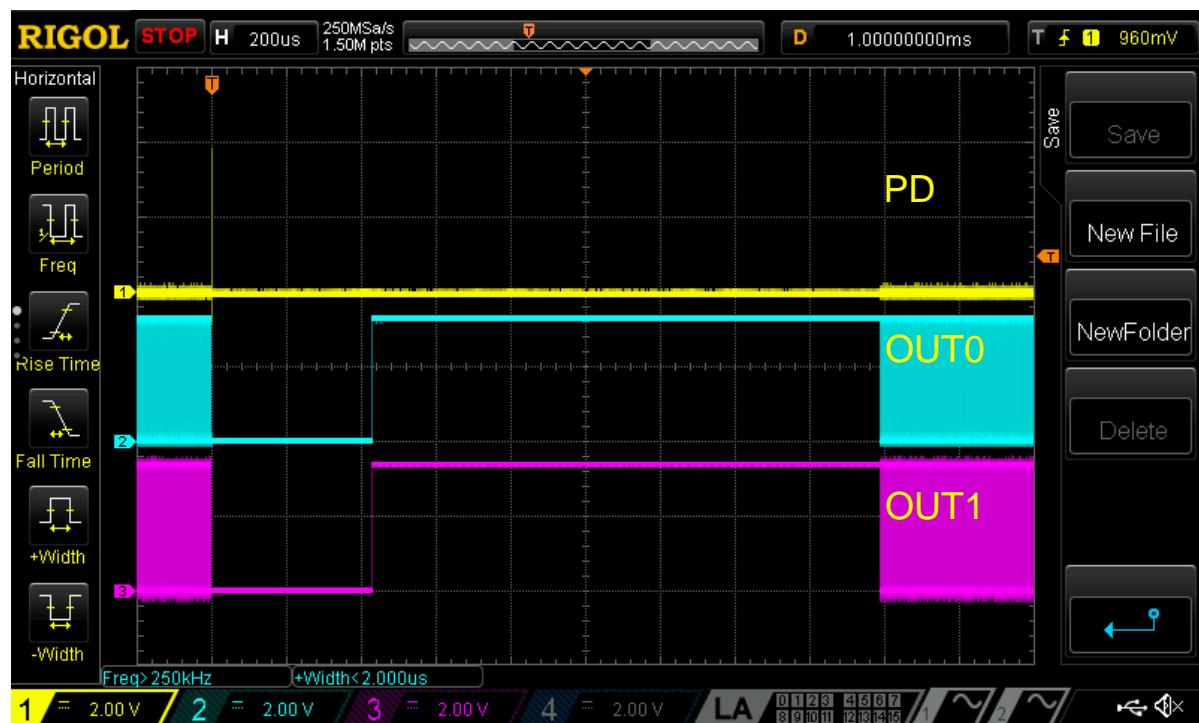
Figure 21. 2 MHz OSC Long Start-Up

If a pulse with a duration of less than ~40 ns is applied to the PWR DOWN input of the oscillator, the oscillator outputs remain stuck for milliseconds, as shown in figures below. The issue is observed for all available oscillators.

Change Fast start-up setting to Enable or omit applying glitches at PWR DOWN input in OSC.

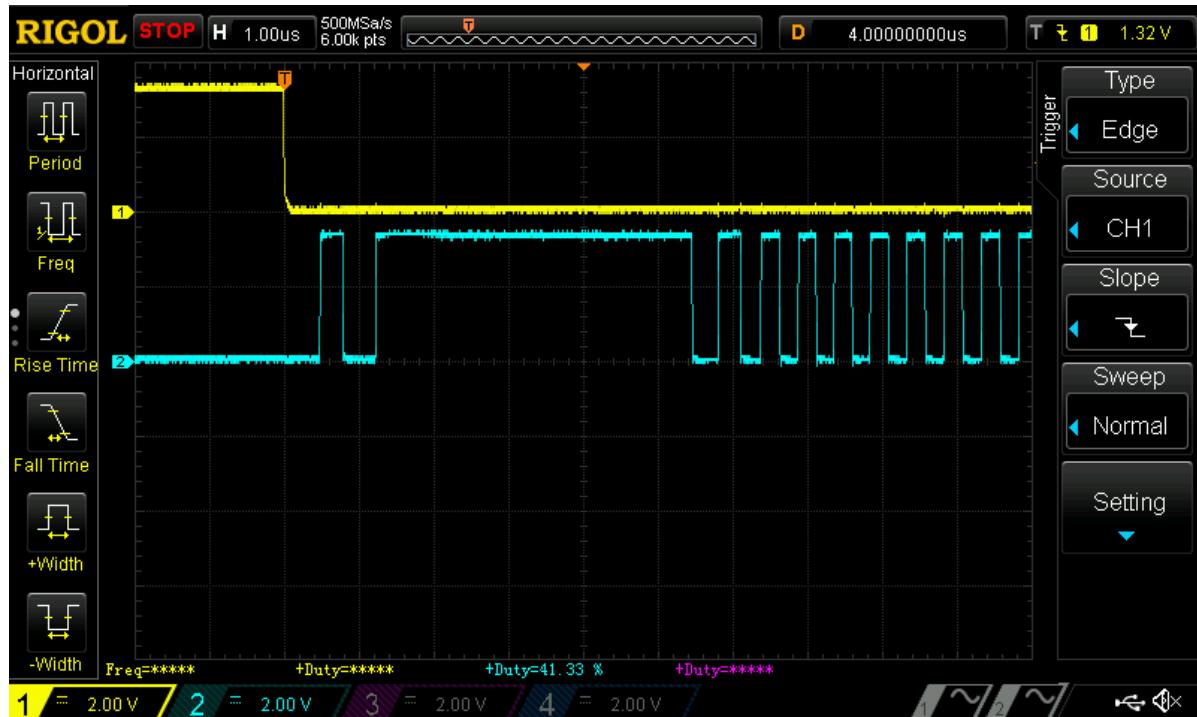
Figure 23. Channel 1 – OSC Power Down; Channel 2 –OSC output

2 MHz OSC has an additional ~ 9 cycles settling period. Higher VDD shows longer settling time.

Such behavior will lead to substantial error in period calculations if the delay time is relatively small.

Enable Fast Start-up option. Fast Start-up means forcing bias ready at the power-up instead of automatic enabling at OSC event. The standby current consumption difference between Fast start-up disabled and enabled is only an additional 300 nA.

Use the “Force power on” OSC power control option to make the OSC operate at all times. However, this will cause increased constant current consumption.
