SLG46582 Errata

CE-GP-002

This document contains the known errata for SLG46582 and the recommended workarounds.

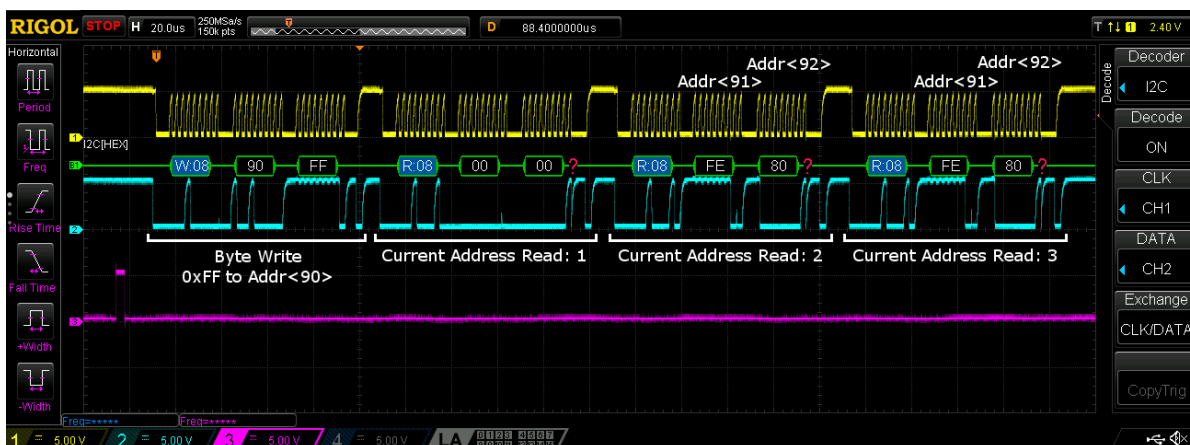
The first “Current Address Read” or “Sequential Read” command following an I²C “Byte Write” or a “Sequential Write” command will produce incorrect data. Additional read commands will return the expected data. See the waveform below for more information.

Channel 1 (yellow/top line) – PIN#8 (SCL).
 Channel 2 (light blue/2nd line) – PIN#9 (SDA).
 Channel 3 (magenta /3rd line) – I²C Software Trigger.

Note: In the GreenPAK test design, Addr<91> and Addr<92> expect FE and 80 respectively.

If possible, use the “Random Read” command as described in the datasheet for SLG46580. This command will output the correct data.

If you expect consecutive reads of the same register, we recommend sending a “Random Read” command to the register preceding the register of interest. After the “Random Read” command finishes, the chip’s register pointer will increment to the desired register and the following “Current

Address Read” or “Sequential Read” commands will produce the correct data. Note that the “Current Address Read” and “Sequential Read” commands don’t increment the GreenPAK’s register pointer.

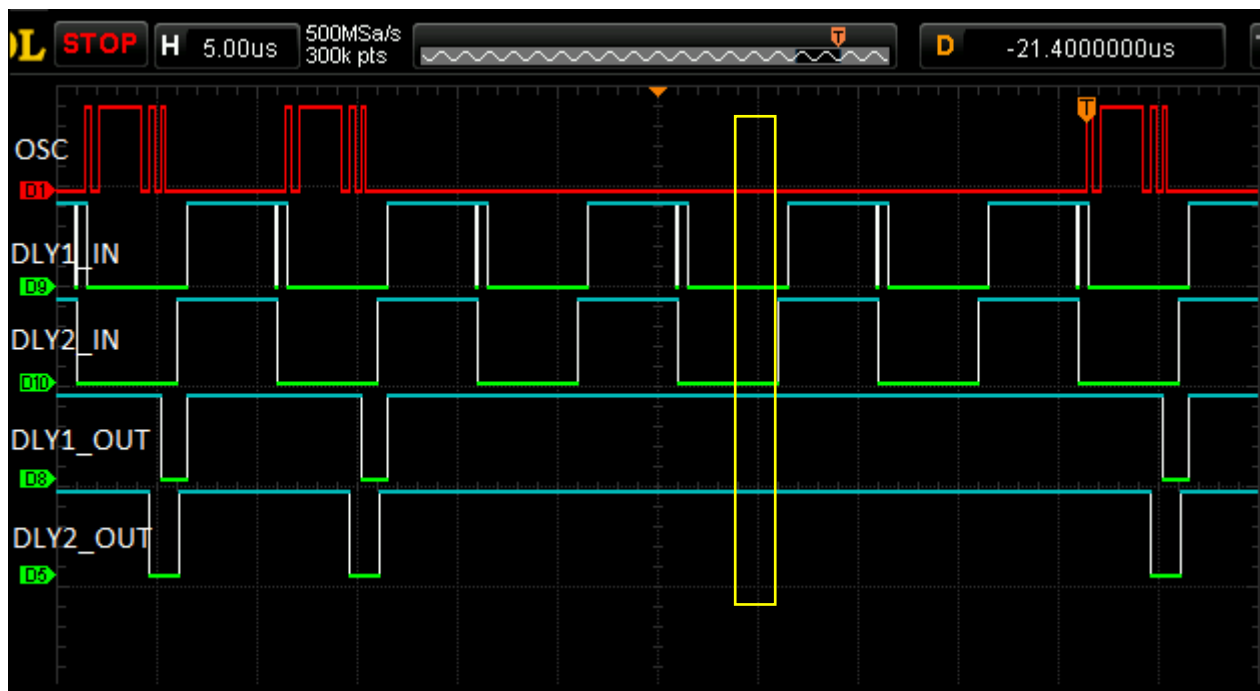
Figure 3: Errata Capture (Zoom Out)

Figure 3 shows a series of DLY output events are missing, where the OSC is correspondingly not triggering when it was supposed to. Figure 4 is a zoom in of the boxed region from Figure 3. The total glitch/chatter time was measured in this case at 152 ns. By using the composite OR of the two delay channels, we can asynchronously strobe with tiny frequency variations, and so tune the timing to induce this errata. Note that the error is not persistent – the system is recovered when all DLYs are returned to inactive state, such as when input of falling edge DLY goes high, thus canceling delay, or after DLY out finishes.

1. Use signal conditioning circuits to prevent glitch on DLY inputs < 200 ns. Examples:
 - a. ACMP with Hysteresis
 - b. External RC in front of Digital Input with Schmitt Trigger
 - c. Filter cell.
2. Set OSC power mode to Force Power On mode instead of Auto Power On.
3. Use different oscillator, such as 25 MHz Ring OSC, which does not have Auto Power On issue.

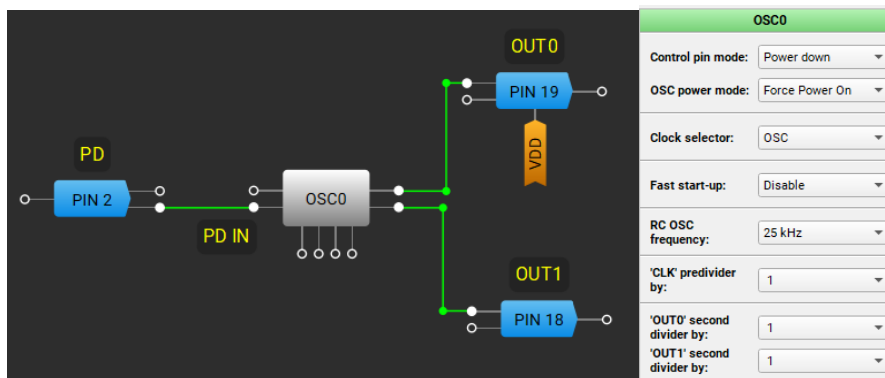
Short pulse of less than ~40ns is applied to PWR DOWN OSC.

If a pulse with a duration of less than ~40 ns is applied to the PWR DOWN input of an oscillator, the oscillator outputs remain stuck for milliseconds.

Change Fast start-up setting to Enable or omit applying glitches at PWR DOWN input in OSC.

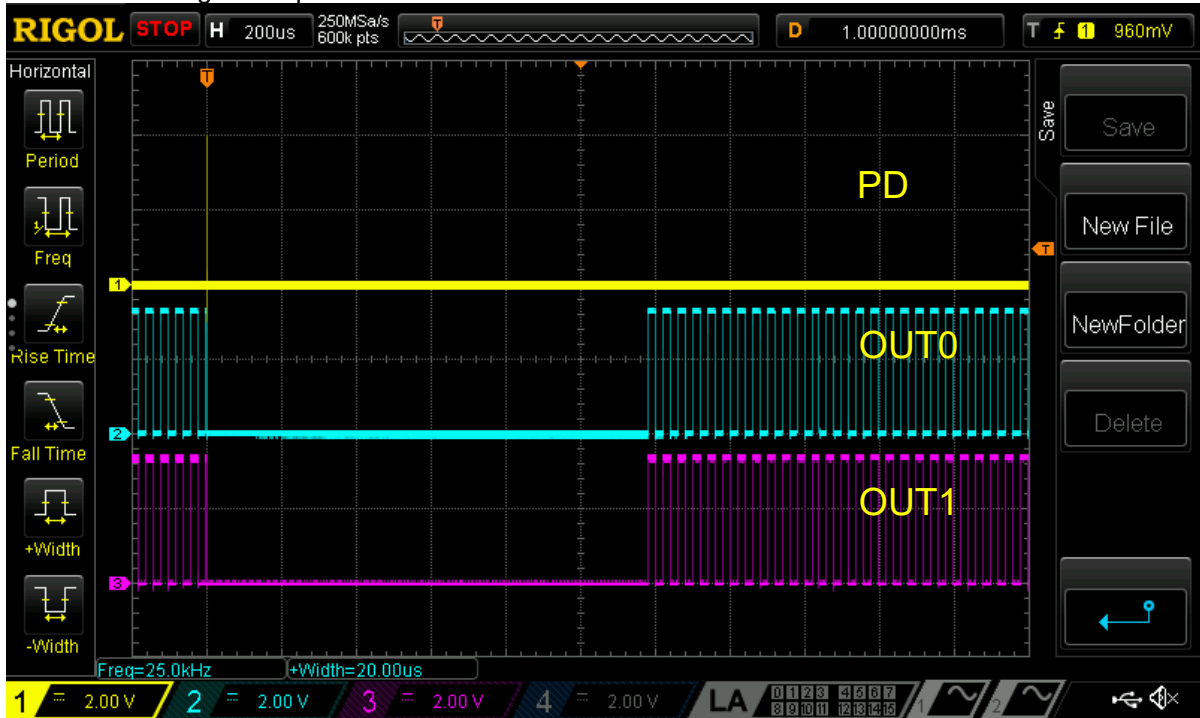
25 kHz OSC long start-up:

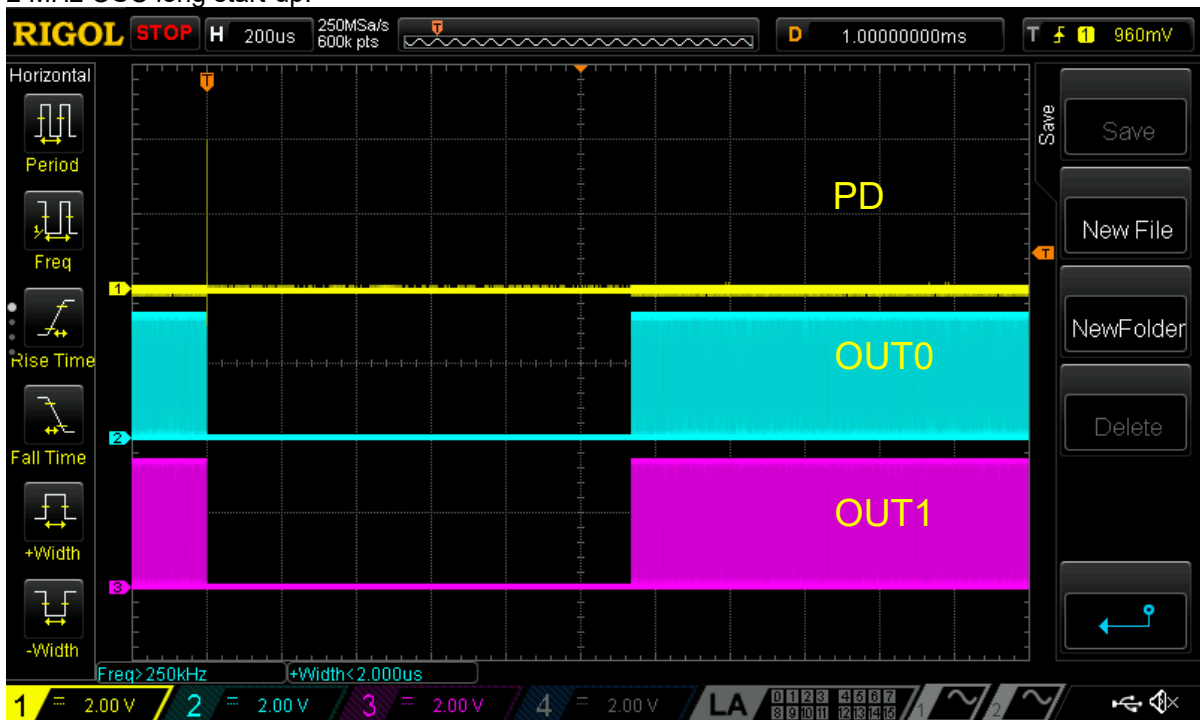
2 MHz OSC long start-up:
