SLG46583 Errata

CE-GP-002

This document contains the known errata for SLG46583 and the recommended workarounds.

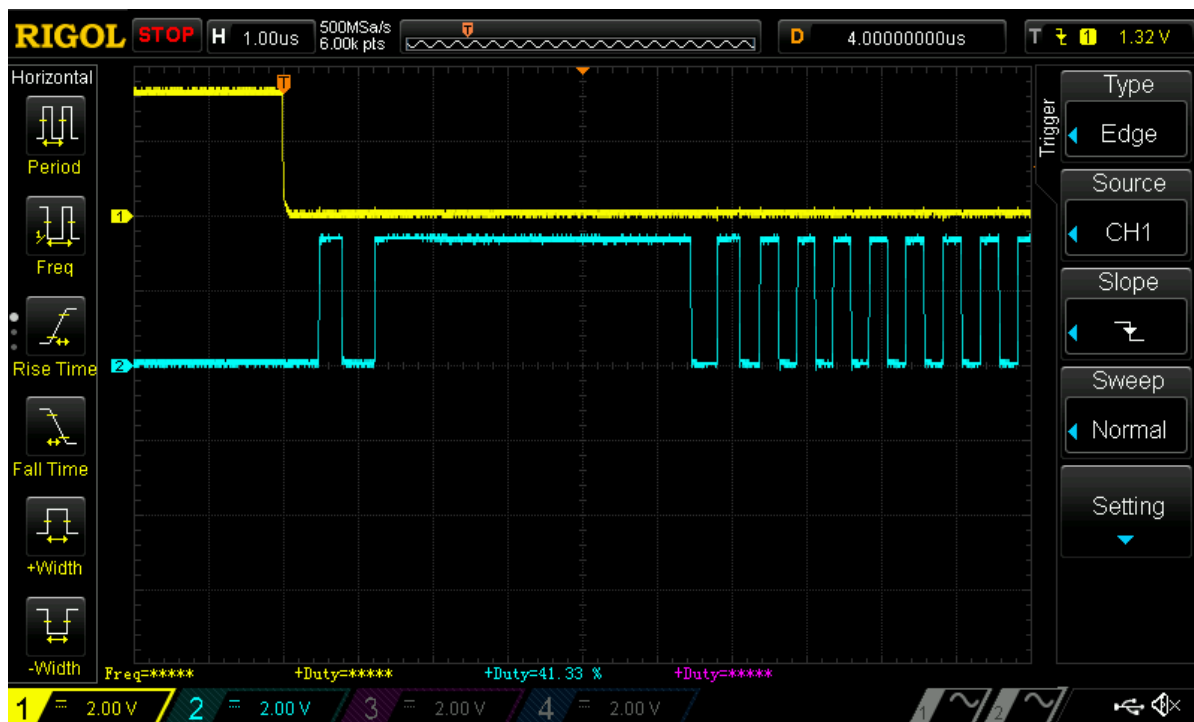
2 MHz OSC has an additional ~ 9 cycles settling period. Higher V_{DD} shows longer settling time.

Channel 1 – OSC Power Down; Channel 2 –OSC output

Such behavior will lead to substantial error in period calculations if the delay time is relatively small.

- Enable Fast Start-up option. Fast Start-up means forcing bias ready at the power-up instead of automatic enabling at OSC event. The standby current consumption difference between Fast start-up disabled and enabled is only an additional 300 nA.
- Use the “Force power on” OSC power control option to make the OSC operate at all times. However, this will cause increased constant current consumption.

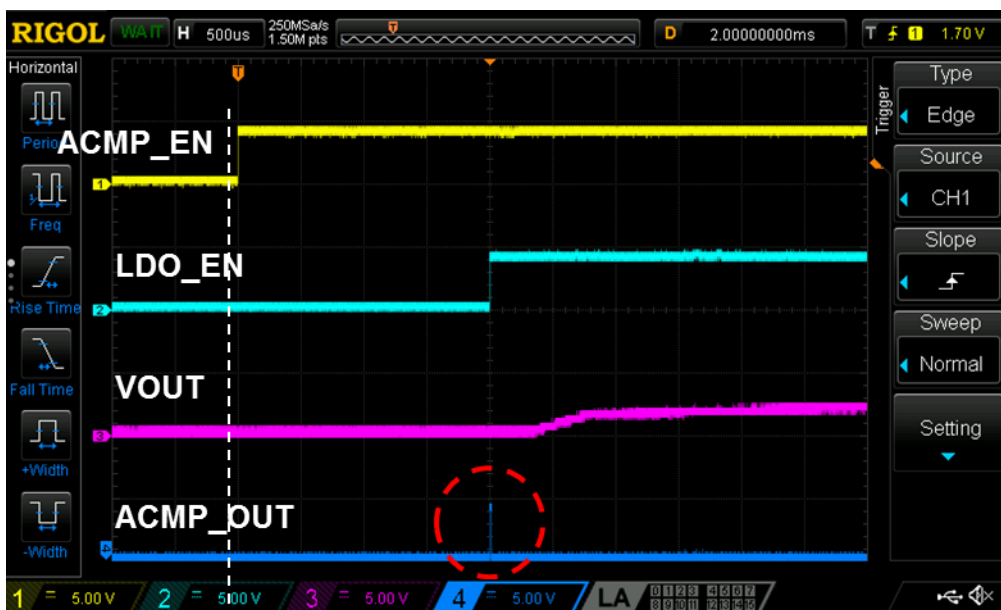
If an LDO's Low Power Mode is selected (for example tied to V_{DD}) a glitch may appear on the ACMP's output after the first LDO is enabled. When the first LDO is turned on, the Low Power Mode switch causes a drop in the internal bandgap voltage that is used to derive the ACMP reference voltages.

- Use both edge delay on the output to filter out the glitch.
- Use some logic to avoid turning on Low Power Mode before enabling LDO and powering up the ACMP. Example is shown below.

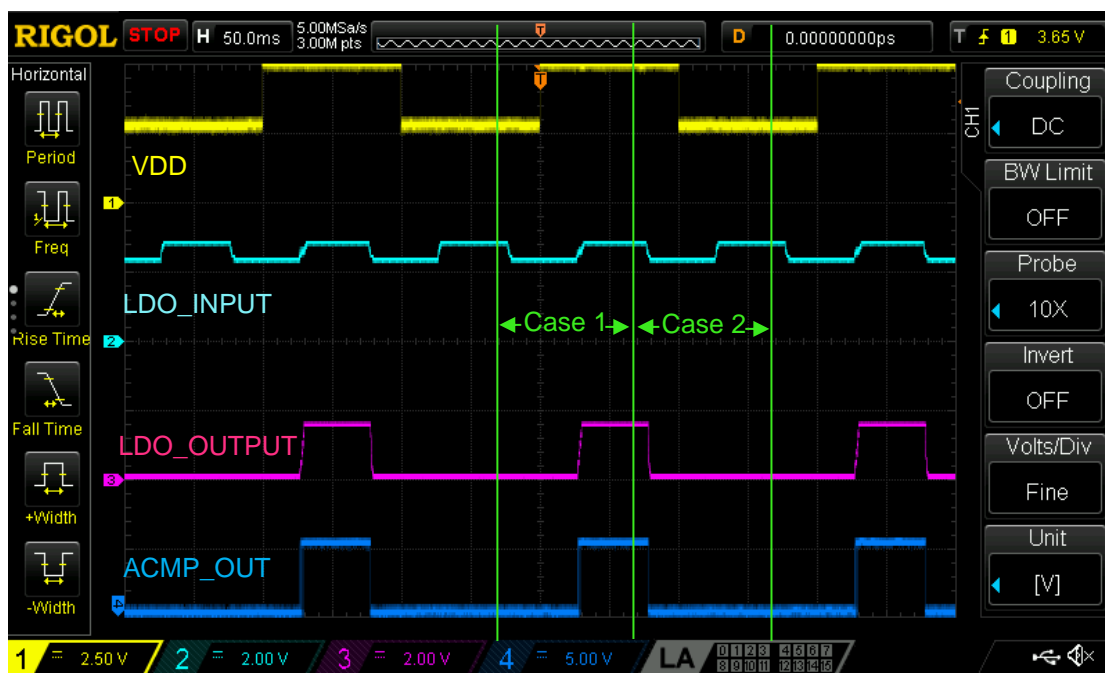
Case 1: proper behavior at $V_{DD} = 5\text{ V}$.

With a 5 V V_{DD} , the NMOS transmission gate passes the 2.25 and 2.75 V LDO_INPUT pin voltages to the ACMP's IN+ port. When the input voltage exceeds the 2.4 V IN- threshold of the ACMP, the LDO is enabled.

Case 2: erroneous behavior at $V_{DD} = 2.75\text{ V}$.

When the V_{DD} is reduced to 2.75 V, the NMOS transmission gate is unable to pass LDO_INPUT's full magnitude to the ACMP's IN+ port. Since the IN+ port of the ACMP doesn't exceed the 2.4 V IN- threshold, the ACMP's output stays low and keeps the LDO disabled.

If the GreenPAK's V_{DD} is always powered up before the LDO's VIN input, you can externally short the LDO's VIN to another dedicated analog input pin for the desired ACMP.

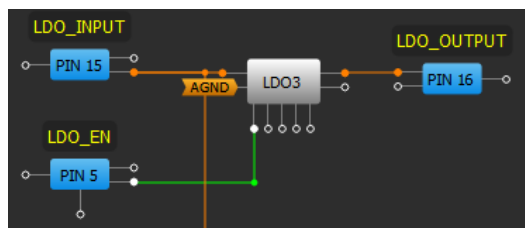
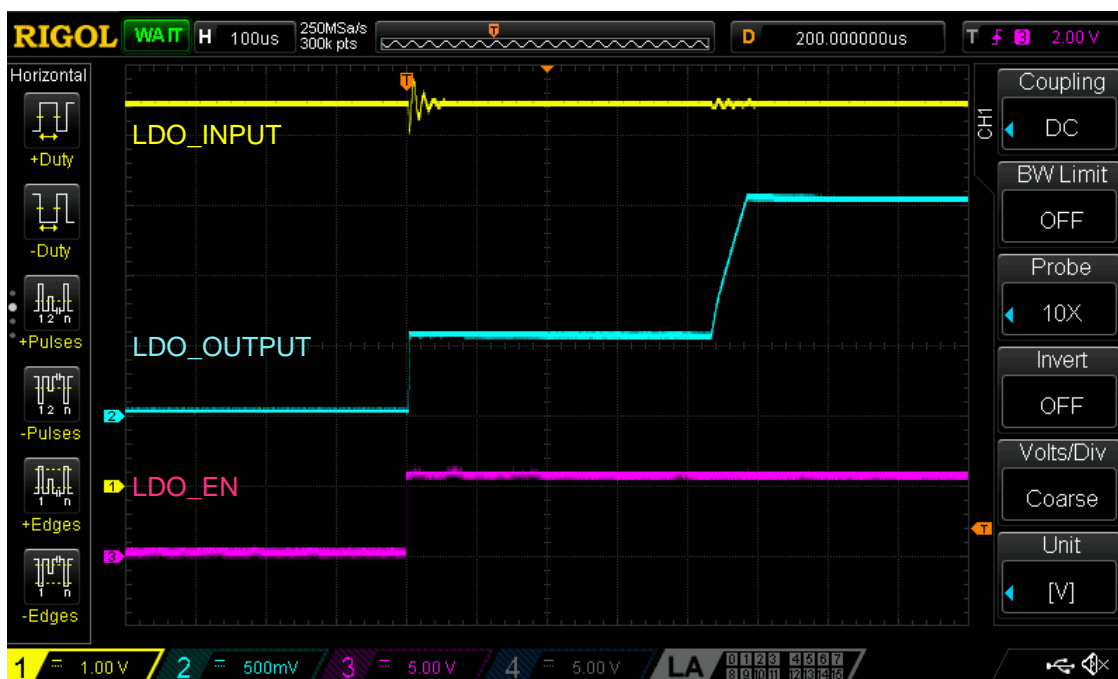
When a GreenPAK's first LDO is enabled, the LDO's VOUT will step to a non-zero voltage during its 500 μs wait time. The magnitude of this step is directly proportional to the LDO's VIN and the GreenPAK's V_{DD} . With a large LDO input voltage and V_{DD} , this step can exceed 500 mV.

$V_{DD} = 5.5\text{ V}$, LDO_INPUT = 5.5 V, all other LDOs disabled.

If your GreenPAK design has an unused LDO, you can reduce the magnitude of this voltage step by keeping an unused LDO enabled in high power mode.

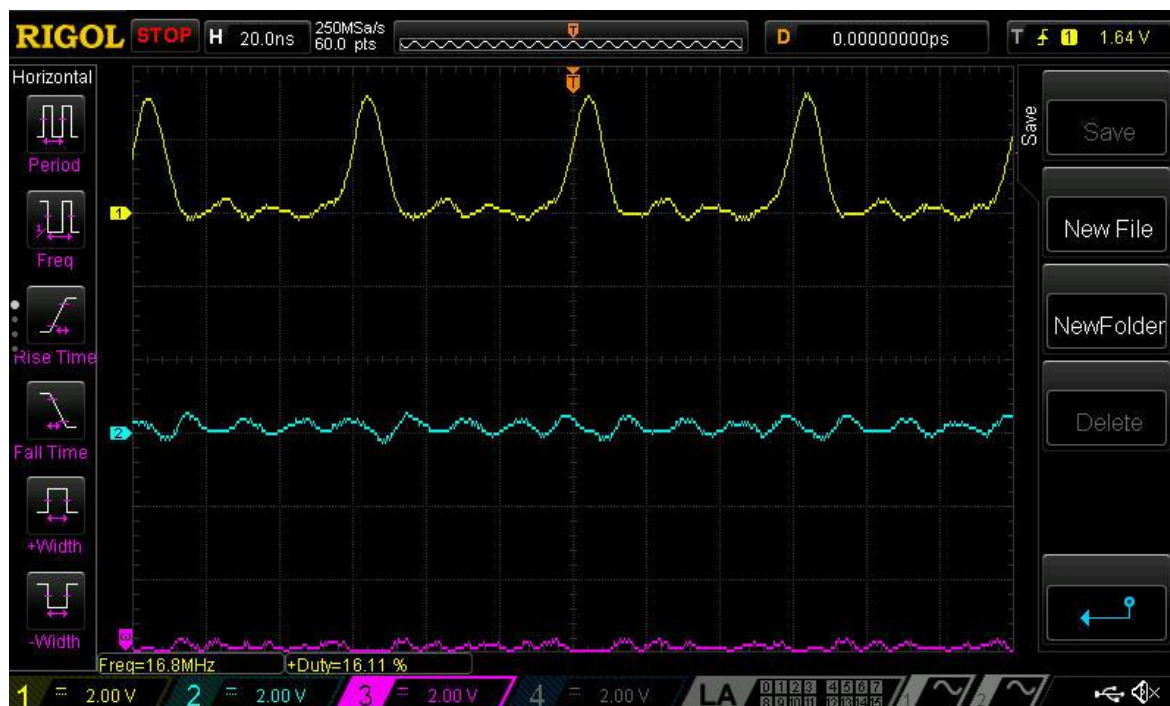
1. Period is 60 ns. Pulse width is 10 ns, DC = 16.7 % (correct functionality).

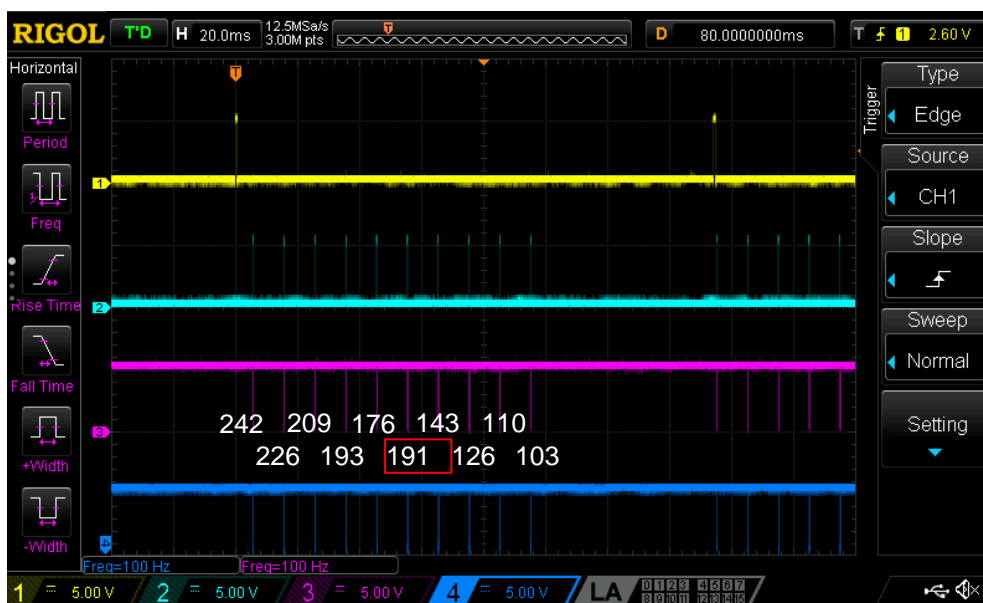
Asynchronous interaction between the CNT/DLY clock input and the I²C latch signal (generated by an I²C read command of the CNT/DLY block's count value) can result in an incorrect I²C data read. The CNT/DLY block will count accurately, but the count value transferred into the block's I²C read register might be loaded incompletely if the I²C latch signal and the clock input occur at about the same time.

The example data capture below shows ten periodic I²C reads of CNT2/DLY2 configured to count down at about 16 clocks per read. The sixth read sample erroneously shows a value greater than that of the fifth. The seventh sample reads as if the previous I²C error never occurred - the difference from the fifth sample (176) to the seventh (143) is 33 clocks or 16 clocks + 17 clocks as expected.

Channel 1 (yellow/top line) – PIN#2 (CNT2/DLY2 Out).
 Channel 2 (light blue/2nd line) – PIN#1 (I²C Read Triggers).
 Channel 3 (magenta /3rd line) – PIN#8 (I²C SCL).
 Channel 3 (dark blue /4th line) – PIN#9 (I²C SDA).

If the possibility of incorrect I²C data reads can't be accommodated for by external software checks, one can guarantee proper operation by stopping the CNT/DLY block's clock during I²C reads through one of the following methods: by disabling the oscillator block, by reconfiguring the CNT/DLY block's clock source, or by gating an external clock using a LUT (Look-up Table) in the signal matrix. After disabling the CNT/DLY block's clock, the count registers can be read without error. Please note that this workaround will add the I²C read and processing time to the counter's overall clock period.

The best workaround depends on the resource constraints of the application. If the oscillator block doesn't clock other logic elements within the design, a matrix output can be used to manually power down the oscillators for the I²C read. When the CNT/DLY block's clock source is routed internally from the oscillator block, I²C commands can temporarily reconfigure the CNT/DLY block's clock source registers to select "Ext. CLK. (From Matrix)." This action will disable the clock by connecting it to ground. If the CNT/DLY block is clocked from the signal matrix, a LUT can be used to gate the clock during an I²C read.

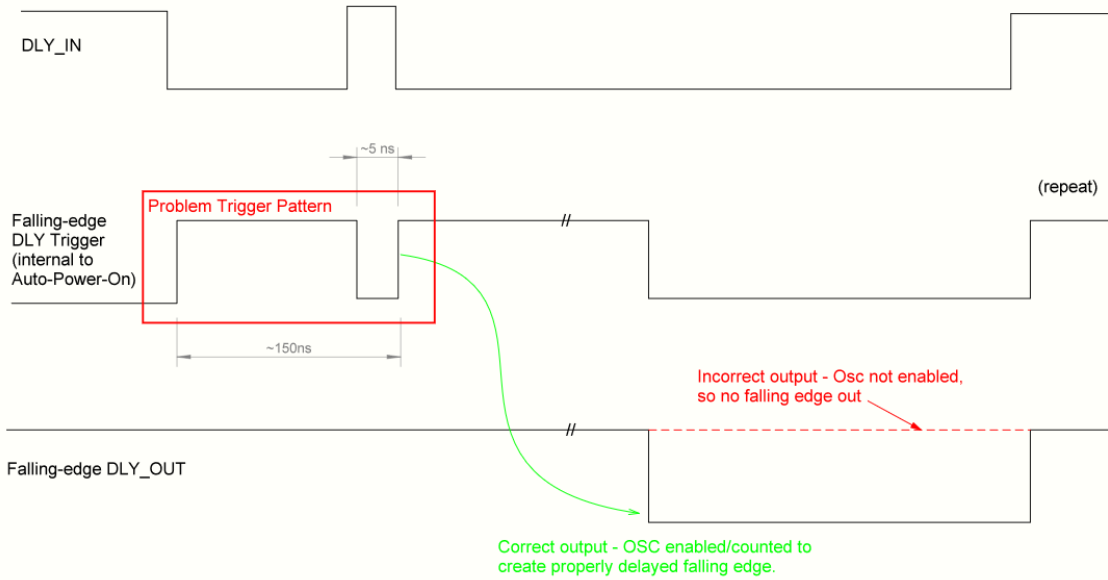
Figure 1: Problem Trigger Pattern

For this chip, the Auto Power On circuitry of the 25 kHz/2 MHz generators contains a circuit errata, which can potentially fail to power on the OSC for a specific pattern and timing of the OR of all related DLY trigger signals. The pattern is shown in Figure 1 (boxed in red) and consists of a relatively longer pulse (~145 ns) followed by a shorter (~5 ns) glitch of opposite polarity.

1. Use signal conditioning circuits to prevent glitch on DLY inputs < 200 ns. Examples:
 - a. ACMP with Hysteresis
 - b. External RC in front of Digital Input with Schmitt Trigger
 - c. Filter cell.
2. Set OSC power mode to Force Power On mode instead of Auto Power On.
3. Use different oscillator, such as 25 MHz Ring OSC, which does not have Auto Power On issue.

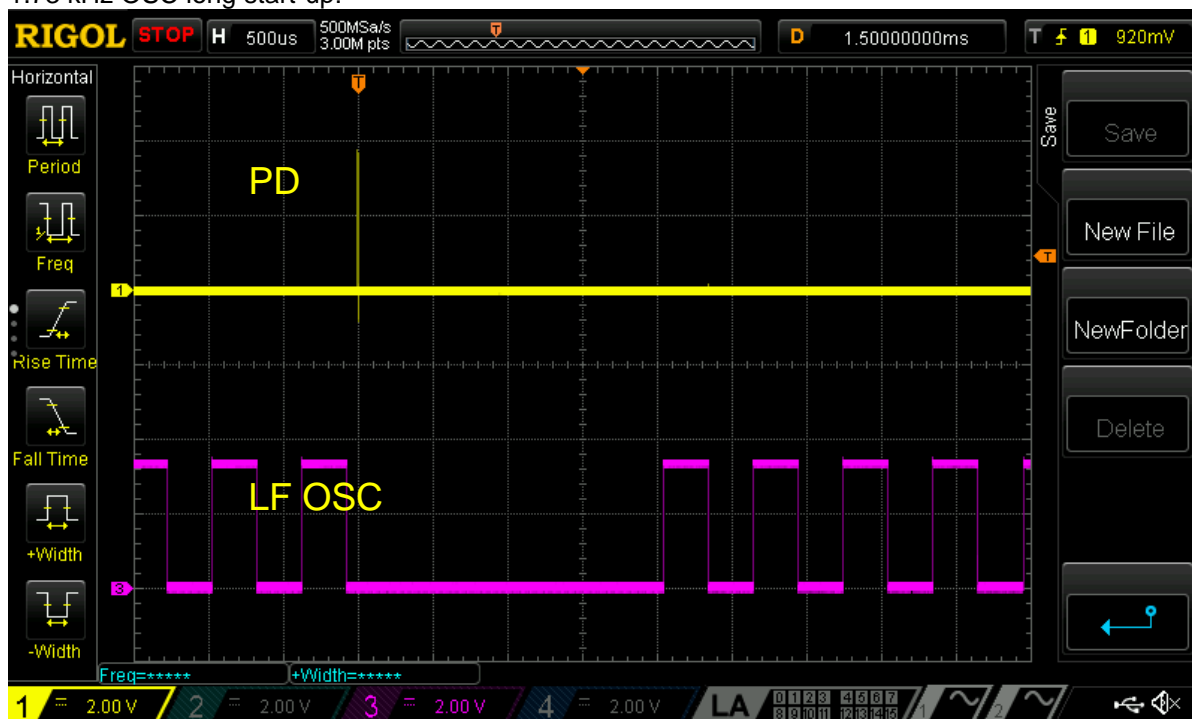
1.73 kHz OSC long start-up:

If a pulse with a duration of less than ~40 ns is applied to the PWR DOWN input of an oscillator, the oscillator outputs remain stuck for milliseconds.

Change Fast start-up setting to Enable or omit applying glitches at PWR DOWN input in OSC.
