## SLG46583 Errata

### CE-GP-002

*This document contains the known errata for SLG46583 and the recommended workarounds.*

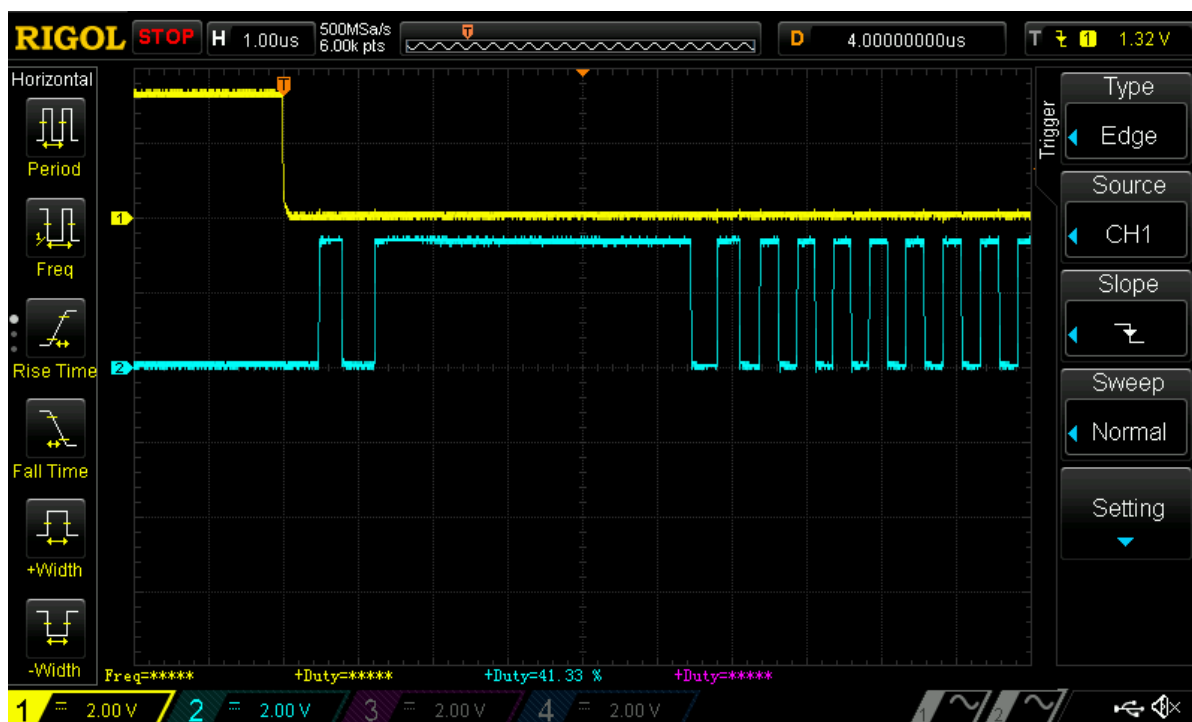
2 MHz OSC has an additional ~ 9 cycles settling period. Higher  $V_{DD}$  shows longer settling time.

Channel 1 – OSC Power Down; Channel 2 –OSC output

Such behavior will lead to substantial error in period calculations if the delay time is relatively small.

- Enable Fast Start-up option. Fast Start-up means forcing bias ready at the power-up instead of automatic enabling at OSC event. The standby current consumption difference between Fast start-up disabled and enabled is only an additional 300 nA.
- Use the “Force power on” OSC power control option to make the OSC operate at all times. However, this will cause increased constant current consumption.

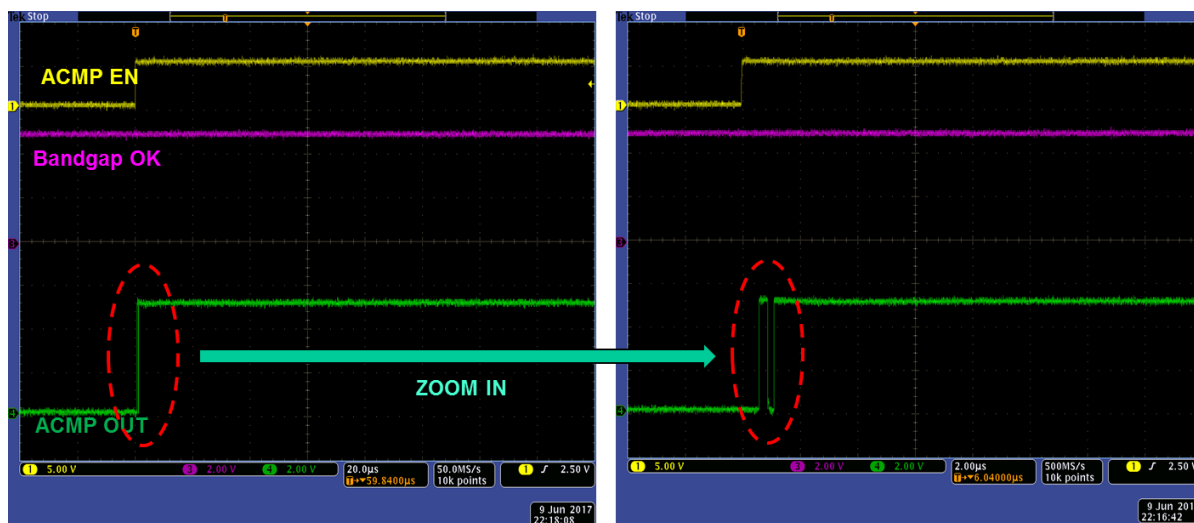
After power-up, if LDO is enabled earlier than ACMP, its output may generate a glitch.

$V_{DD} = 5.0\text{ V}$ , ACMP IN+ > IN-, one of LDOs enabled.

Because BG\_OK is already released by LDO, there is no gating signal. Depending on the ACMP VREF condition & the positive input value, it is possible for the ACMP to have a glitch. Subsequently, the other ACMP will not have an issue unless the customer repeats LDO enable first and ACMP later during power stable.

Use both edge delay on the output to filter out the glitch.

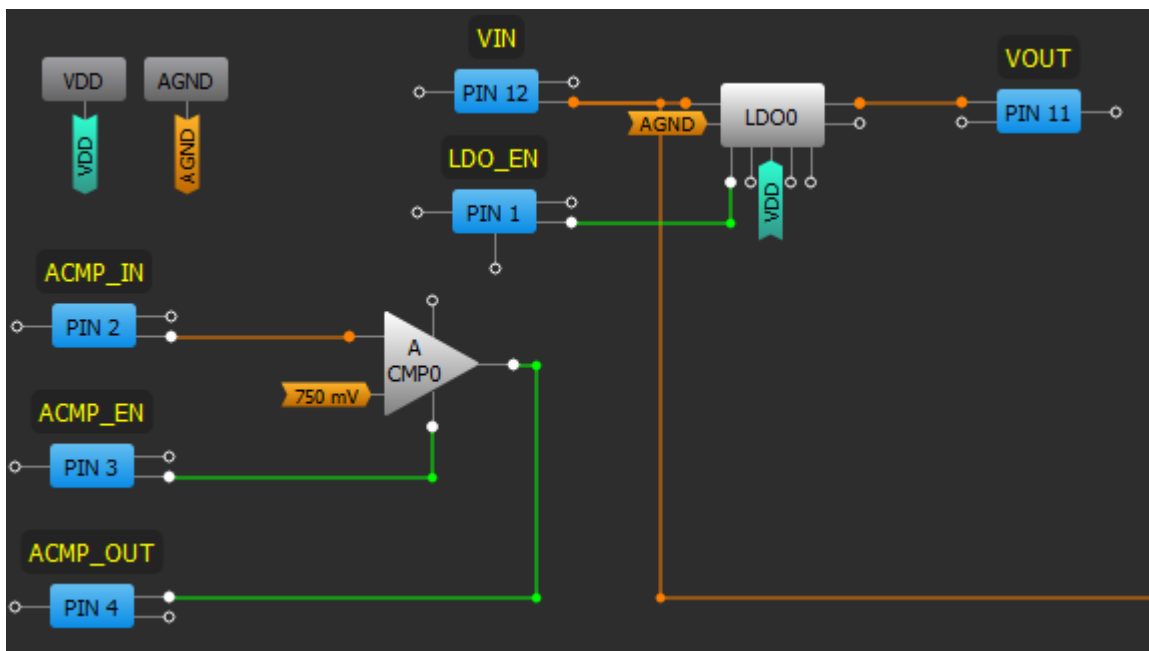
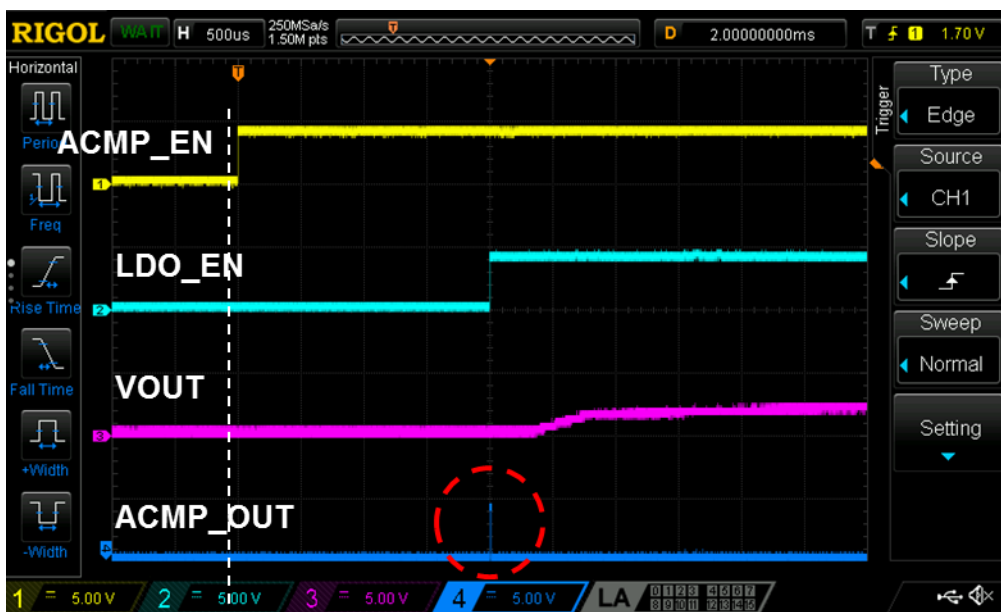
If an LDO's Low Power Mode is selected (for example tied to  $V_{DD}$ ) a glitch may appear on the ACMP's output after the first LDO is enabled. When the first LDO is turned on, the Low Power Mode switch causes a drop in the internal bandgap voltage that is used to derive the ACMP reference voltages.

- Use both edge delay on the output to filter out the glitch.
- Use some logic to avoid turning on Low Power Mode before enabling LDO and powering up the ACMP. Example is shown below.

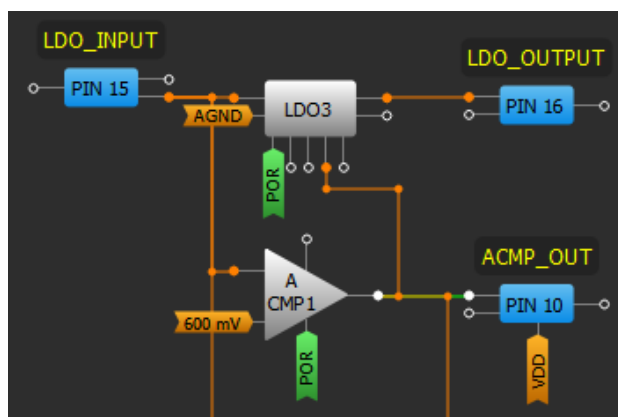
If an LDO's VIN pin (LDO\_INPUT) has an internal connection (depicted with an orange wire) to the ACMP's IN+ port, the ACMP's output may give an erroneous result with respect to the LDO's input voltage. The switch between the LDO's VIN pin and the ACMP's IN+ port is implemented using an NMOS-only based transmission gate with its gate controlled by logic supplied from V<sub>DD</sub>. As a result, this switch is unable to pass LDO input voltages that are close to V<sub>DD</sub>. This can result in the ACMP's IN+ port seeing a lower voltage than the actual voltage present at LDO\_INPUT. This lower input voltage may cause the output of the ACMP to behave unexpectedly.

If the LDO's UVLO feature is enabled, the ACMP's output will cause unexpected LDO behavior that results from the previously described transmission gate voltage drop.

If the GreenPAK's  $V_{DD}$  is always powered up before the LDO's VIN input, you can externally short the LDO's VIN to another dedicated analog input pin for the desired ACMP.

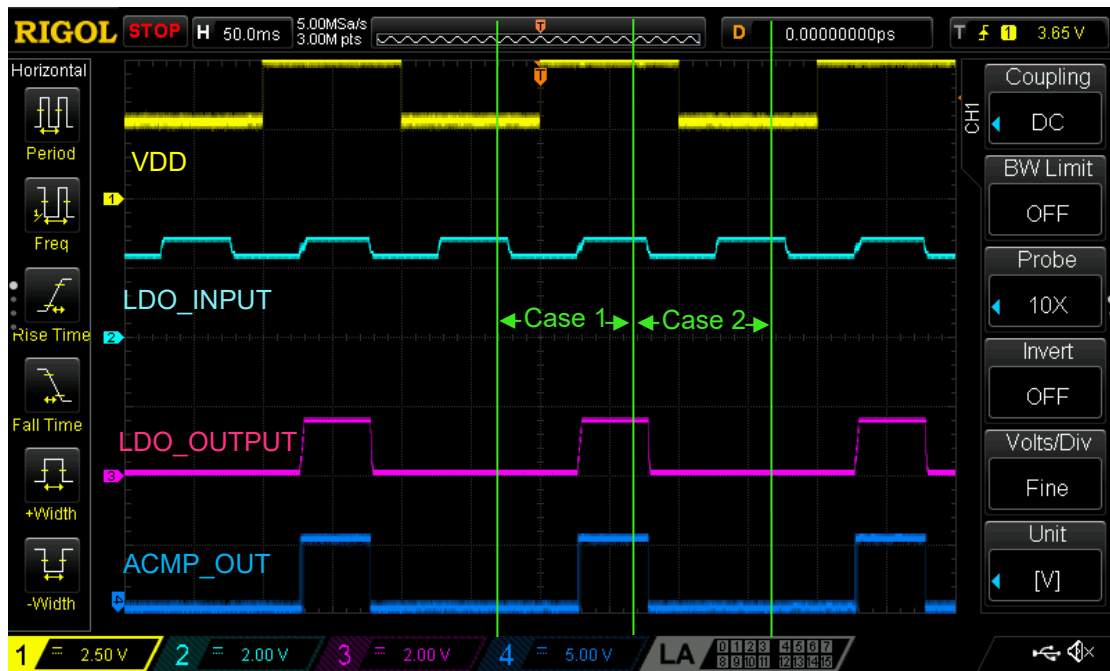
Case 1: proper behavior at  $V_{DD} = 5\text{ V}$ .

With a 5 V  $V_{DD}$ , the NMOS transmission gate passes the 2.25 and 2.75 V LDO\_INPUT pin voltages to the ACMP's IN+ port. When the input voltage exceeds the 2.4 V IN- threshold of the ACMP, the LDO is enabled.

Case 2: erroneous behavior at  $V_{DD} = 2.75\text{ V}$ .

When the  $V_{DD}$  is reduced to 2.75 V, the NMOS transmission gate is unable to pass LDO\_INPUT's full magnitude to the ACMP's IN+ port. Since the IN+ port of the ACMP doesn't exceed the 2.4 V IN- threshold, the ACMP's output stays low and keeps the LDO disabled.

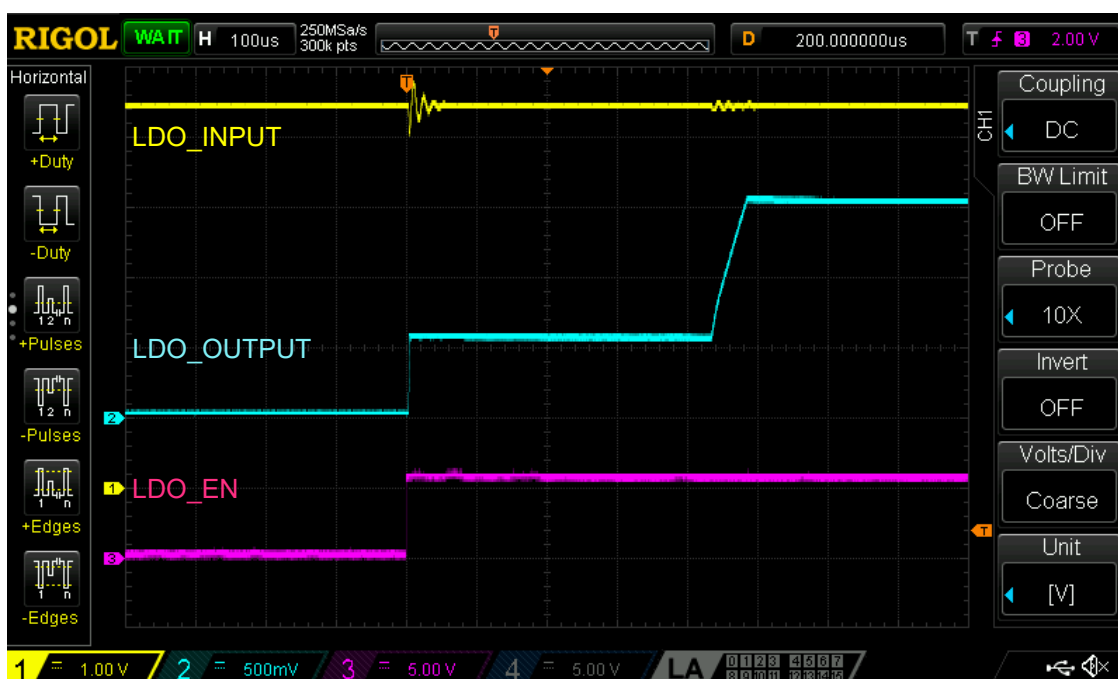
When a GreenPAK's first LDO is enabled, the LDO's VOUT will step to a non-zero voltage during its 500  $\mu\text{s}$  wait time. The magnitude of this step is directly proportional to the LDO's VIN and the GreenPAK's  $V_{DD}$ . With a large LDO input voltage and  $V_{DD}$ , this step can exceed 500 mV.

$V_{DD} = 5.5\text{ V}$ , LDO\_INPUT = 5.5 V, all other LDOs disabled.

If your GreenPAK design has an unused LDO, you can reduce the magnitude of this voltage step by keeping an unused LDO enabled in high power mode.

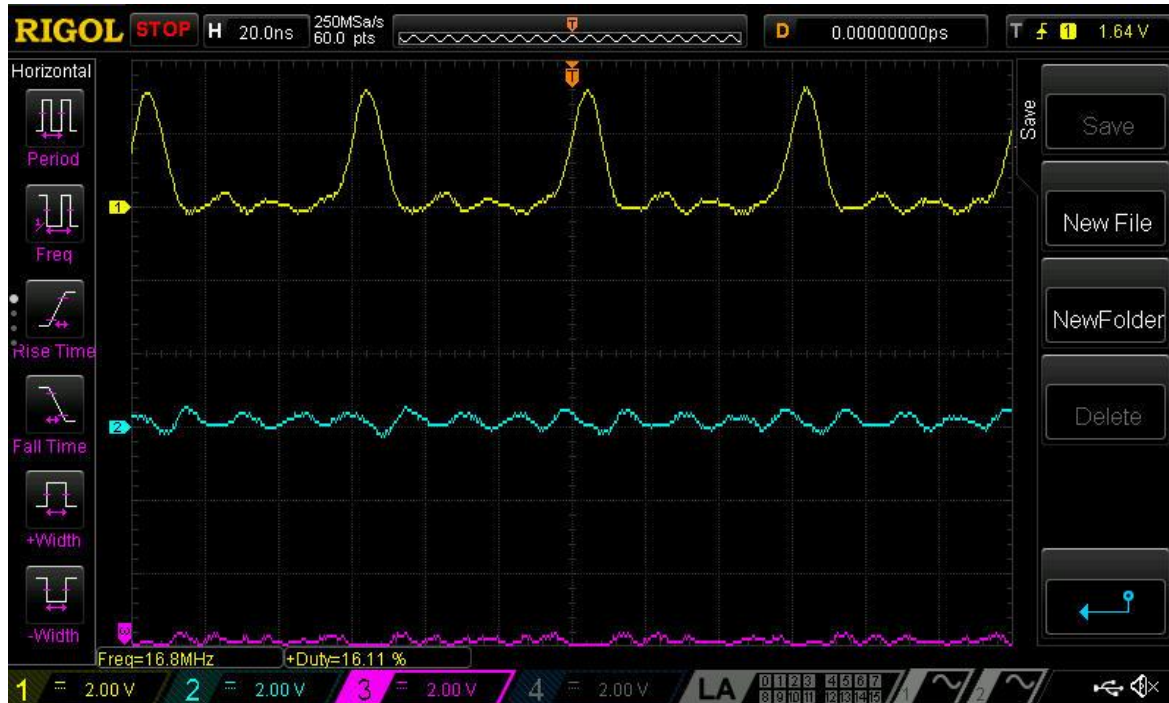
Channel 1 (yellow/top line) – PIN#4 (IN).  
 Channel 2 (light blue/2nd line) – PIN#10 (OUT).  
 Channel 3 (magenta /3rd line) – PIN#12 (DFF).

1. Period is 60 ns. Pulse width is 10 ns, DC = 16.7 % (correct functionality).

Currently, there is no workaround for this issue. The FILTER block correctly filters isolated glitches, but it shouldn't be used to filter repetitive, high frequency input signals.

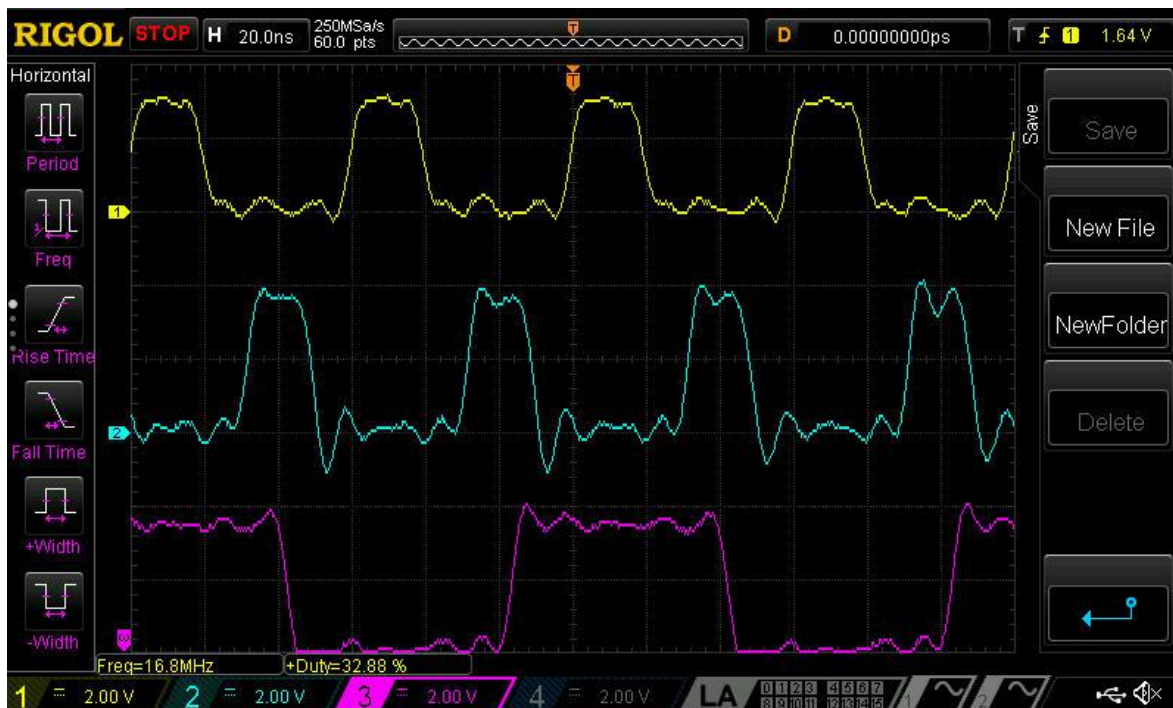
2. Period is 60 ns. Pulse width is 20 ns, DC = 33.3 % (incorrect functionality).

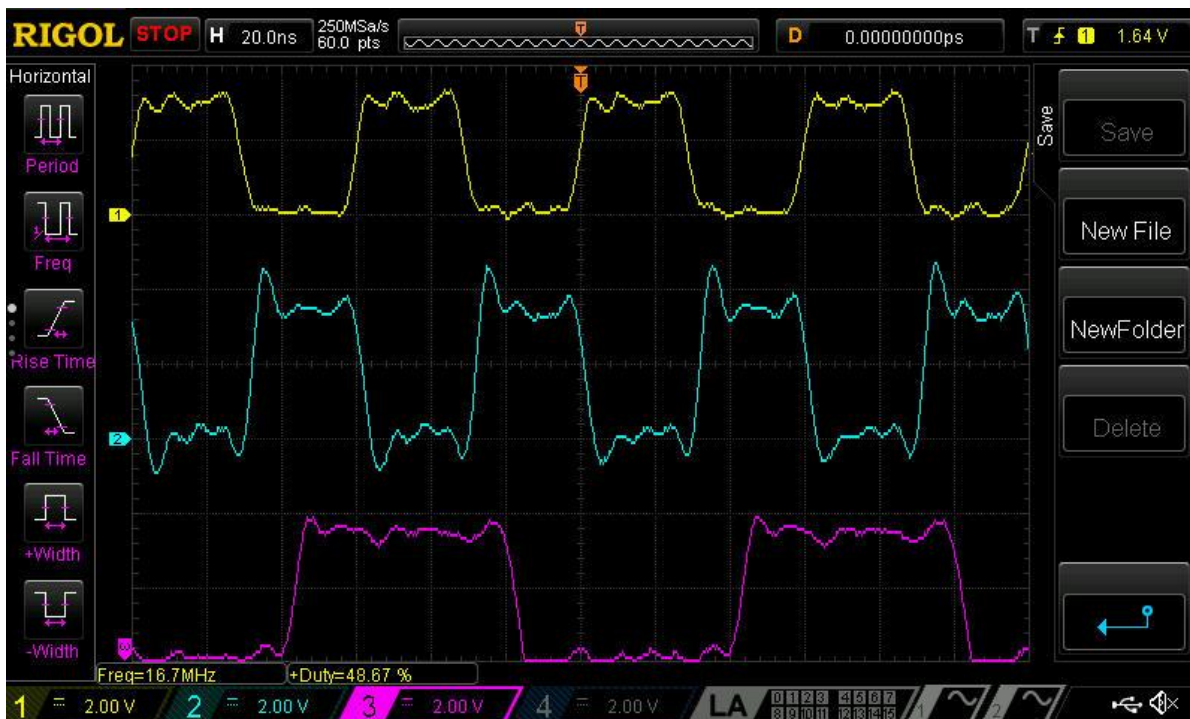
3. Period is 60 ns. Pulse width is 30 ns, DC = 50 % (incorrect functionality).

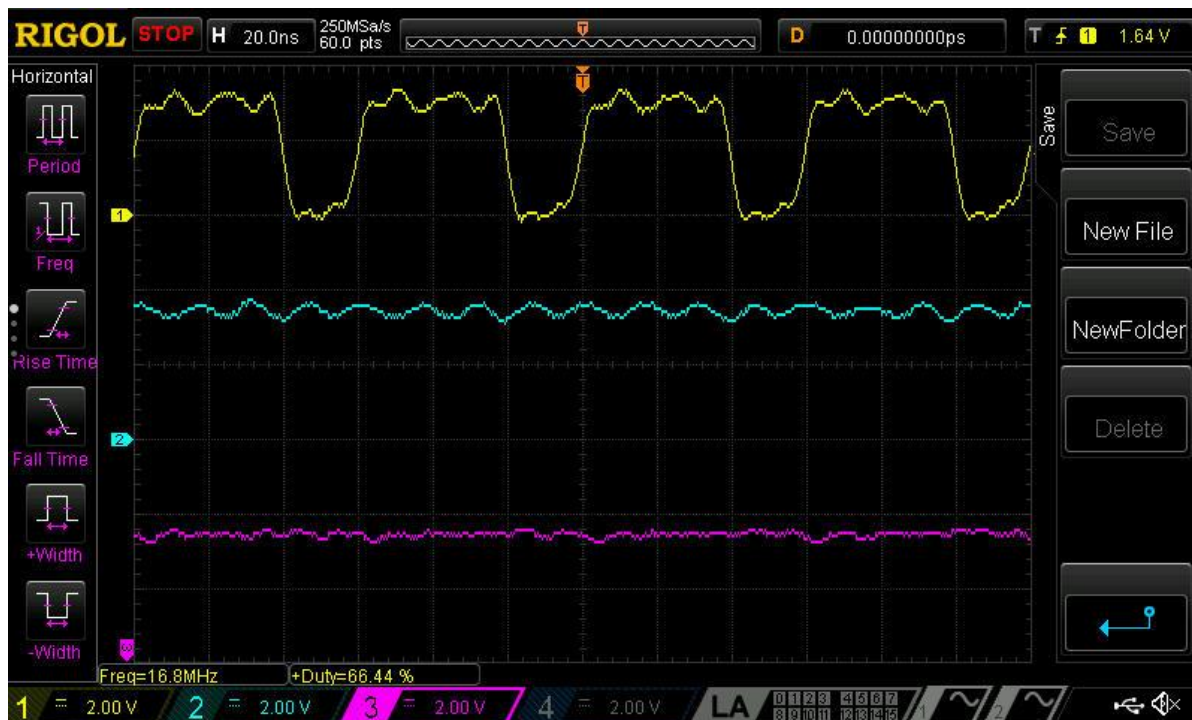
4. Period is 60 ns. Pulse width is 40 ns, DC = 66.67 % (correct functionality).

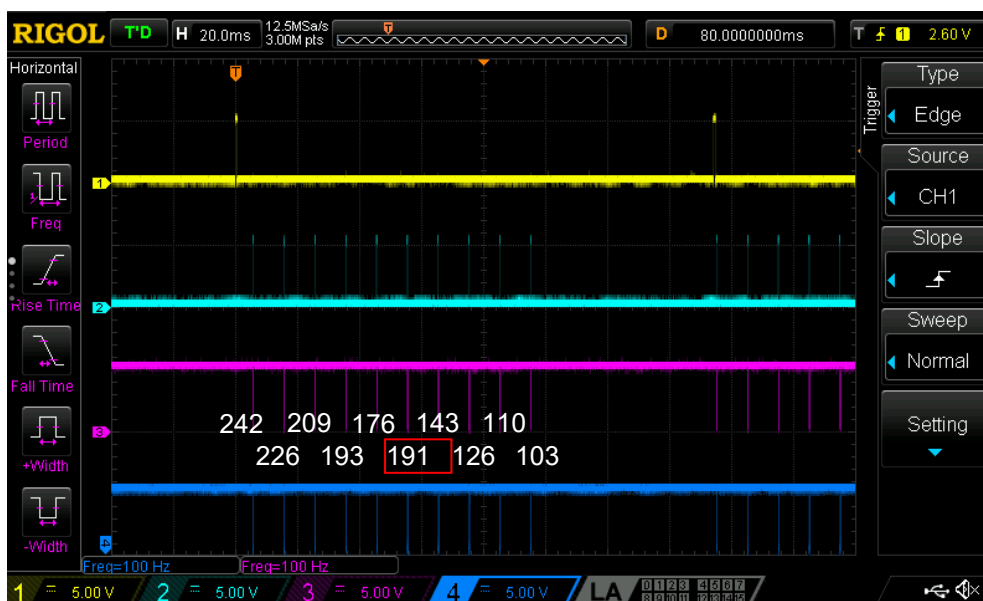
Asynchronous interaction between the CNT/DLY clock input and the I<sup>2</sup>C latch signal (generated by an I<sup>2</sup>C read command of the CNT/DLY block's count value) can result in an incorrect I<sup>2</sup>C data read. The CNT/DLY block will count accurately, but the count value transferred into the block's I<sup>2</sup>C read register might be loaded incompletely if the I<sup>2</sup>C latch signal and the clock input occur at about the same time.

The example data capture below shows ten periodic I<sup>2</sup>C reads of CNT2/DLY2 configured to count down at about 16 clocks per read. The sixth read sample erroneously shows a value greater than that of the fifth. The seventh sample reads as if the previous I<sup>2</sup>C error never occurred - the difference from the fifth sample (176) to the seventh (143) is 33 clocks or 16 clocks + 17 clocks as expected.

Channel 1 (yellow/top line) – PIN#2 (CNT2/DLY2 Out).  
 Channel 2 (light blue/2nd line) – PIN#1 (I<sup>2</sup>C Read Triggers).  
 Channel 3 (magenta /3rd line) – PIN#8 (I<sup>2</sup>C SCL).  
 Channel 3 (dark blue /4th line) – PIN#9 (I<sup>2</sup>C SDA).

If the possibility of incorrect I<sup>2</sup>C data reads can't be accommodated for by external software checks, one can guarantee proper operation by stopping the CNT/DLY block's clock during I<sup>2</sup>C reads through one of the following methods: by disabling the oscillator block, by reconfiguring the CNT/DLY block's clock source, or by gating an external clock using a LUT (Look-up Table) in the signal matrix. After disabling the CNT/DLY block's clock, the count registers can be read without error. Please note that this workaround will add the I<sup>2</sup>C read and processing time to the counter's overall clock period.

The best workaround depends on the resource constraints of the application. If the oscillator block doesn't clock other logic elements within the design, a matrix output can be used to manually power down the oscillators for the I<sup>2</sup>C read. When the CNT/DLY block's clock source is routed internally from the oscillator block, I<sup>2</sup>C commands can temporarily reconfigure the CNT/DLY block's clock source registers to select "Ext. CLK. (From Matrix)." This action will disable the clock by connecting it to ground. If the CNT/DLY block is clocked from the signal matrix, a LUT can be used to gate the clock during an I<sup>2</sup>C read.

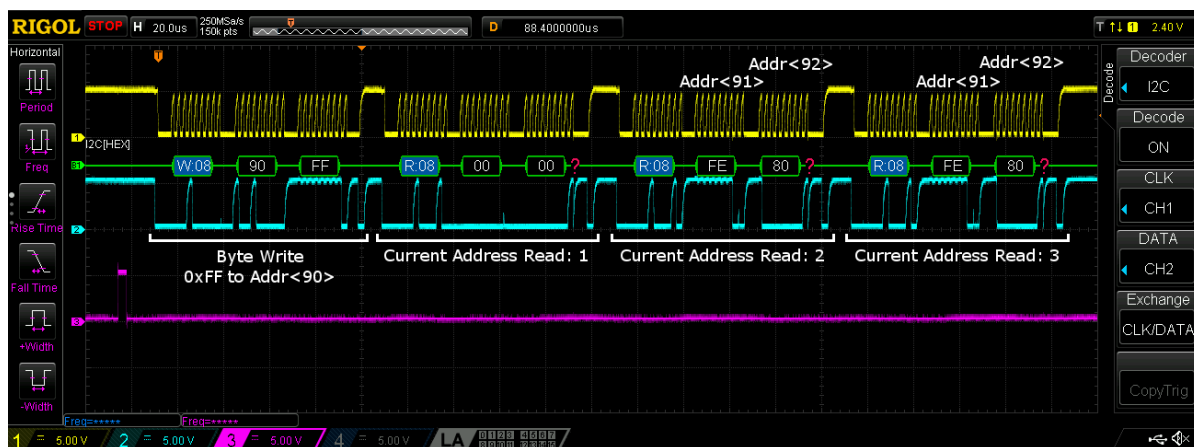
The first “Current Address Read” or “Sequential Read” command following an I<sup>2</sup>C “Byte Write” or a “Sequential Write” command will produce incorrect data. Additional read commands will return the expected data. See the waveform below for more information.

Channel 1 (yellow/top line) – PIN#8 (SCL).  
 Channel 2 (light blue/2nd line) – PIN#9 (SDA).  
 Channel 3 (magenta /3rd line) – I<sup>2</sup>C Software Trigger.

Note: In the GreenPAK test design, Addr<91> and Addr<92> expect FE and 80 respectively.

If possible, use the “Random Read” command as described in the datasheet for SLG46580. This command will output the correct data.

If you expect consecutive reads of the same register, we recommend sending a “Random Read” command to the register preceding the register of interest. After the “Random Read” command finishes, the chip’s register pointer will increment to the desired register and the following “Current

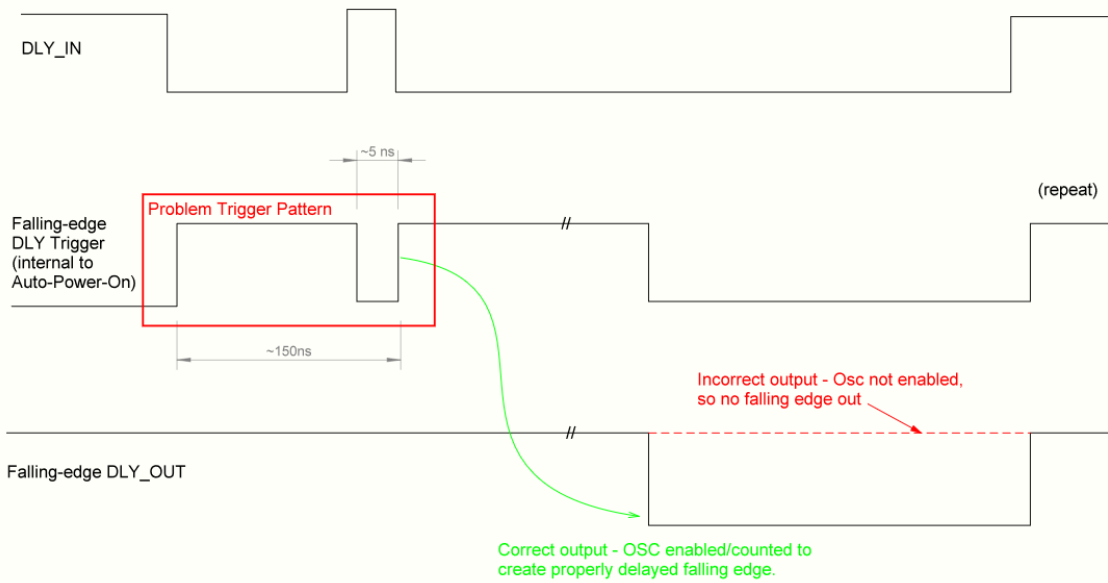
Figure 1: Problem Trigger Pattern

For this chip, the Auto Power On circuitry of the 25 kHz/2 MHz generators contains a circuit errata, which can potentially fail to power on the OSC for a specific pattern and timing of the OR of all related DLY trigger signals. The pattern is shown in Figure 1 (boxed in red) and consists of a relatively longer pulse (~145 ns) followed by a shorter (~5 ns) glitch of opposite polarity.

1. Use signal conditioning circuits to prevent glitch on DLY inputs < 200 ns. Examples:
  - a. ACMP with Hysteresis
  - b. External RC in front of Digital Input with Schmitt Trigger
  - c. Filter cell.
2. Set OSC power mode to Force Power On mode instead of Auto Power On.
3. Use different oscillator, such as 25 MHz Ring OSC, which does not have Auto Power On issue.

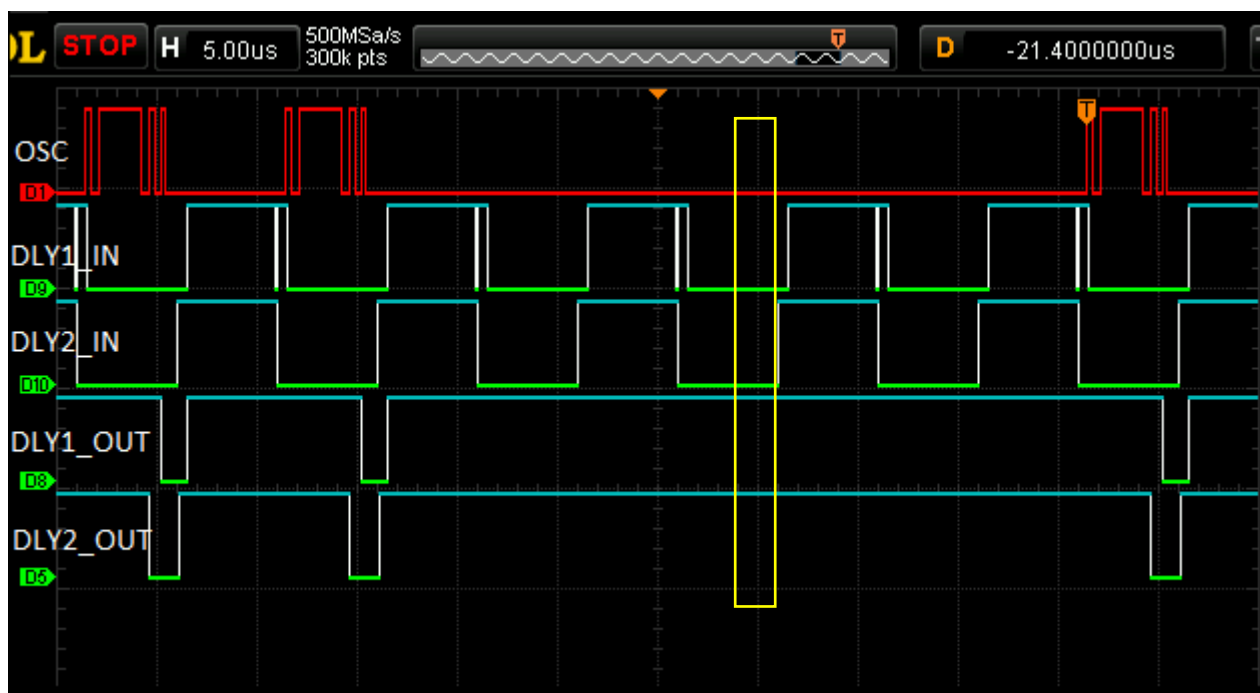
Figure 3: Errata Capture (Zoom Out)

Figure 3 shows a series of DLY output events are missing, where the OSC is correspondingly not triggering when it was supposed to. Figure 4 is a zoom in of the boxed region from Figure 3. The total glitch/chatter time was measured in this case at 152 ns. By using the composite OR of the two delay channels, we can asynchronously strobe with tiny frequency variations, and so tune the timing to induce this errata. Note that the error is not persistent – the system is recovered when all DLYs are returned to inactive state, such as when input of falling edge DLY goes high, thus canceling delay, or after DLY out finishes.

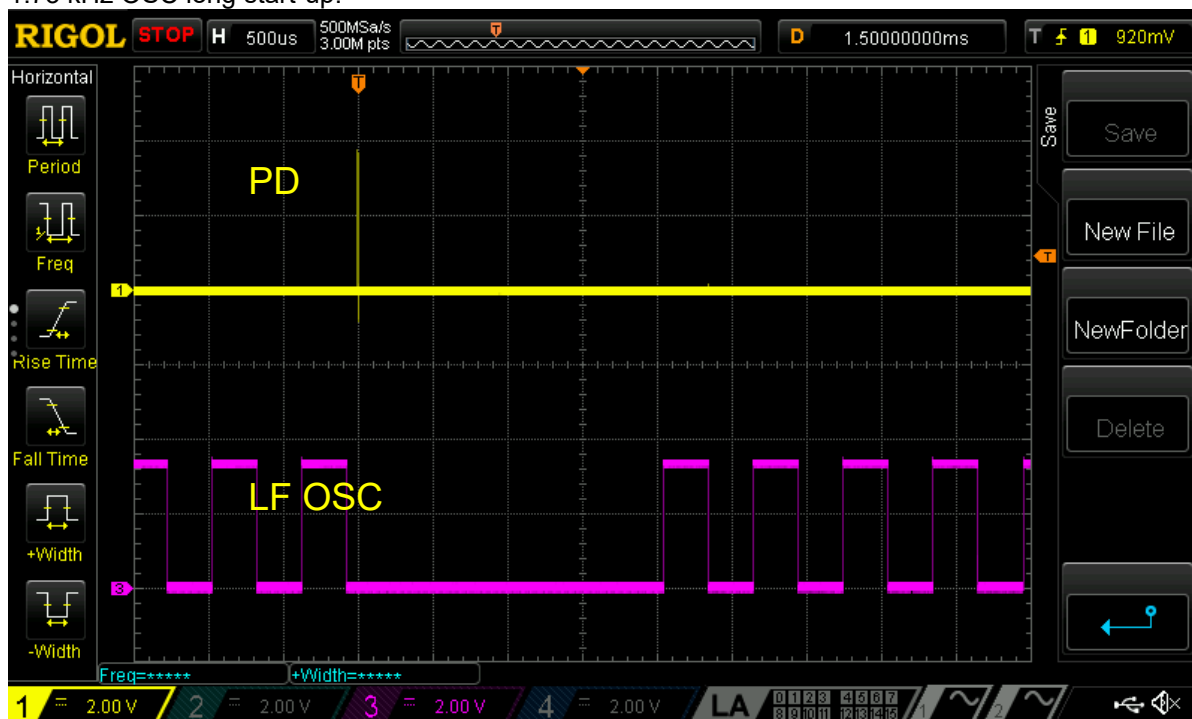
1.73 kHz OSC long start-up:

If a pulse with a duration of less than ~40 ns is applied to the PWR DOWN input of an oscillator, the oscillator outputs remain stuck for milliseconds. The issue is observed for all available oscillators.

Change Fast start-up setting to Enable or omit applying glitches at PWR DOWN input in OSC.
