SLG46585 Errata

CE-GP-002

This document contains the known errata for SLG46585 and the recommended workarounds.

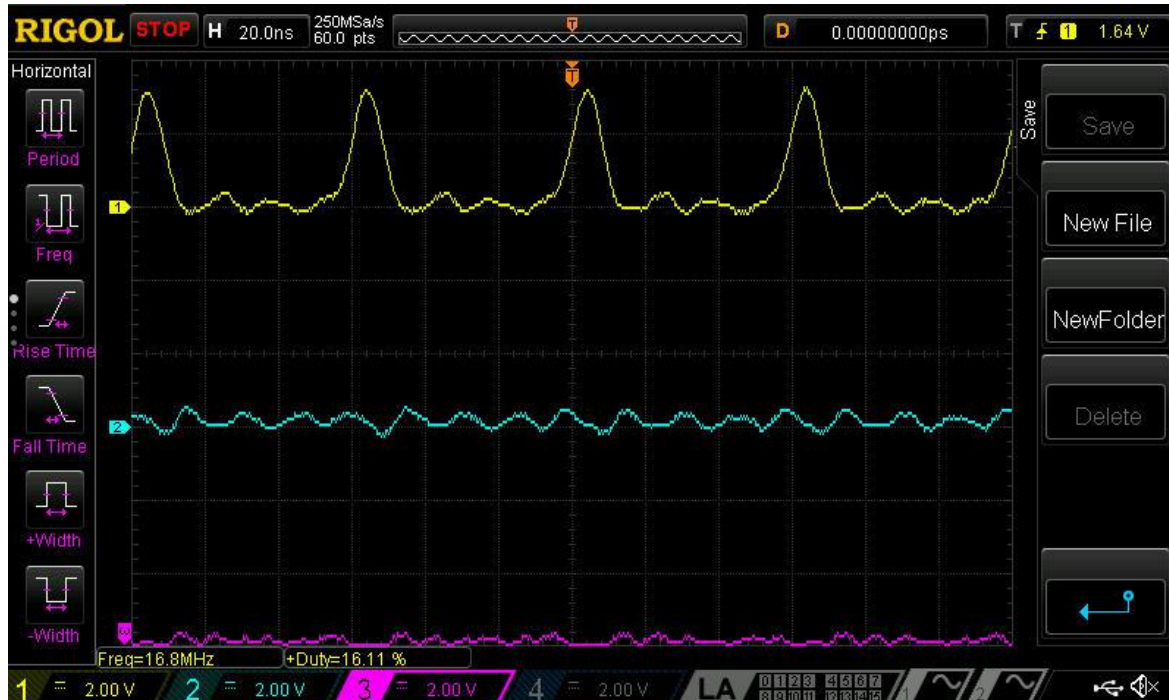
If the FILTER cell's input signal contains multiple consecutive pulses within short time intervals, the FILTER cell may not filter the input pulses as expected. The errant behavior applies only to repeated input pulses and depends on both their frequency and duty cycle.

1. Period is 60 ns. Pulse width is 10 ns, DC = 16.7 % (correct functionality).

Currently, there is no workaround for this issue. The FILTER block correctly filters isolated glitches, but it shouldn't be used to filter repetitive, high frequency input signals.

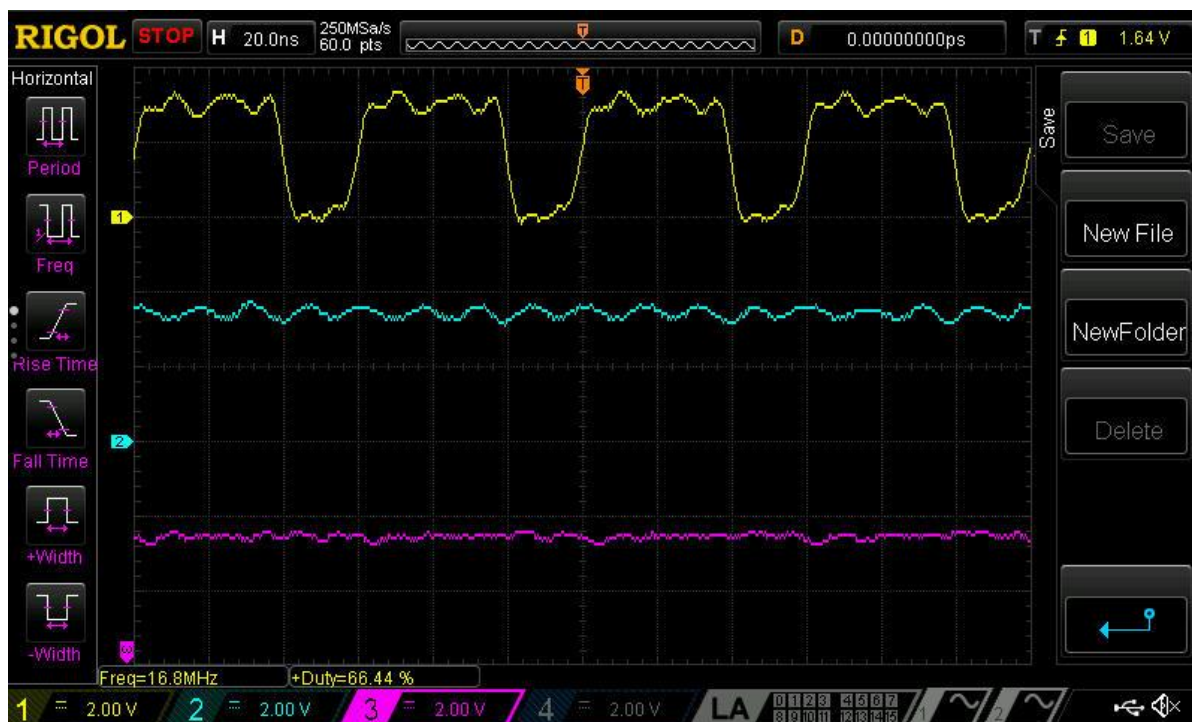
4. Period is 60 ns. Pulse width is 40 ns, DC = 66.67 % (correct functionality).

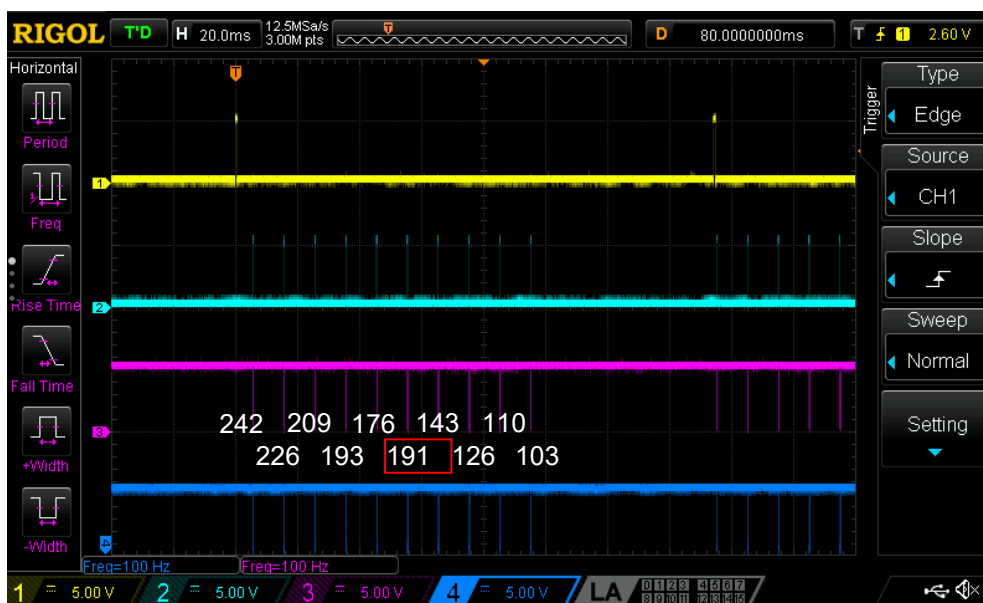
Asynchronous interaction between the CNT/DLY clock input and the I²C latch signal (generated by an I²C read command of the CNT/DLY block's count value) can result in an incorrect I²C data read. The CNT/DLY block will count accurately, but the count value transferred into the block's I²C read register might be loaded incompletely if the I²C latch signal and the clock input occur at about the same time.

The example data capture below shows ten periodic I²C reads of CNT2/DLY2 configured to count down at about 16 clocks per read. The sixth read sample erroneously shows a value greater than that of the fifth. The seventh sample reads as if the previous I²C error never occurred - the difference from the fifth sample (176) to the seventh (143) is 33 clocks or 16 clocks + 17 clocks as expected.

If the possibility of incorrect I²C data reads can't be accommodated for by external software checks, one can guarantee proper operation by stopping the CNT/DLY block's clock during I²C reads through one of the following methods: by disabling the oscillator block, by reconfiguring the CNT/DLY block's clock source, or by gating an external clock using a LUT (Look-up Table) in the signal matrix. After disabling the CNT/DLY block's clock, the count registers can be read without error. Please note that this workaround will add the I²C read and processing time to the counter's overall clock period.

The best workaround depends on the resource constraints of the application. If the oscillator block doesn't clock other logic elements within the design, a matrix output can be used to manually power down the oscillators for the I²C read. When the CNT/DLY block's clock source is routed internally from the oscillator block, I²C commands can temporarily reconfigure the CNT/DLY block's clock source registers to select "Ext. CLK. (From Matrix)." This action will disable the clock by connecting it to ground. If the CNT/DLY block is clocked from the signal matrix, a LUT can be used to gate the clock during an I²C read.

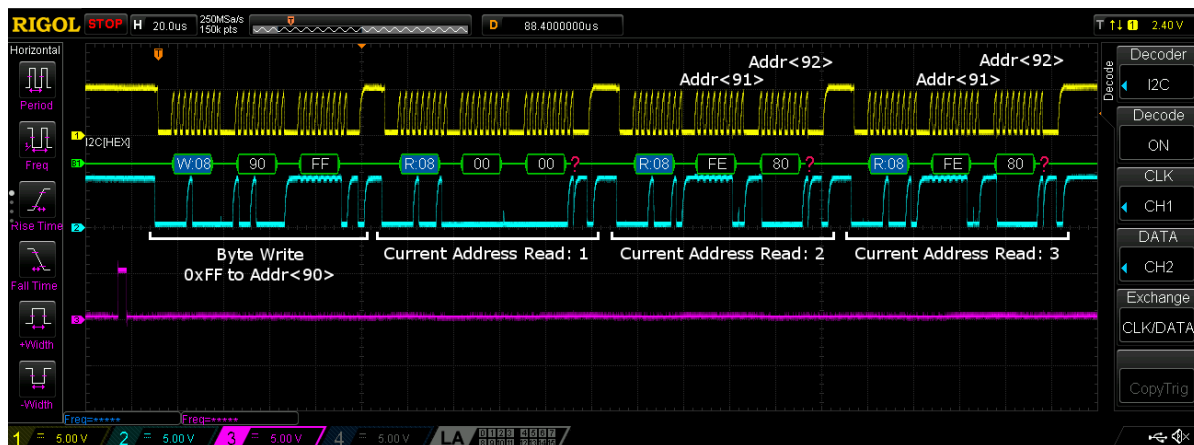
The first “Current Address Read” or “Sequential Read” command following an I²C “Byte Write” or a “Sequential Write” command will produce incorrect data. Additional read commands will return the expected data. See the waveform below for more information.

Note: In the GreenPAK test design, Addr<91> and Addr<92> expect FE and 80 respectively.

If possible, use the “Random Read” command as described in the datasheet for SLG46580. This command will output the correct data.

If you expect consecutive reads of the same register, we recommend sending a “Random Read” command to the register preceding the register of interest. After the “Random Read” command finishes, the chip’s register pointer will increment to the desired register and the following “Current

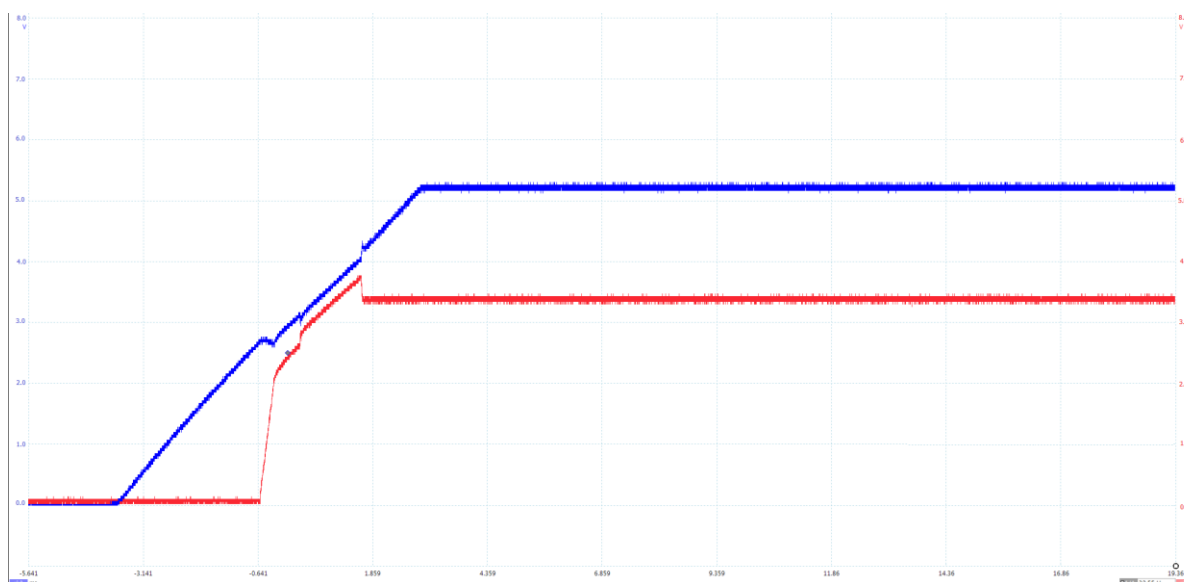
The maximum DC_VOUT to DC_VIN duty cycle ratio is 80 % for fsw=1.5 MHz and 75 % for fsw=2 MHz (See Table 20 in Datasheet section 5.11 parameter Maximum Duty Cycle). This voltage glitch issue only occurs if the DC_VOUT to DC_VIN ratio exceeds this maximum, meaning DC_VIN does not have enough headroom above DC_VOUT.

For DC_VOUT selections 1.2 V, 1.5 V, and 1.8 V, the UVLO can block the ON/OFF signal from enabling the DC/DC Buck Converter until DC_VIN is greater than 2.3 V. However, for selections 2.5 V, 3.0 V, and 3.3 V, which are greater than the UVLO threshold, there is no protection against enabling the DC/DC while the DC_VIN does not satisfy the Maximum Duty Cycle ratio specified above.

This glitch can be seen in an application where there is a slow DC_VIN/VDD ramp and the DC/DC’s enable signal is tied to DC_VIN/VDD, as shown in the example capture below.

The example capture below shows DC_VIN/VDD ramping from 0 V to 5.5 V at 1 V/ms. The output voltage is set to 3.3 V.

Use an ACMP to detect when DC_VIN is greater than DC_VOUT divided by Maximum Duty Cycle, and then AND the ACMP output with the ON/OFF signal.

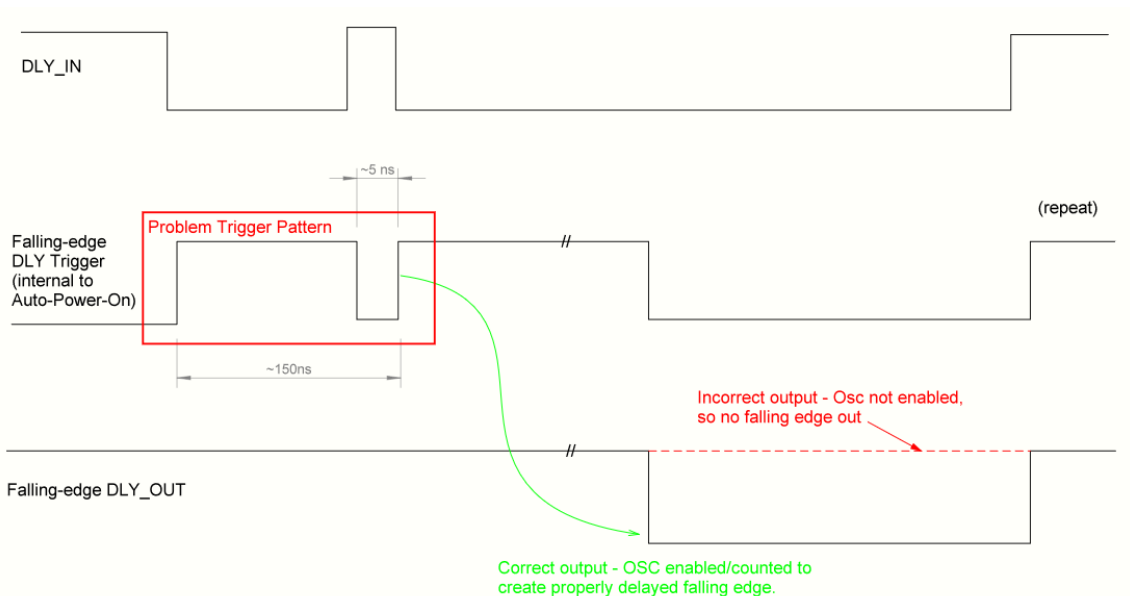
Figure 1: Problem Trigger Pattern

For this chip, the Auto Power On circuitry of the 25 kHz/2 MHz generators contains a circuit errata, which can potentially fail to power on the OSC for a specific pattern and timing of the OR of all related DLY trigger signals. The pattern is shown in Figure 1 (boxed in red) and consists of a relatively longer pulse (~145 ns) followed by a shorter (~5 ns) glitch of opposite polarity.

1. Use signal conditioning circuits to prevent glitch on DLY inputs < 200 ns. Examples:

- a. ACMP with Hysteresis
 - b. External RC in front of Digital Input with Schmitt Trigger
 - c. Filter cell.
2. Set OSC power mode to Force Power On mode instead of Auto Power On.
 3. Use different oscillator, such as 25 MHz Ring OSC, which does not have Auto Power On issue.

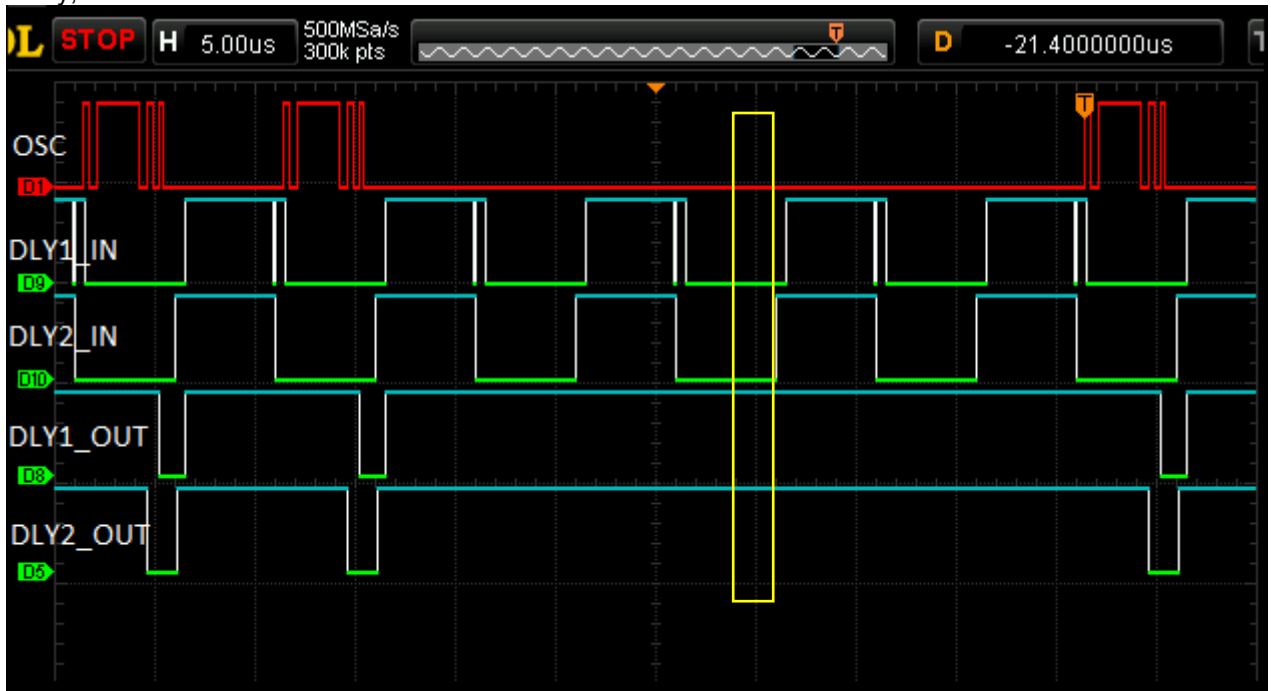
Figure 3: Errata Capture (Zoom Out)

Figure 3 shows a series of DLY output events are missing, where the OSC is correspondingly not triggering when it was supposed to. Figure 4 is a zoom in of the boxed region from Figure 3. The total glitch/chatter time was measured in this case at 152 ns. By using the composite OR of the two delay channels, we can asynchronously strobe with tiny frequency variations, and so tune the timing to induce this errata. Note that the error is not persistent – the system is recovered when all DLYs are returned to inactive state, such as when input of falling edge DLY goes high, thus canceling delay, or after DLY out finishes.

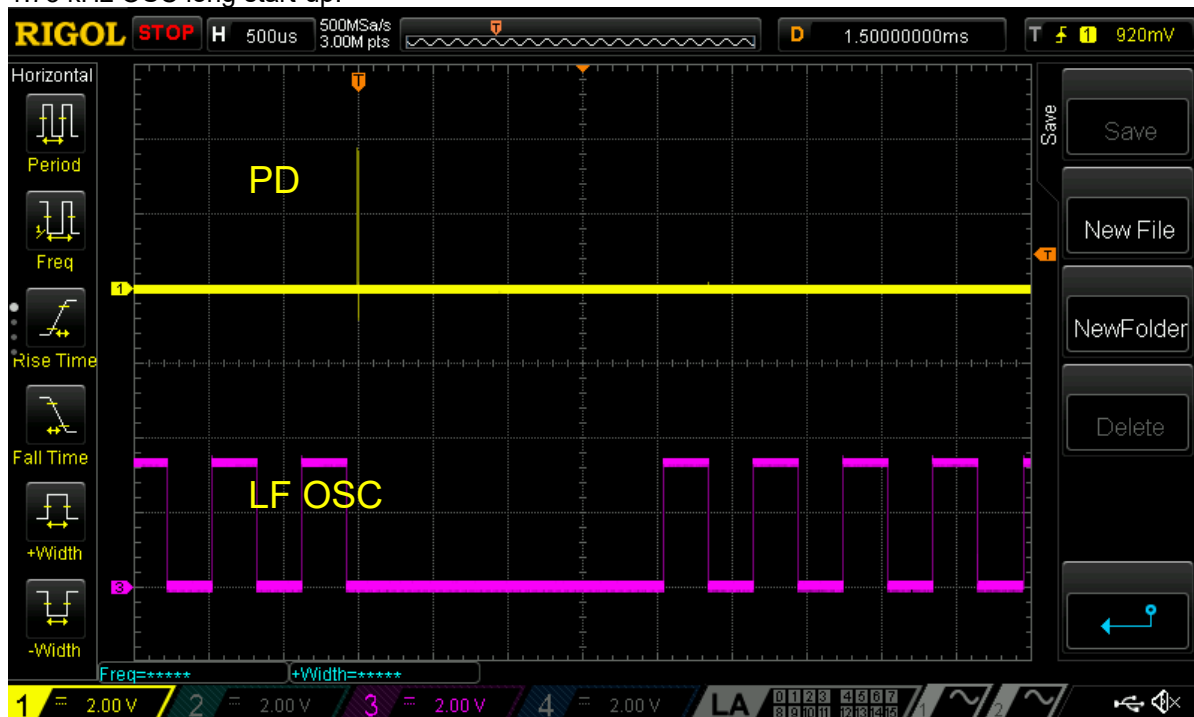
If a pulse with a duration of less than ~40 ns is applied to the PWR DOWN input of an oscillator, the oscillator outputs remain stuck for milliseconds.

1.73 kHz OSC long start-up:

Change Fast start-up setting to Enable or omit applying glitches at PWR DOWN input in OSC.

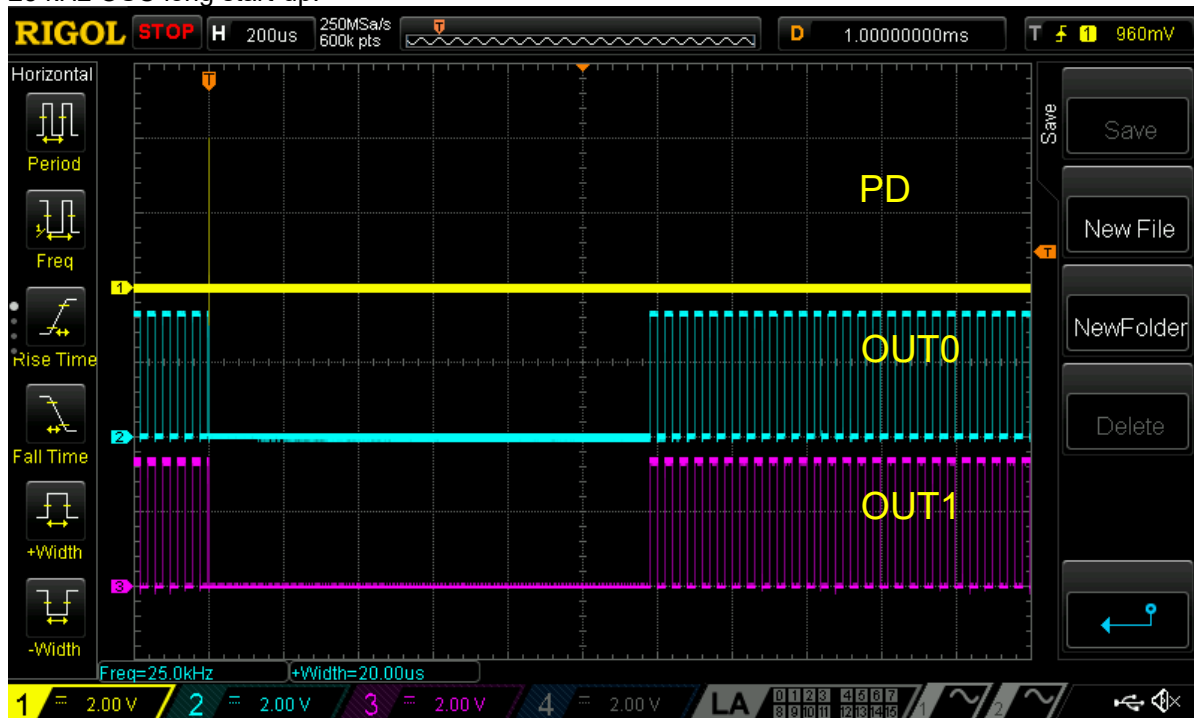
25 kHz OSC long start-up:

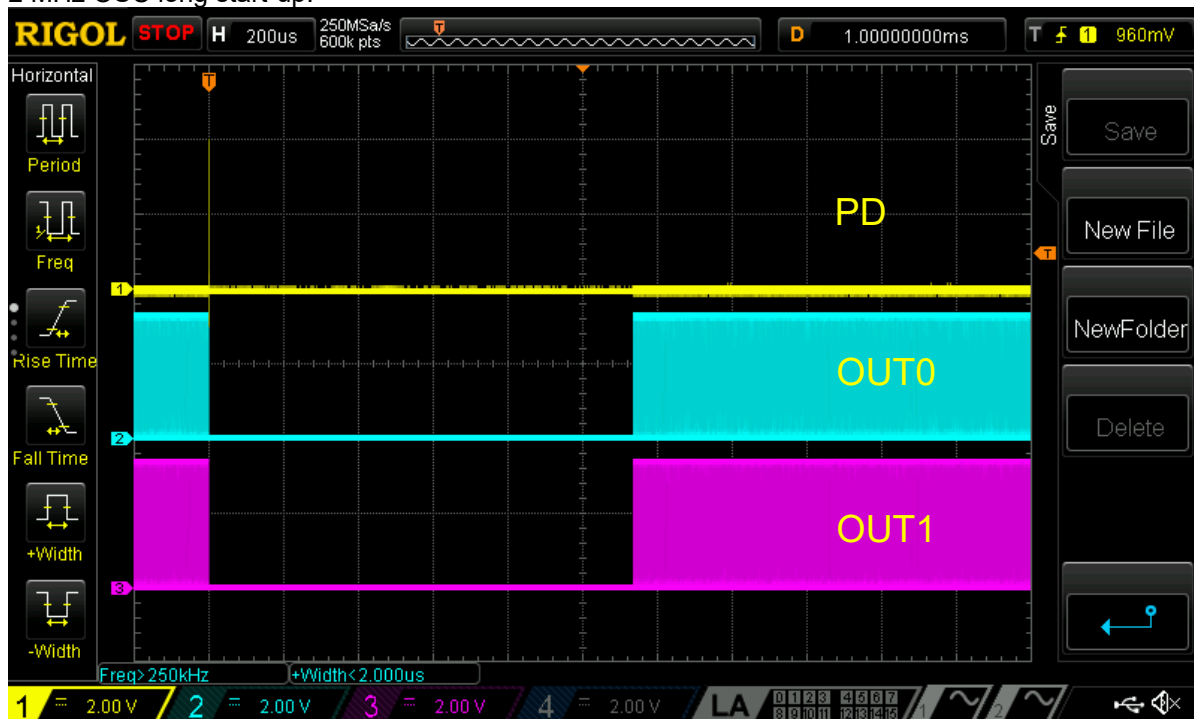
2 MHz OSC long start-up:
