SLG46880-A Errata Note

This document contains the known errata for SLG46880-A and the recommended workarounds.

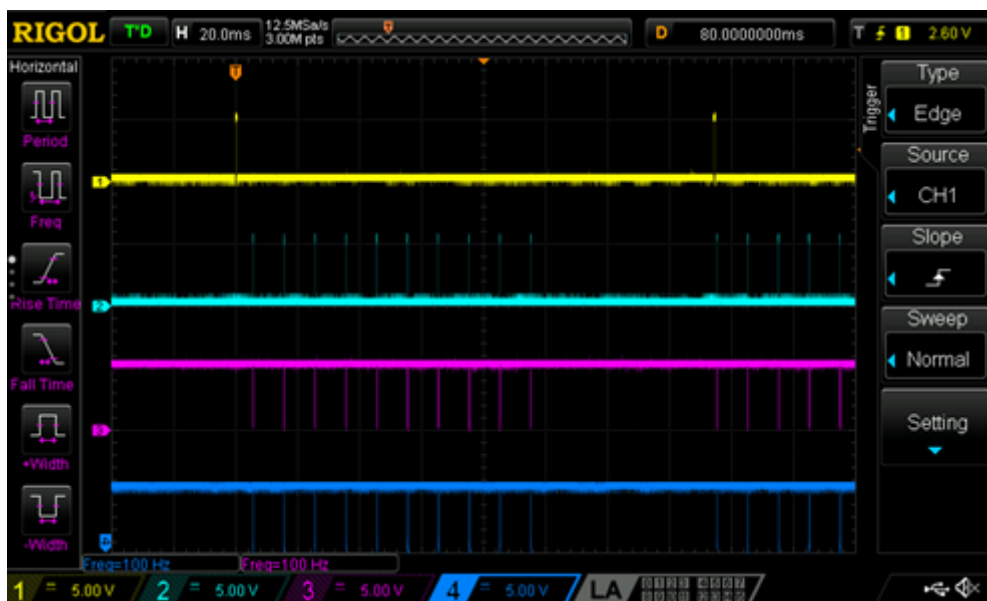
Figure 1. Example Data

Asynchronous interaction between the CNT/DLY clock input and the I<sup>2</sup>C latch signal (generated by an I<sup>2</sup>C read command of the CNT/DLY block's count value) can result in an incorrect I<sup>2</sup>C data read. The CNT/DLY block will count accurately, but the count value transferred into the block's I<sup>2</sup>C read register might be loaded incompletely if the I<sup>2</sup>C latch signal and the clock input occur at about the same time.

The example data capture below shows ten periodic I<sup>2</sup>C reads of CNT2/DLY2 configured to count down at about 16 clocks per read. The sixth read sample erroneously shows a value greater than that of the fifth. The seventh sample reads as if the previous I<sup>2</sup>C error never occurred - the difference from the fifth sample (176) to the seventh (143) is 33 clocks or 16 clocks + 17 clocks as expected.

If the possibility of incorrect I<sup>2</sup>C data reads can't be accommodated for by external software checks, one can guarantee proper operation by stopping the CNT/DLY block's clock during I<sup>2</sup>C reads through one of the following methods: by disabling the oscillator block, by reconfiguring the CNT/DLY block's clock source, or by gating an external clock using a LUT (Look Up Table) in the signal matrix. After disabling the CNT/DLY block's clock, the count registers can be read without error. Please note that this workaround will add the I<sup>2</sup>C read and processing time to the counter's overall clock period.

The best workaround depends on the resource constraints of the application. If the oscillator block doesn't clock other logic elements within the design, a matrix output can be used to manually power down the oscillators for the I<sup>2</sup>C read. When the CNT/DLY block's clock source is routed internally from the oscillator block, I<sup>2</sup>C commands can temporarily reconfigure the CNT/DLY block's clock source registers to select "Ext. CLK. (From Matrix)." This action will disable the clock by connecting it to ground. If the CNT/DLY block is clocked from the signal matrix, LUT can be used to gate the clock during an I<sup>2</sup>C read.

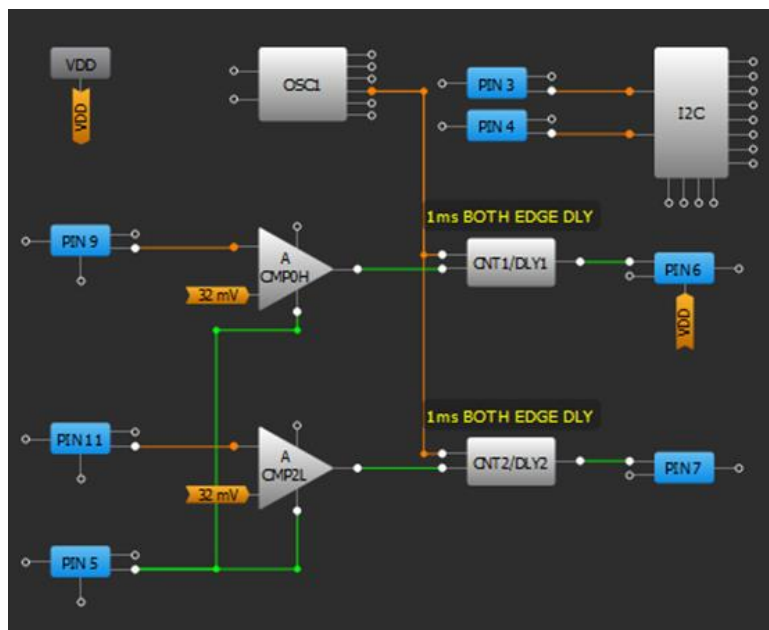
Figure 2. Testing Design

There is some noise coupling from the Vrefs of high-speed ACMPs to the low-power bandgap (BG) while the high-speed ACMPs Vref is turning on and off.

There is no issue with manually powering up the low-speed ACMPs. If you are manually powering up the high-speed ACMPs via the "PWR UP" connector, you should add a 1 ms delay to the output of all of the ACMPs used in the design.

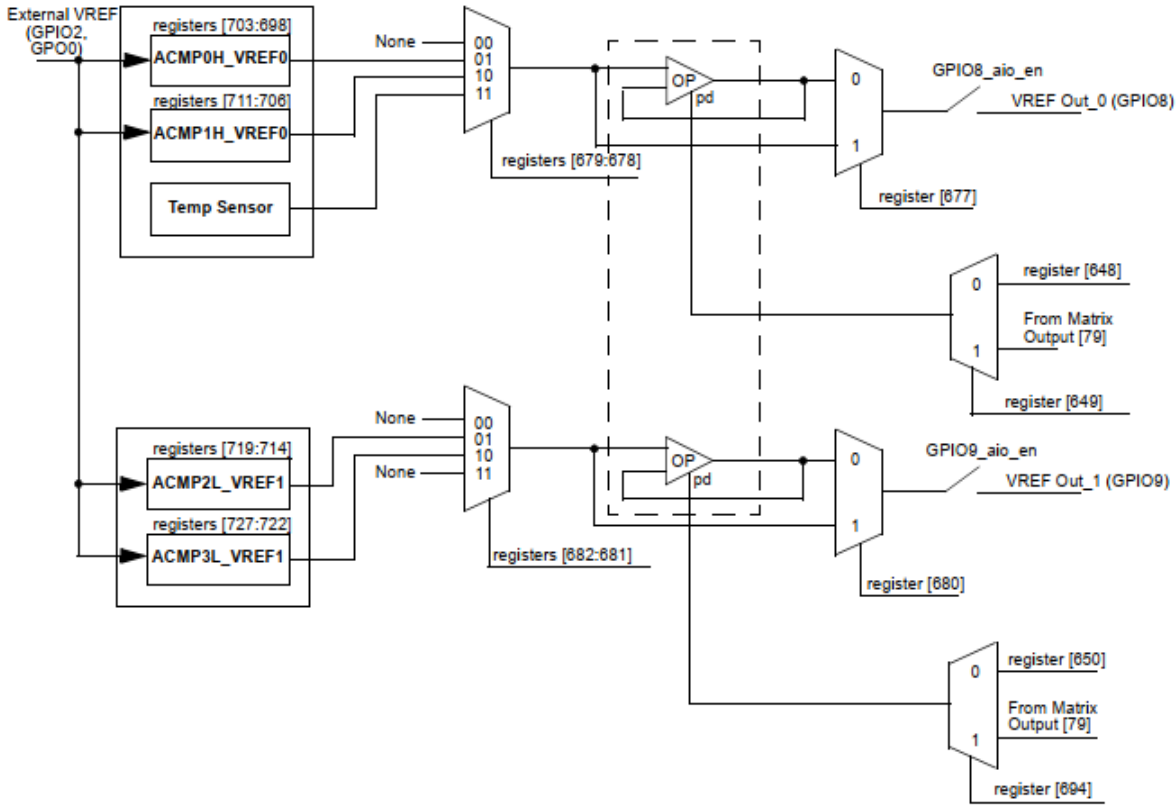
Figure 3. Testing Design

For systems where  $V_{DD} = 2.5\text{ V}$ , the Vref output buffer will be unstable if the output voltage is around  $0.5 \times V_{DD}$ .

For a system where  $V_{DD} = 2.5\text{ V}$ , bypass the buffer if the output voltage of the Vref buffer is within  $(0.5 \times V_{DD}) \pm 0.4$ . Check the Vref section of the device datasheet to see which registers need to be modified.
