Product Change Notice (PCN)

Subject: Add Alternate Assembly Location on Select VFQFPN Package

P9260 Qualification at UTL Test Report

Product: P9260-10ZNLG2

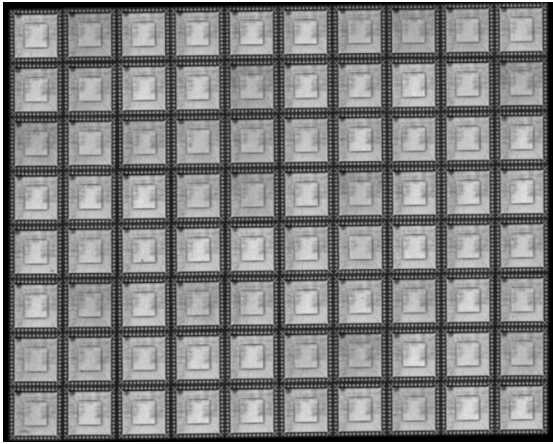
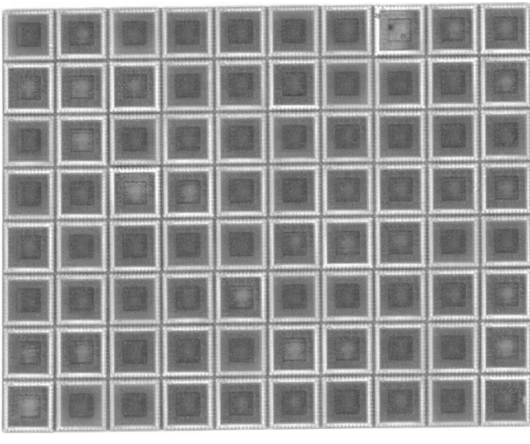
Rel Stress	Top Scan	Through Scan	Note
TC	CSAM @ T0		No anomalies found

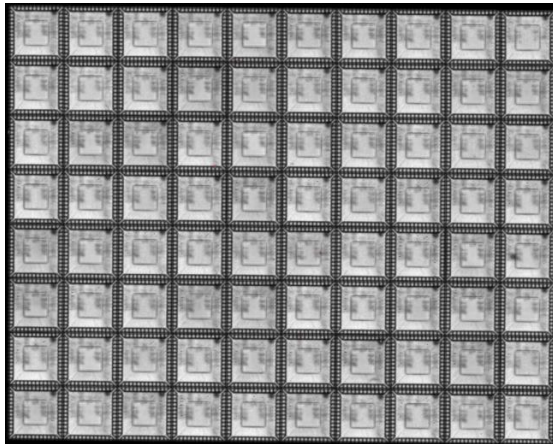
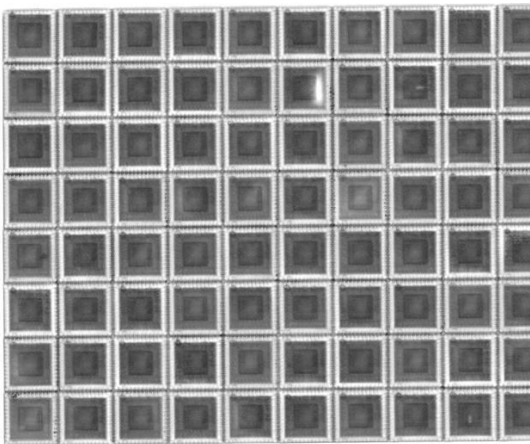
TC	CSAM post PC		No anomalies found

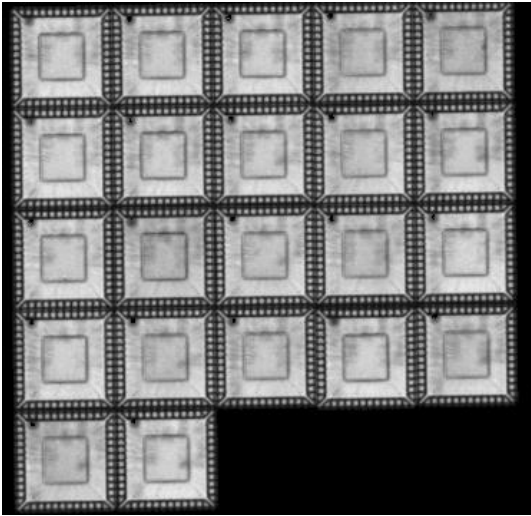
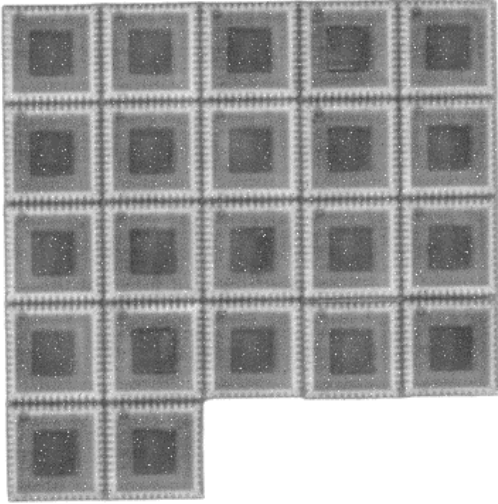
TC	<p data-bbox="628 324 895 353">CSAM post-1x stress</p> <div data-bbox="199 378 732 891">

</div>	<p data-bbox="1382 365 1516 472">No anomalies found</p>
TC	<p data-bbox="580 936 943 965">Cross Section post-1x stress</p> <div data-bbox="376 987 1153 1449">

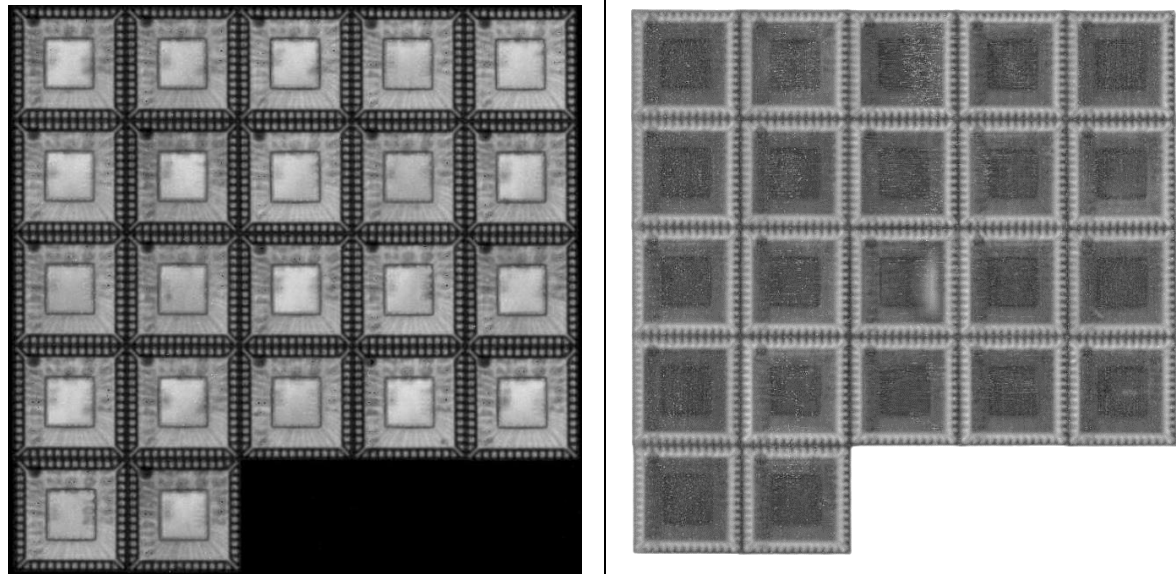
TC	<p data-bbox="630 324 893 358">CSAM post-2x stress</p>

No anomalies found
TC	<p data-bbox="582 996 941 1030">Cross Section post-2x stress</p>

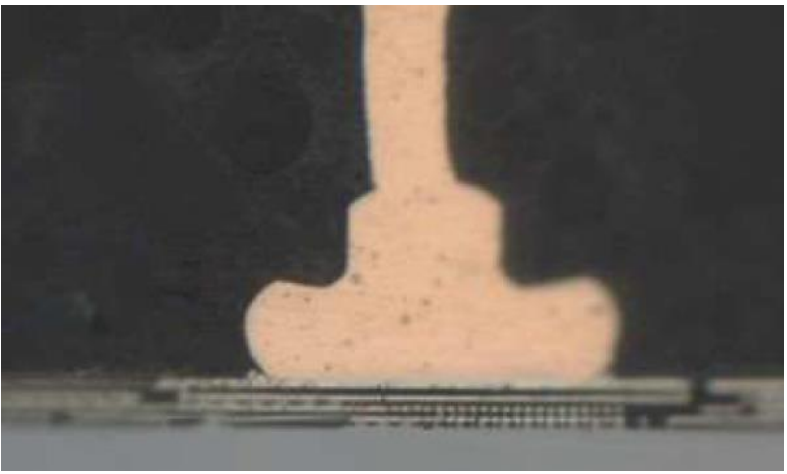
No anomalies found

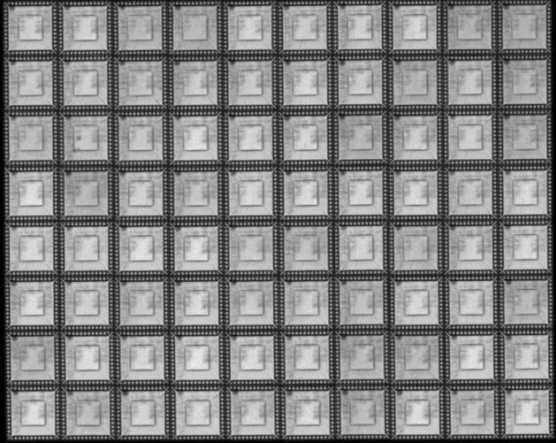
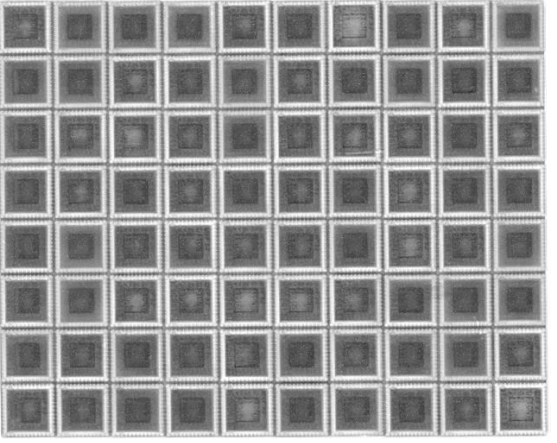
HAST	CSAM @ T0		No anomalies found

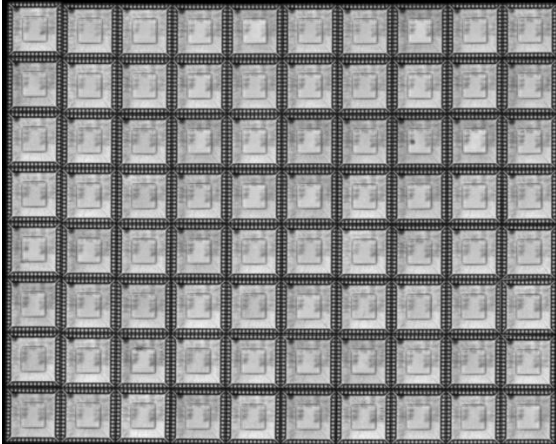
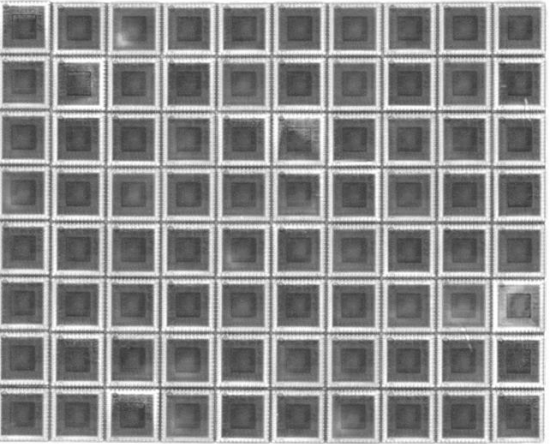
HAST	CSAM post PC		No anomalies found

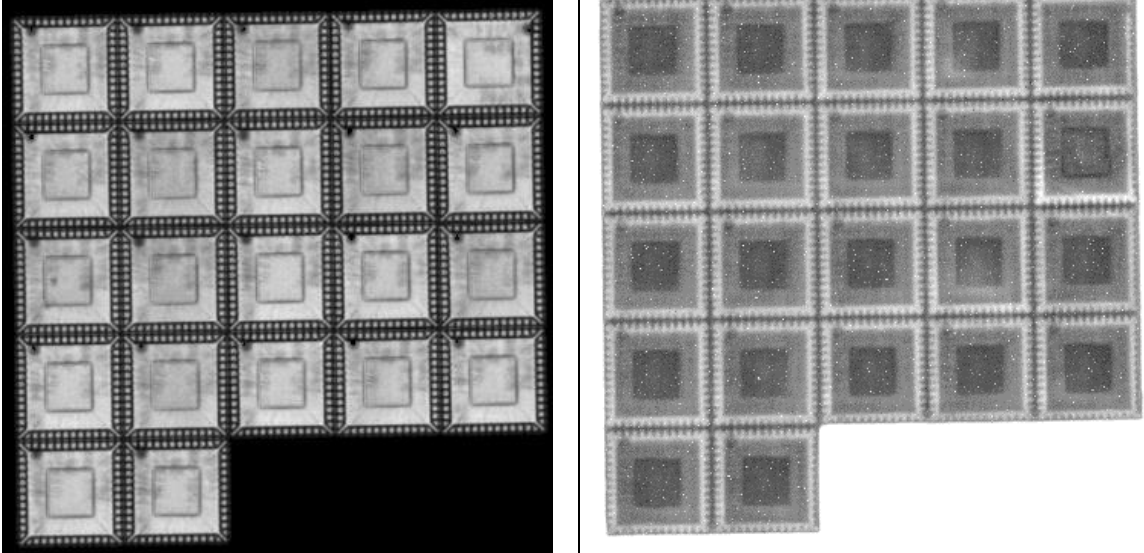
HAST	<p data-bbox="628 405 895 434">CSAM post-1x stress</p>

No anomalies found
HAST	<p data-bbox="628 1061 991 1090">Cross Section-post 1x stress</p>

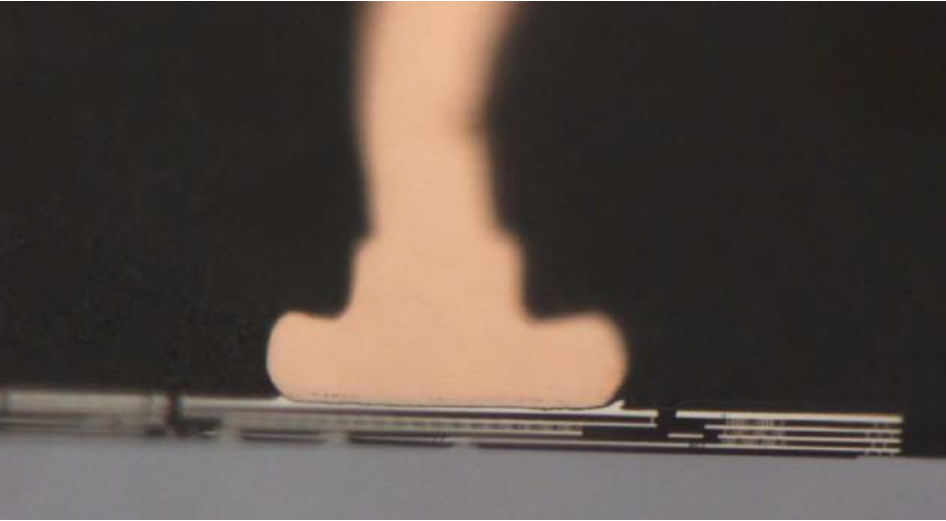
No anomalies found

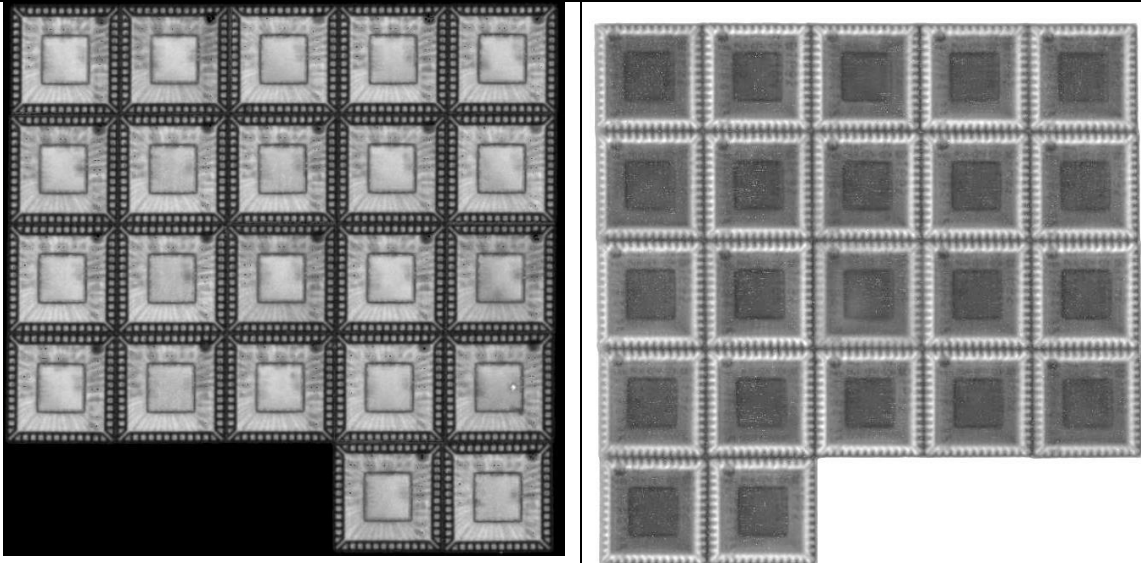
<p>HAST</p>	<p style="text-align: center;">CSAM-post 2x stress</p>

<p>No anomalies found</p>
<p>HAST</p>	<p style="text-align: center;">Cross Section-post 2x stress</p>

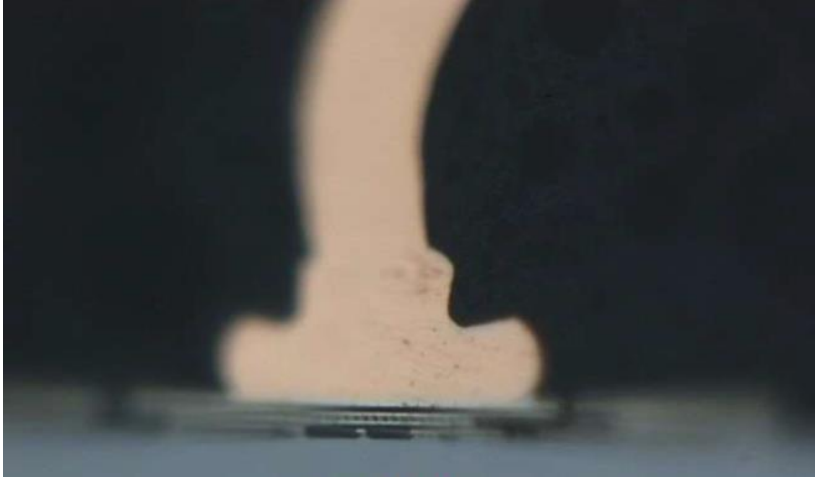
<p>No anomalies found</p>
