## Product Change Notice (PCN)

**Subject:** RA2E2 group I3C function revision

**Publication Date:** 2/24/2022

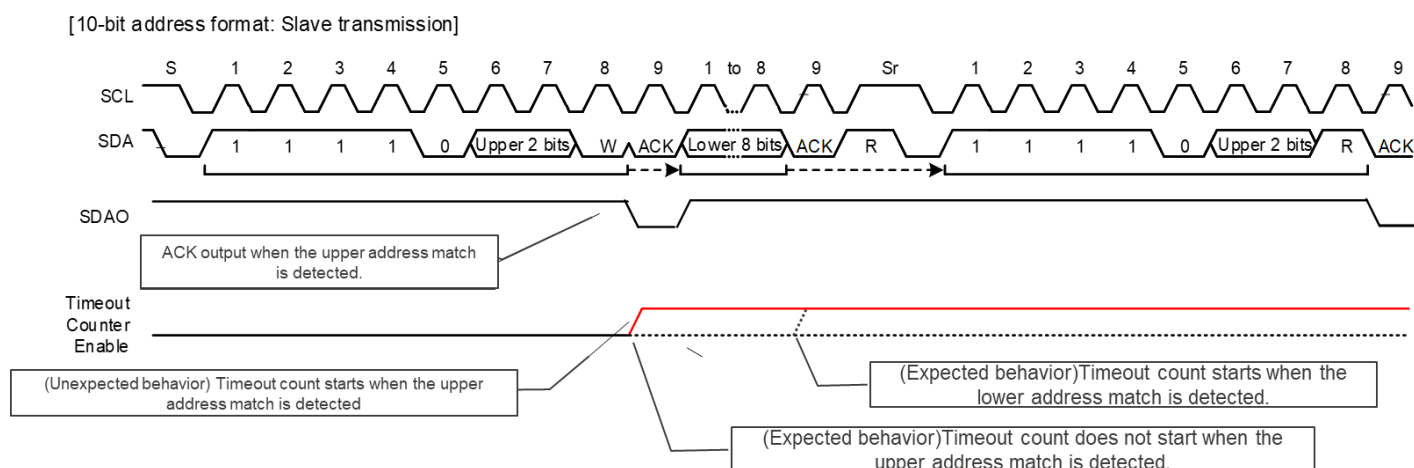
In MCU Ver.1, the timeout count starts when 10-bit address communication and the upper address match is detected.

MCU Ver.2 is revised the circuit so that the timeout count does not start until the lower address match is detected after the upper address match is detected.

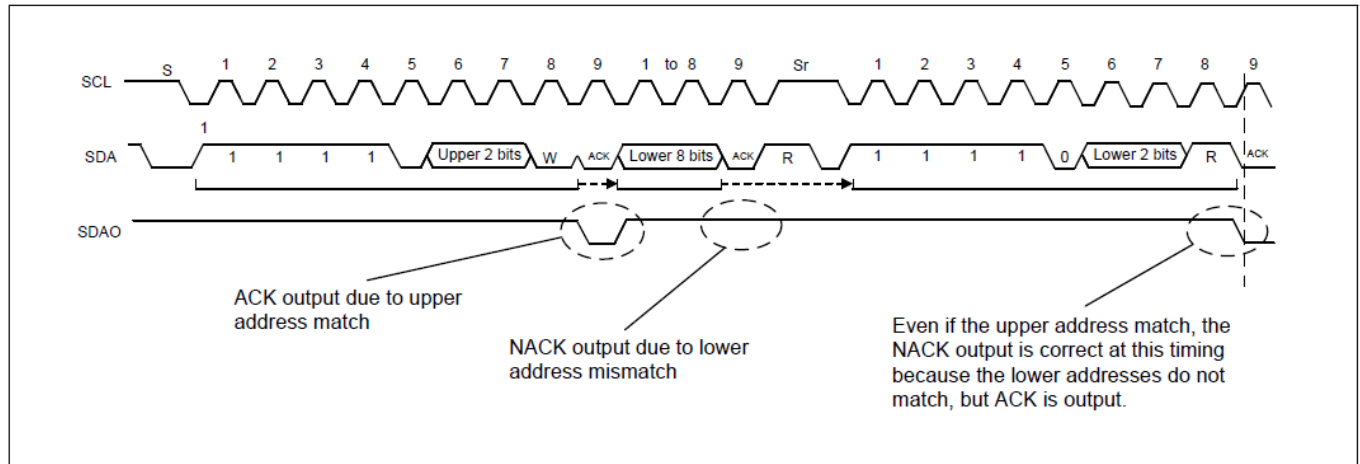
MCU Ver.1 has the following restrictions and workarounds when using 10-bit address communication. The restrictions and workarounds are not required for MCU Ver.2

When multiple I<sup>2</sup>C slaves are connected to the I<sup>2</sup>C bus and there is a possibility that an I<sup>2</sup>C Slave other than this module will NACK for the upper address / R after Repeated START, there are the following restrictions and workarounds.

- Work around : Set the upper 2 bits of the 10-bit address assigned to this module to a value different from other Slave. If the address is exhausted and cannot be set to a different value, use restriction (1).
- Restriction (1) : 10-bit address not available.
- Restriction (2) : After the ACK response in the red circle in the above figure, none of the slaves respond to data, so the SDA keeps the high level and the I<sup>2</sup>C Master receives the 0xFF data. In the case of a system that can handle 0xFF as abnormal data, 0xFF is read and discarded on the I<sup>2</sup>C Master side. If 0xFF is valid data, use restriction (1).

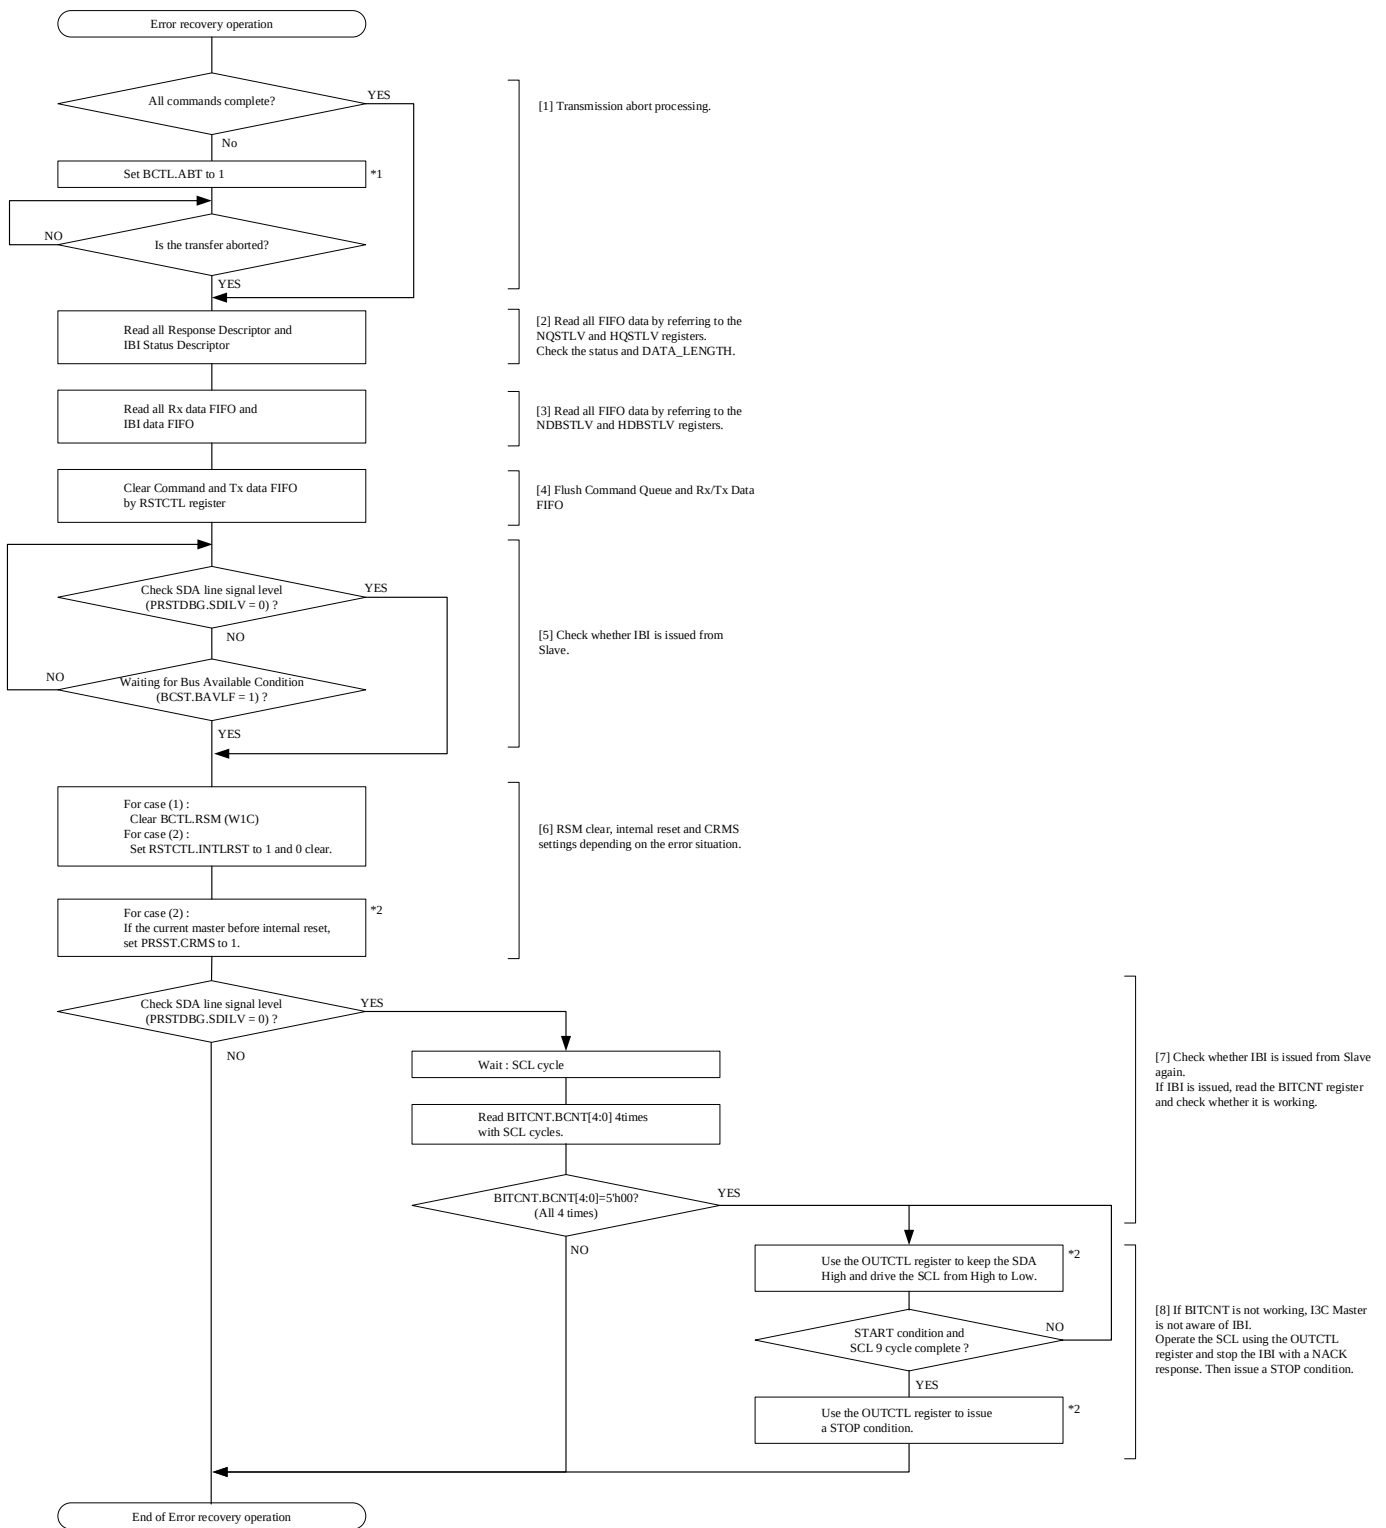
Figure 25.96 Example of error recovery operation flowchart for I3C Master

In order to improve the complexity of the error recovery flow, MCU Ver.2 is revised the circuit so that I3C will be suspended (BCTL.RSM becomes 1) when an error occurs. After I3C is suspended, the application must write the value 1 to the BCTL.RSM bit to resume I3C operation and recover from suspended state. In MCU Ver.2, the error recovery flow shown in Figures 25.96 and Figures 25.97 are simplified by the above improvements.

Figure 25.96 and Figure 25.97 show the error recovery flow.

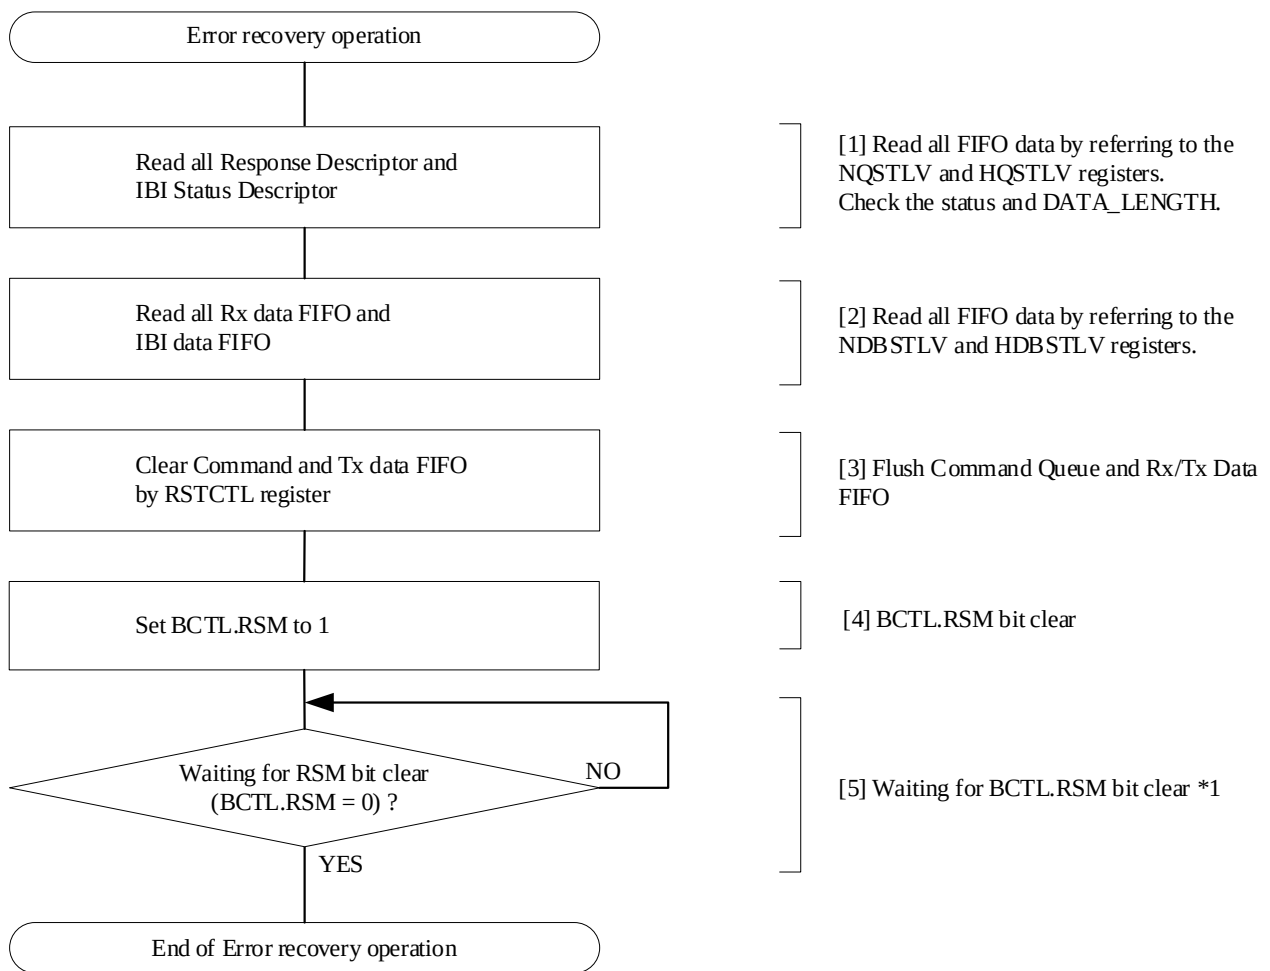
**Figure 25.96-2 Example of error recovery operation flowchart for I3C Master**

If an error occurs, I3C will be suspended. (BCTL.RSM becomes 1.) After I3C is suspended, the application must write the value 1 to the BCTL.RSM bit to resume I3C operation and recover from the suspended state.

Note 1. It is possible to set the Command Descriptor while waiting for the RSM bit to be cleared.

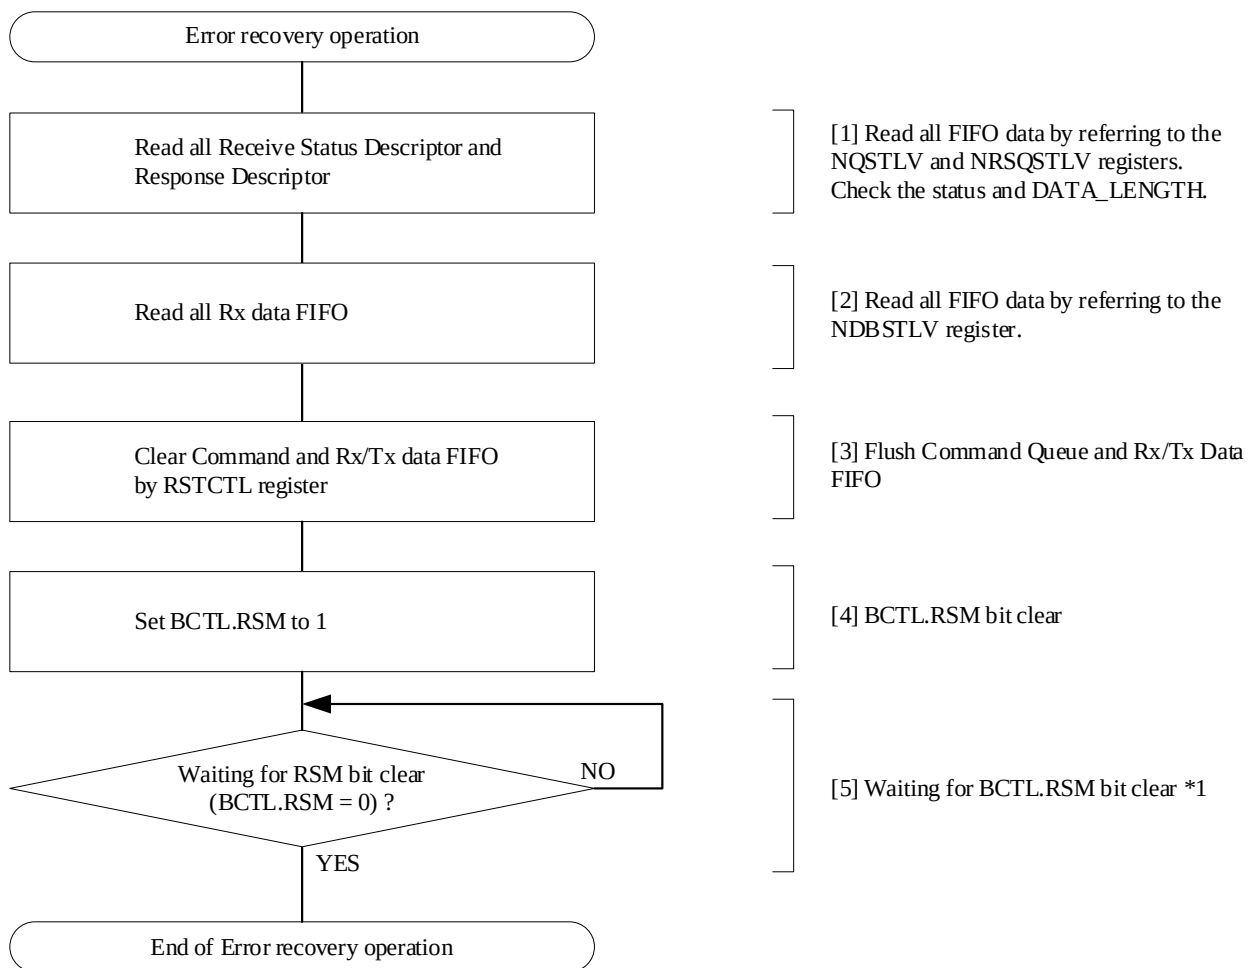
**Figure 25.97-2 Example of error recovery operation flowchart for I3C Slave**

Note 1. It is possible to set the Command Descriptor for issuing IBI while waiting for the RSM bit to be cleared.
