1 Purpose of Document

This document summarizes the changes between the previous SAP5 silicon revision C and the current silicon revision D. These include requested UART design changes. The purpose of the redesign was to correct reported timing errors by the UART in the following modes: Master, Monitor, and Repeater. A problem with slave communication in special network constellations was also fixed.

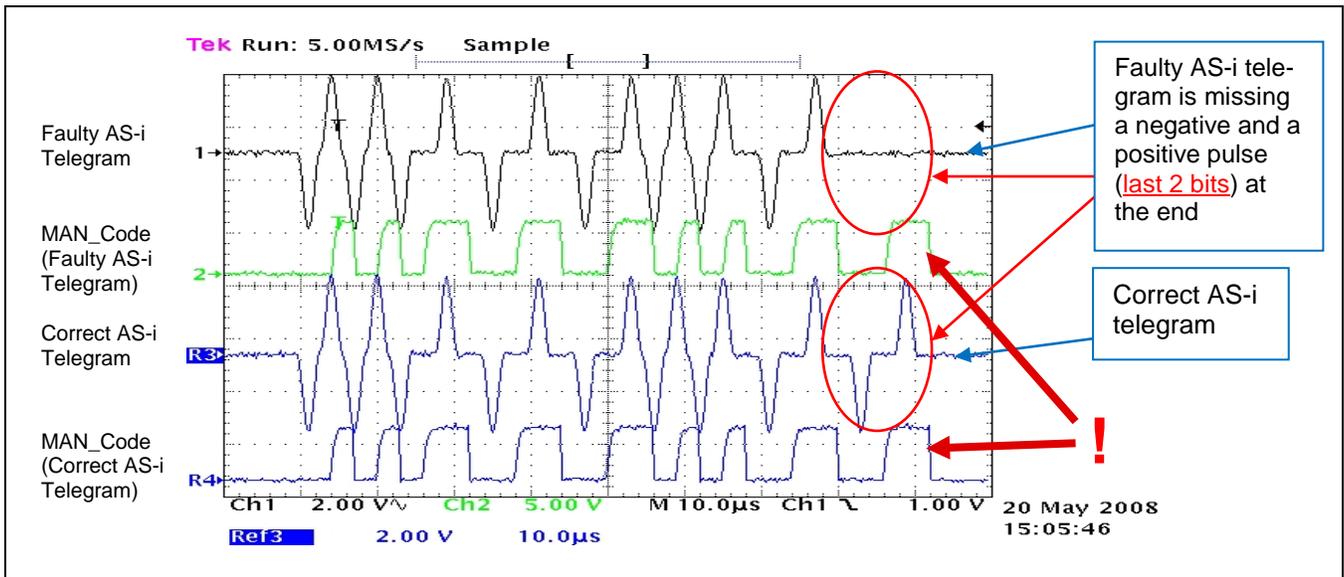
Figure 2.1 Comparison of Valid MAN-Code Signal to Faulty MAN-Code Signal

If the SAP5 revision C operates in Master Mode or in Repeater Mode, the error signaling for an *End_Bit_Error* does not work correctly. In some special cases, the generated MAN-Code of a signal with an *End_Bit_Error* looks similar to the MAN-Code of a signal without any errors as demonstrated in Figure 2.1.

This malfunction of the SAP5 revision C results in an MAN coded output signal that does not allow distinction between correct AS-I pulse sequences and pulse sequences that are shortened (missing one negative and one positive pulse). It occurs only under the following conditions:

- The parity of the signal is even.
- The last bit of the corrupt telegram is equal to binary 1.
- The *Stop_Bit* and the *Parity_Bit* or the *Start_Bit* and the *Control_Bit* are missing.
- If the *Start_Bit* and the *Control_Bit* are missing, the first pulse must have a negative polarity.

The following changes in the UART block were implemented in SAP5 silicon revision D:

1. A new principle for ASI-telegram pause detection was implemented. The previous method caused erroneous pause detection in some cases; e.g., a telegram starting with a wrong Start bit (SB=1) and second bit = 0.
2. A new *Endbit_error* detection principle was implemented to comply with the *AS-I Complete Specification V3.0*. The new principle ensures that an *Endbit_error* is detected only if the polarity of the pulse at time (36µs/78µs ± tolerance) is negative.
3. The internal computation of *No_info_error*, *Timing_error*, and *Length_error* was reviewed and corrected to comply with the *AS-I Complete Specification V3.0*.

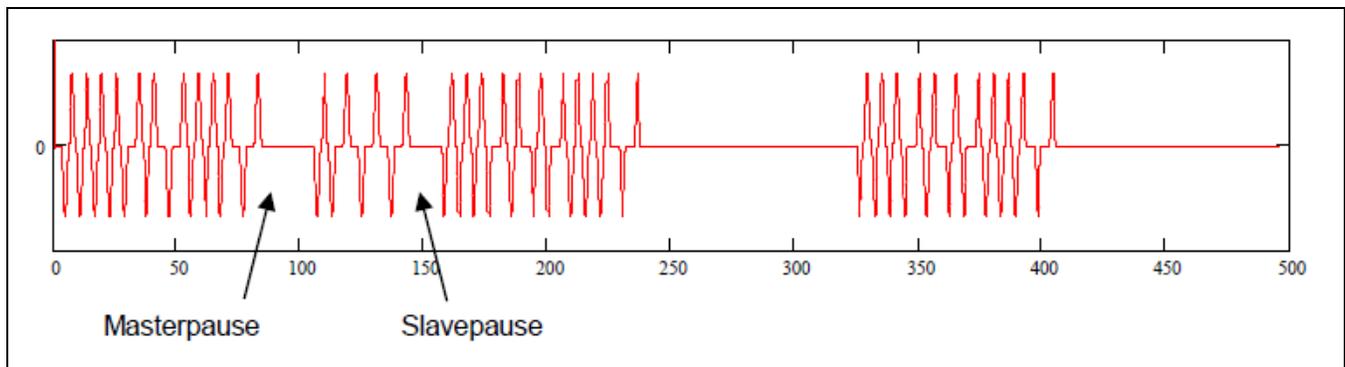
Figure 3.1 Test for SAP5 Revision C Error in Master Pause Detection

If the previous SAP5 revision C is operated in Slave Mode, the UART Master Pause detection does not always function correctly when the UART must listen to slave responses from a different slave. Depending on the actual AS-I line pulse timing, a slave response from a different slave is sometimes not recognized correctly, which results in a UART communication error. This prevents the Slave from understanding the next Master telegram correctly. If the Master telegram addresses the Slave itself, the error leads to a missing slave response and the Slave replies on a second repetition of the Master Call to its own address in asynchronous mode.

This behavior was mostly observed in mixed networks that used modules with the ASI4U, SAP5, and SAP4.1.

Figure 3.1 shows a telegram test case to reproduce the error. The AS-I signals shown in Figure 3.1 were generated by a signal generator that allowed sweeping the Master Pause and Slave Pause duration over the allowed specification limit. The first Master Call contains a different slave address than the tested slave. The second and third master calls address the tested slave. The tested slave replied with the erroneous behavior for certain Master pause and Slave pause scenarios only. The majority of the test cases were passed without error.

A new principle of AS-i telegram pause detection was implemented in SAP5 silicon revision D that is more precise and able to cover all valid timing scenarios for Master and Slave pauses. The new principle is now independent of the internal timing constraints of the UART state machine.
