# RENESAS TECHNICAL UPDATE

Product Category	MPU/MCU		Document No.	TN-RH8-B0590A/E	Rev.	1.00
Title	RH850/U2C Clock Monitor Backup Clock Limitation		Information Category	Technical Notification		
Applicable Product	RH850/U2C8-EVA, U2C8, U2C4, U2C2	Lot No.	Reference Document	R01UH1018EJ0100 (User's Manual: Hardware)		
		All

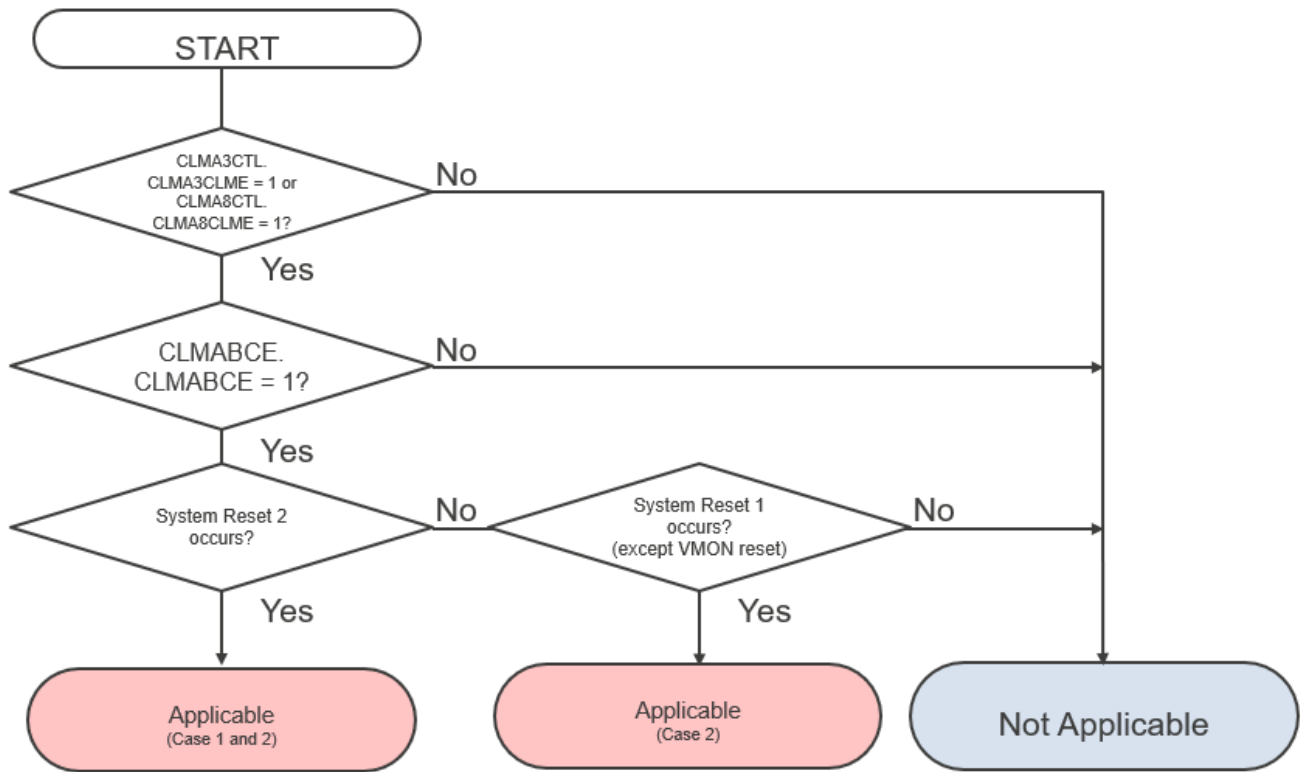
[Judgement Flow]

When both following conditions are configured and System Reset 2 or System Reset 1 (except Primary VMON Reset) occurs.

- CLMA3 or CLMA8 is enabled (CLMA<sub>n</sub>CTL.CLMA<sub>n</sub>CLME = 1)
- The backup clock is enabled (CLMABCE.CLMABCE = 1)

Set the Backup clock to disable. (CLMABCE.CLMABCE = 0)
