## SLG46625-A Errata Note

This document contains the known errata for SLG46625-A and the recommended workarounds.

<b>Package(s)</b>	20-pin TQFN: 3.5 mm x 3.5 mm x 0.75 mm, 0.5 mm pitch
-------------------	--

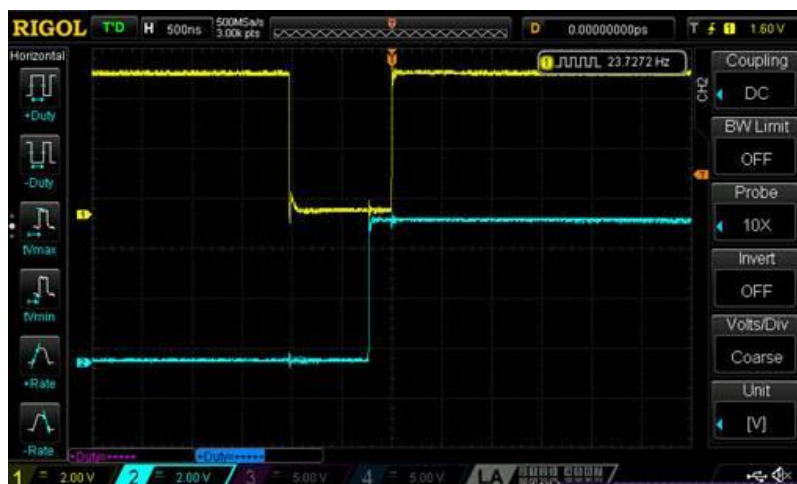
Figure 1. ACMP Output Glitch

The output of the ACMP incorrectly goes low even when IN+ is greater than IN- if the RING OSC is active when the WS signal rises.

Channel 1 – ACMP out

Channel 2 – WS\_OUT

Avoid using the RING OSC with the WS Controller or add a filtering block on the ACMP output to filter out the glitch.

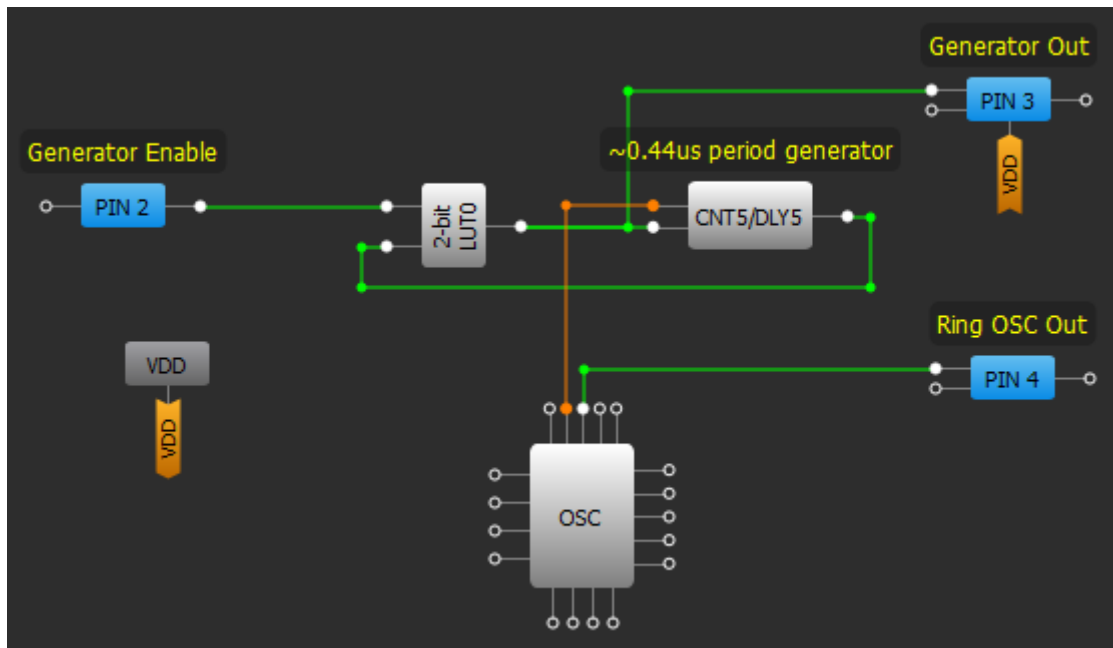
Figure 2. Ring OSC Test Design

The Ring OSC has a longer settling time when configured as Auto Power On in the designs that have very short Ring OSC disable time. An example of this issue is shown in the following configuration:

Set Ring OSC power mode to “Force Power On” or Set Turn on by register option in BG (Band Gap) block as “Enable”.

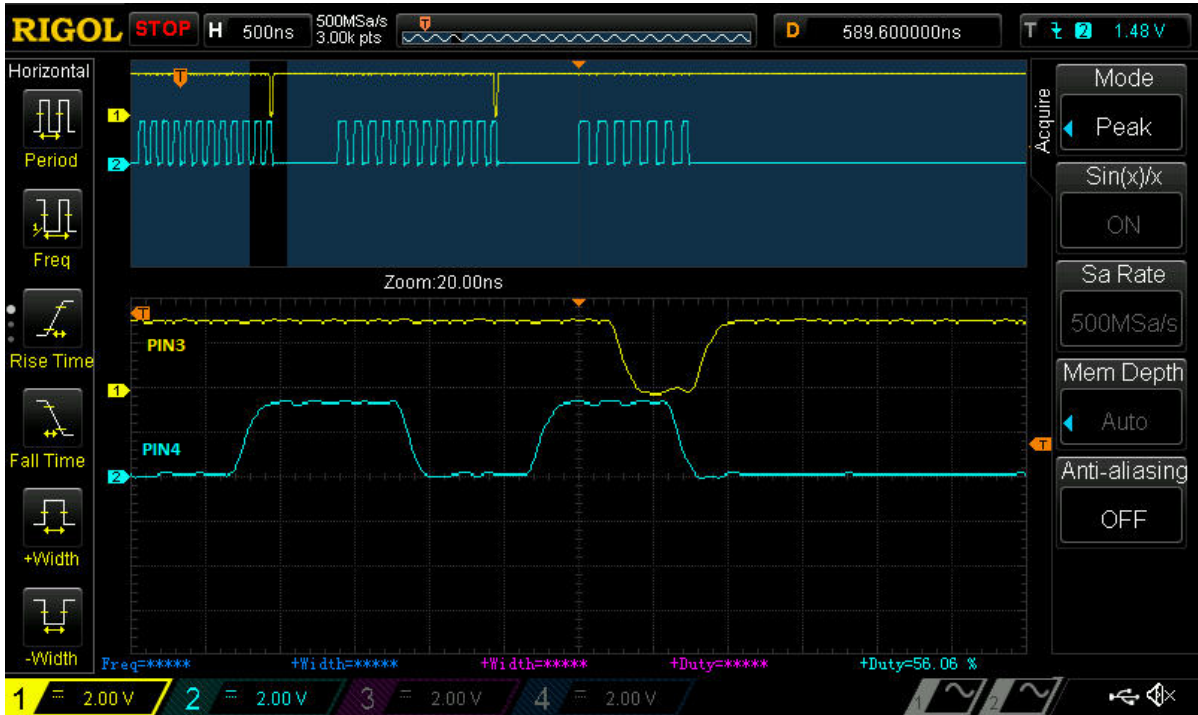
Figure 4. Ring OSC Output

The configuration shown above generates a periodical signal with a frequency defined by the Delay cell and started by a high signal on PIN2. The issue becomes apparent in a longer settling time when the scheme generates short pulses (Delay is configured as a rising edge delay only). See the waveform in [Figure 4](#).

Channel 1 – 2-bit LUT0 output

Channel 2 – Ring OSC output

Such behavior will lead to substantial error in period calculations if the delay time is relatively small.

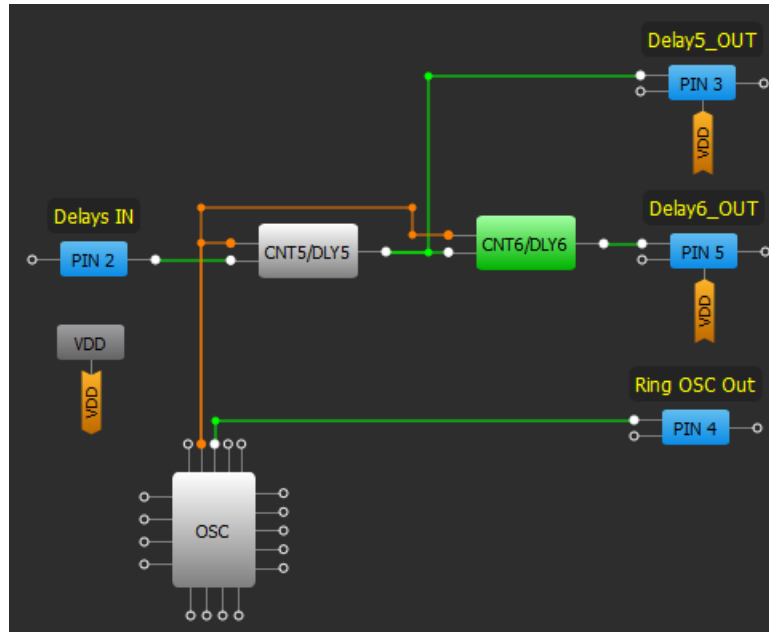
Figure 5. Ring OSC with DLY5, DLY6 Test Design

A similar situation can occur while using two connected delays (all edge detect types except for a pair “Rising edge DLY – Falling edge DLY”).

In [Figure 5](#), Delay5 and Delay6 are configured in the same way. However, Delay5 time is 11.4 us instead of expected 0.4 us (Delay5 time).

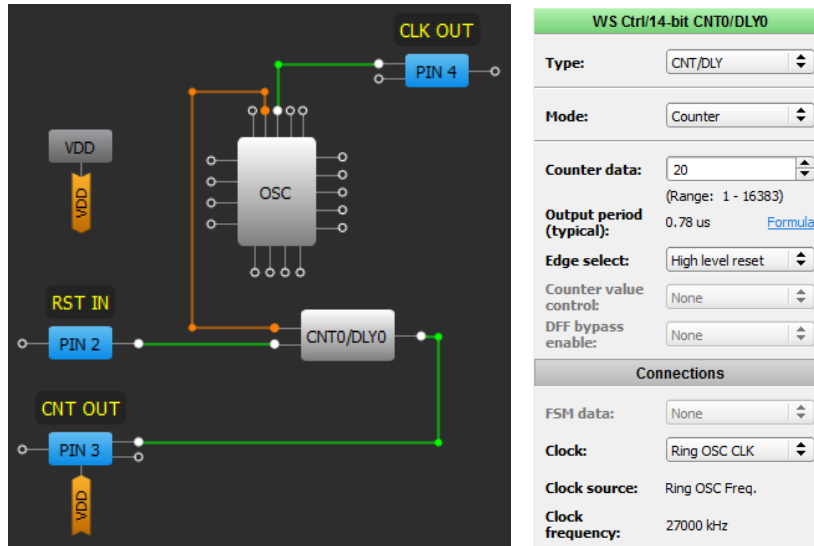
Figure 7. CNT Test Design

If the Counter Reset occurs at a time very close to a rising edge of the clock signal during clock signal generation (for example OSC operation), there is a possibility that the Counter Data of the Counter is reset incorrectly and the counter end signal (HIGH pulse) may appear faster than expected. This phenomena appears more frequently the higher the clock frequency is.

Synchronize RESET input of the Counter with its CLK using 2 DFF cells as shown in Figure 9.

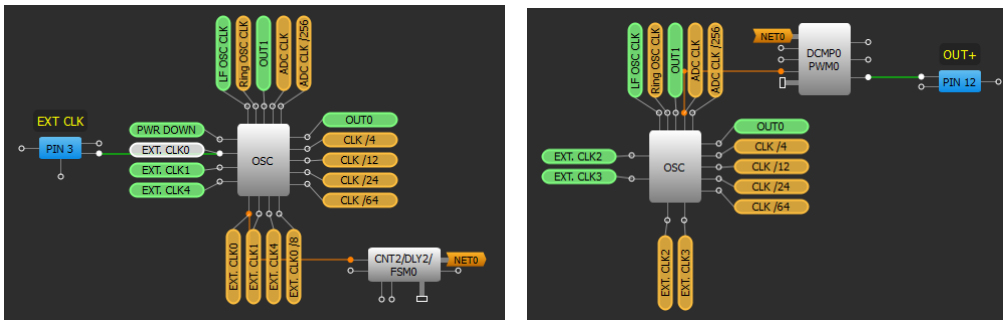
Figure 10. DCMP Test Design

DCMP's OUT+ output may have a glitch when the input data is changed. This issue appears more frequently the higher DCMP clock is.

For example, DCMP IN+ sources from FSM0 and IN- from Register0. DCMP is clocked from the Ring OSC.

Synchronize the data source clock with the DCMP clock source using 2 DFF cells as shown in [Figure 12](#).

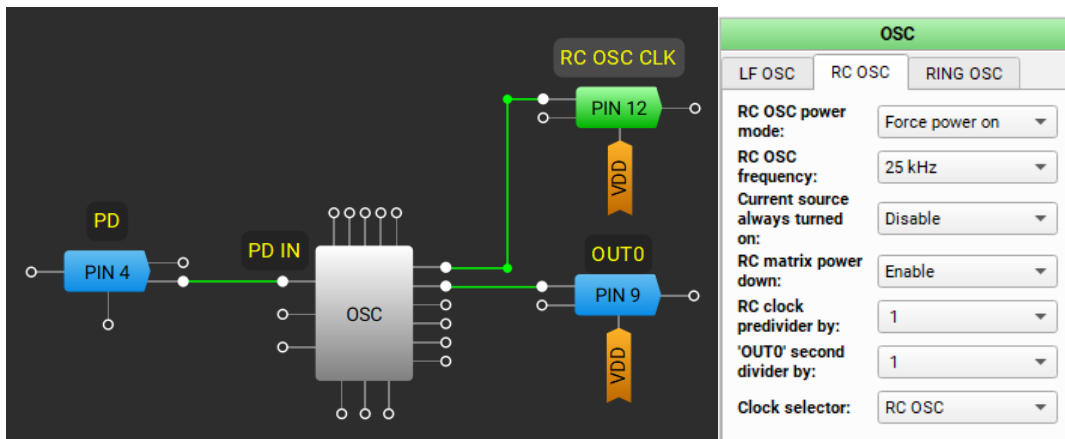
Figure 13. Test Design

When a short pulse of less than ~40 ns is applied to the PWR DOWN input.

Avoid applying glitches to the PWR DOWN input of an OSC.

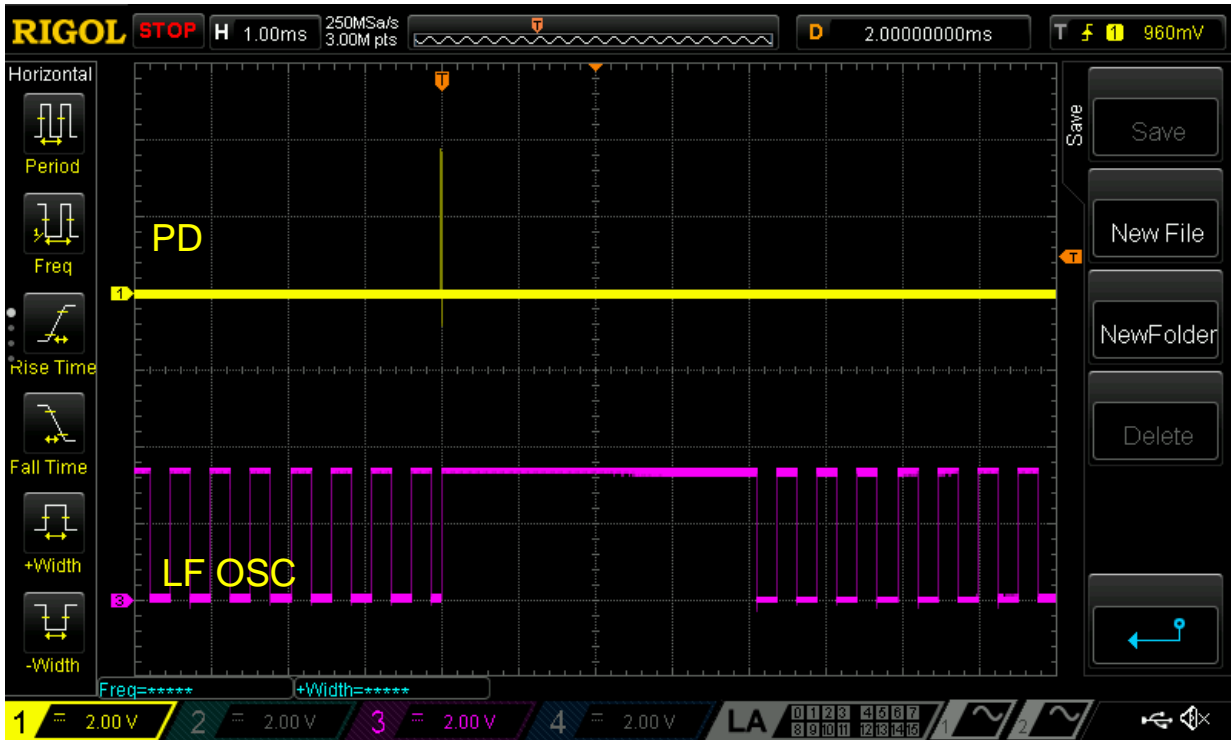
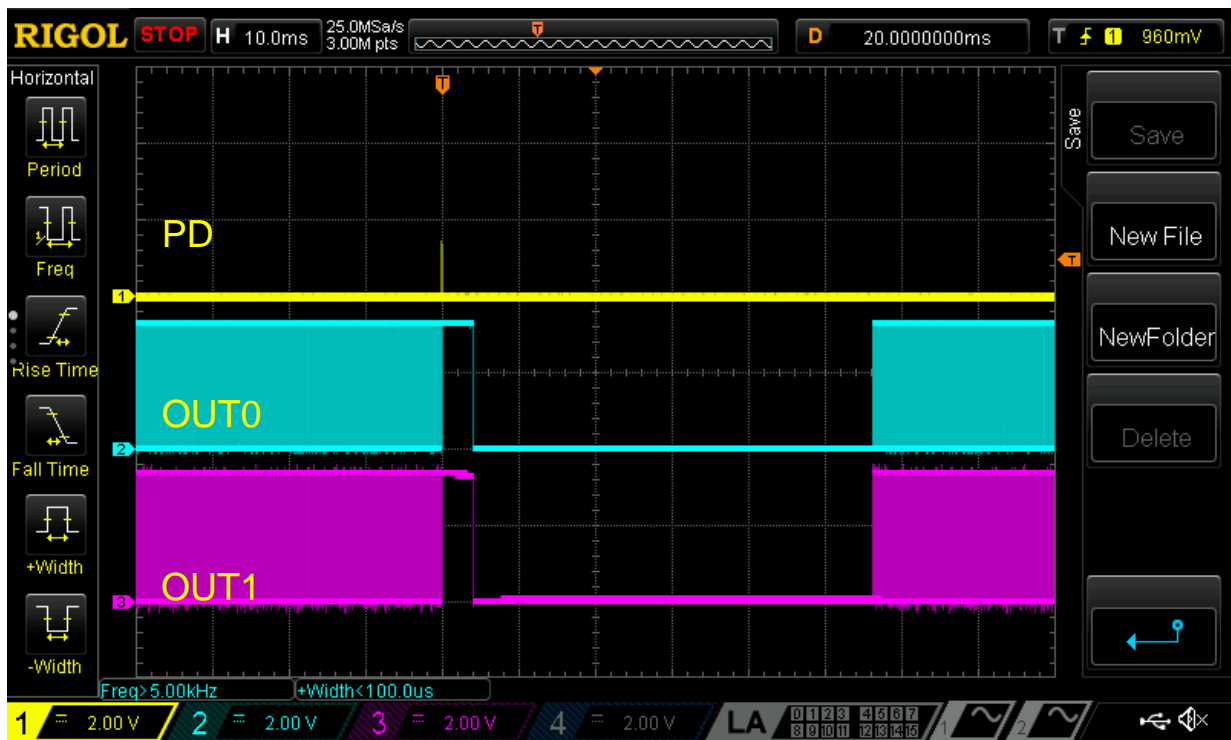
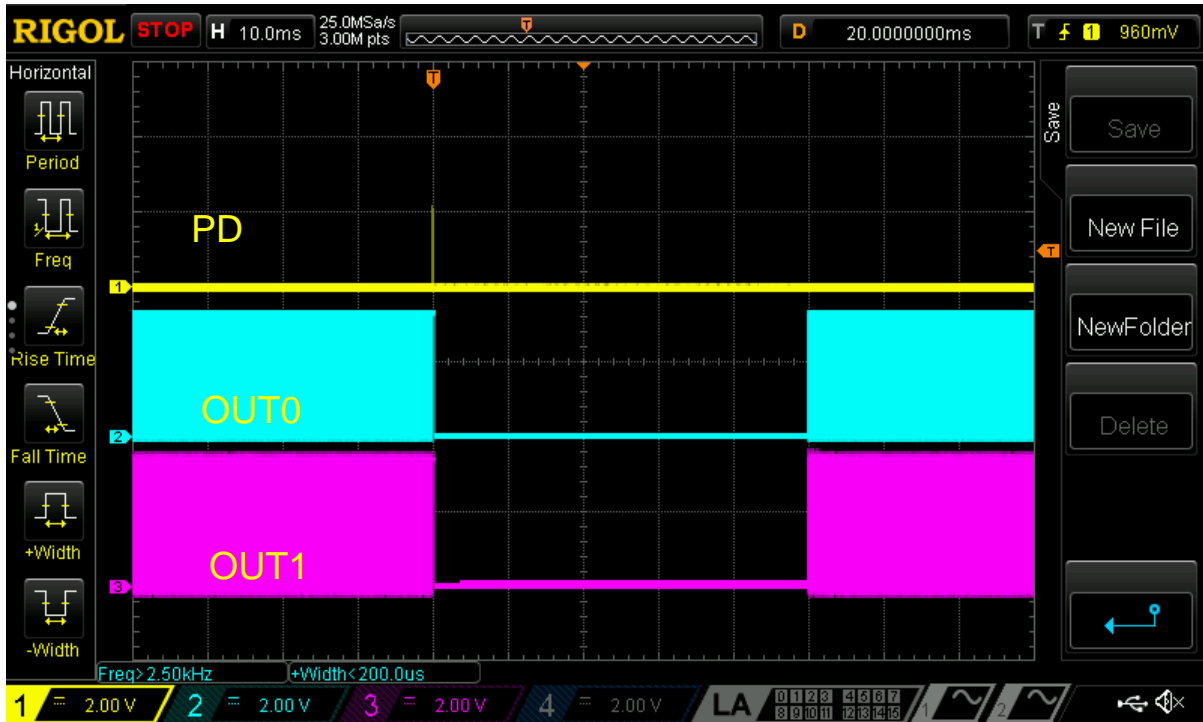
If a pulse with a duration of less than ~40 ns is applied to the PWR DOWN input of the oscillator, the oscillator outputs remain stuck for milliseconds, as shown in Figure 14, Figure 15 and Figure 16. The issue is observed for all available oscillators.

Figure 14. 1.9 kHz OSC Long Start-Up

Figure 15. 25 kHz OSC Long Start-Up

Figure 16. 2 MHz OSC Long Start-Up
