[Notes]

R20TS0523EJ0100

Dec. 16, 2019

# CS+ Code Generator for RX, e<sup>2</sup> studio Code Generator Plug-in, AP4 Coding Assistance Tool for RX

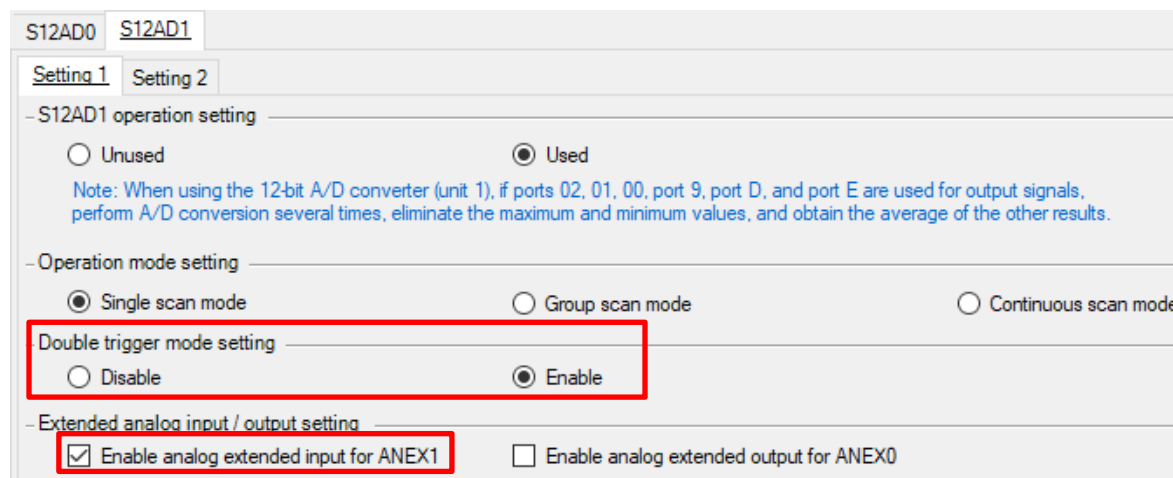
Error location

When using Double trigger mode on Single Scan Mode component of the 12-bit A/D converter, “Enable analog extended input for ANEX1” is still available for configuration even though it cannot be used simultaneously.

Do not select [Enable analog extended input for ANEX1] when using double trigger mode.
