Errata

SLG46116

CE-GP-010

This document contains the known errata for SLG46116 and the recommended workarounds.

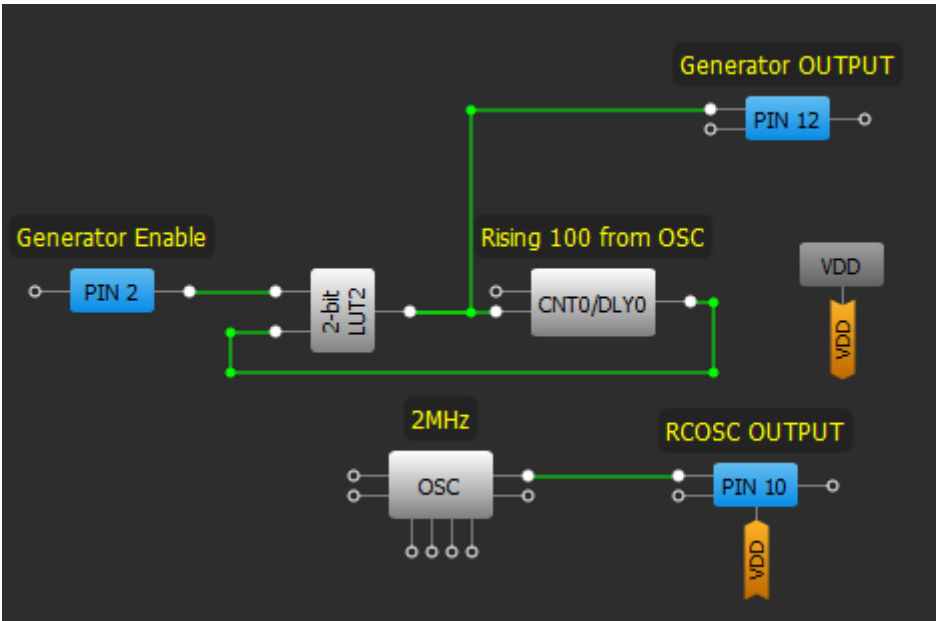
An example of such issue is in the following configuration:

The RC OSC has a longer settling time when configured as 2 MHz with Auto Power On in the designs that have very short RC OSC disable time.

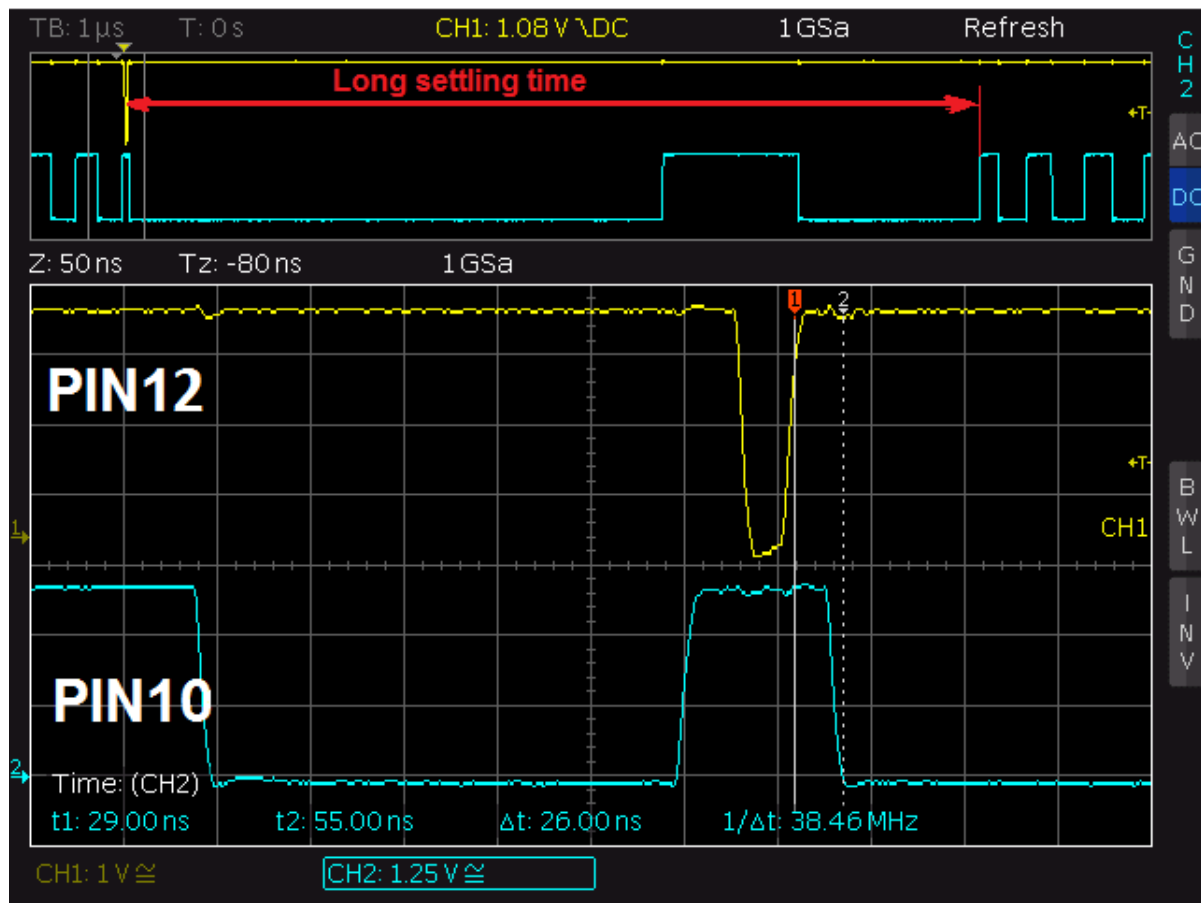
The configuration shown above generates a periodical signal with a frequency defined by the Delay cell and started by a HIGH signal on PIN2. The issue becomes apparent in a longer settling time when the scheme generates short pulses (Delay is configured as a rising edge delay only). See waveform below.

Channel 1 – 2-bit LUT0 output; Channel 2 – RC OSC output

Such behavior will lead to substantial error in period calculations if the delay time is relatively small.

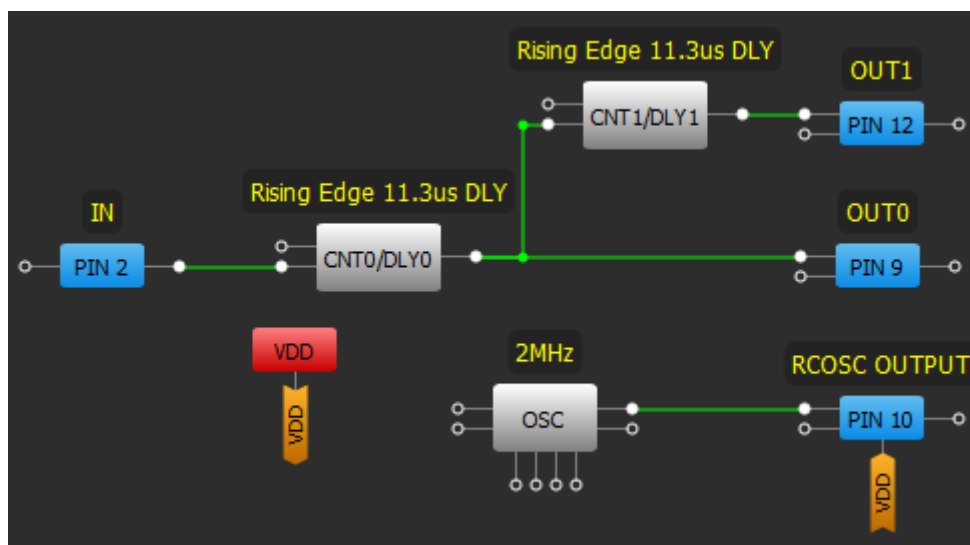
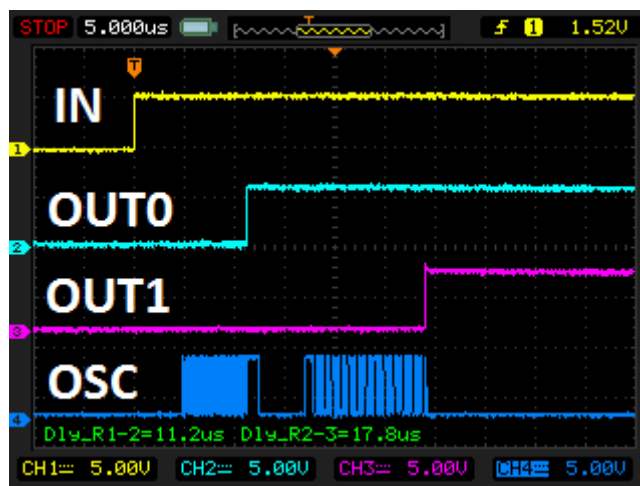
The same situation occurs while using two connected delays (all edge detect types except for a pair “Rising edge DLY – Falling edge DLY”).

In the following example, Delay0 and Delay1 are configured in the same way. However, Delay1 time is 17.8us instead of expected 11.3us (Delay0 time).

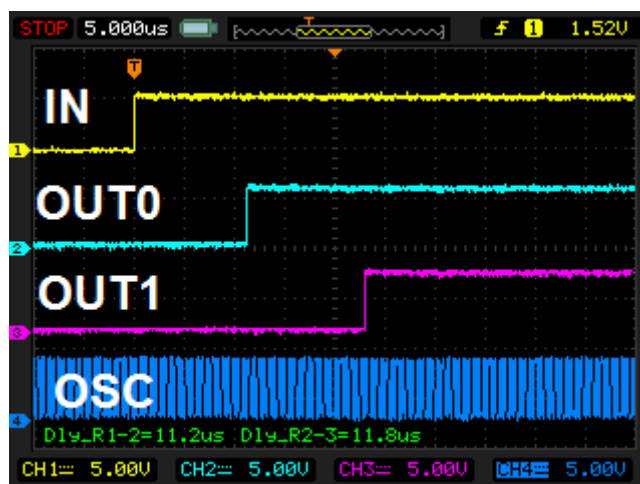
If there are some inner blocks which use RC OSC at the moment or RC OSC is forced power on when such error appears, RC OSC will be operational and delay value will be proper.

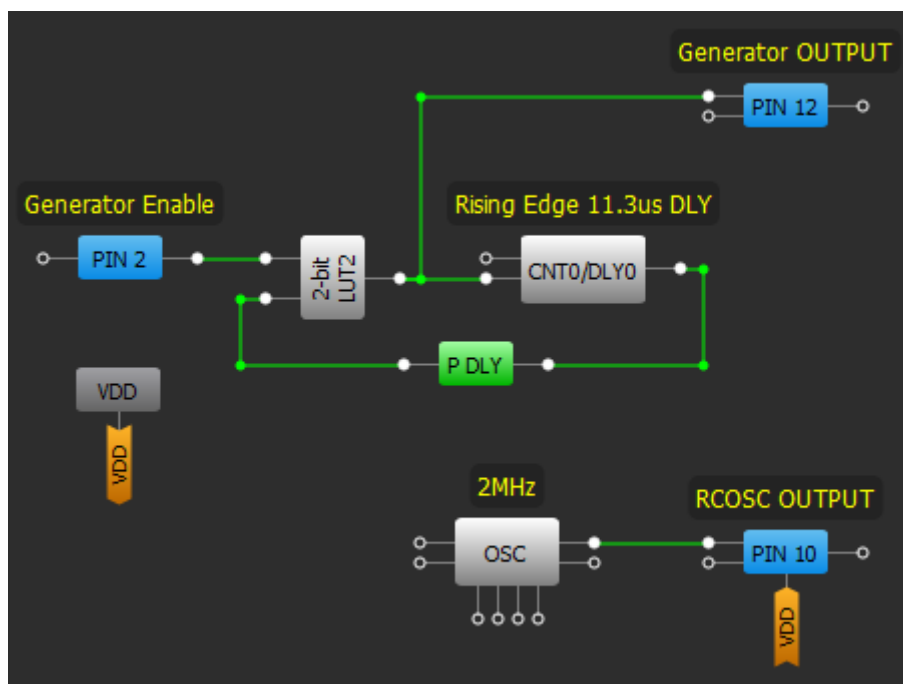
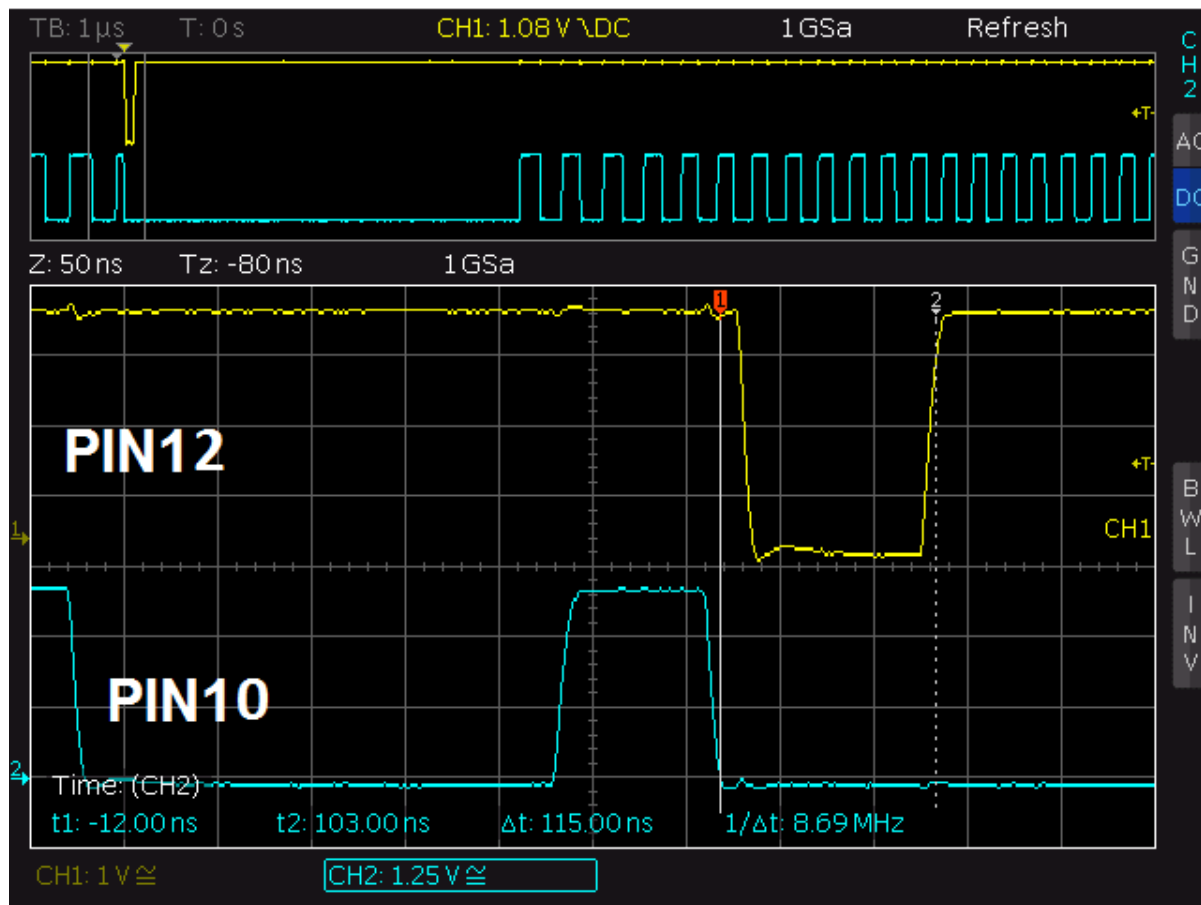
Channel 1 – 2-bit LUT0 output; Channel 2 – RC OSC output

- In first case use block with longer propagation time.

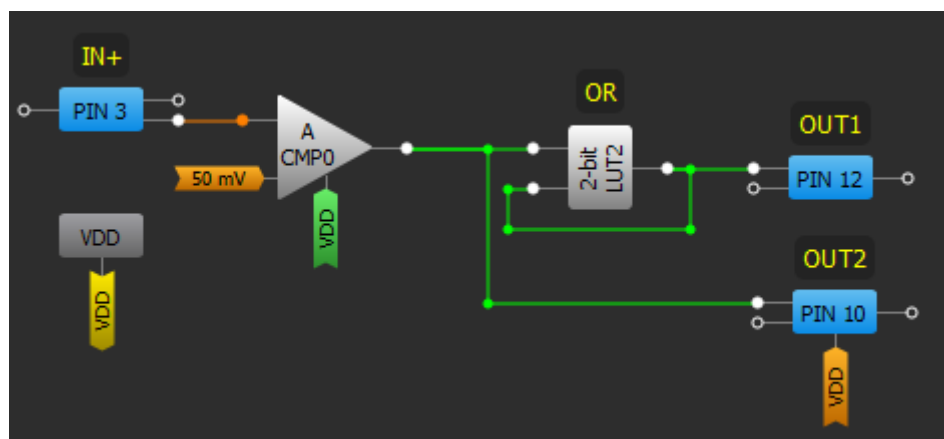
In some cases, ACMP may have short high-level glitches on its output (even if IN+ voltage is less than IN- voltage) after GreenPAK chip being powered up. Such cases may appear when using ACMP with Low Bandwidth mode enabled and Power Up is connected directly to the V_{DD} .

In order to detect such glitches, scheme with additional LUT was used. This LUT detects high level on ACMP output and stays high until chip powers down.

ACMP IN+ is connected to the Ground.

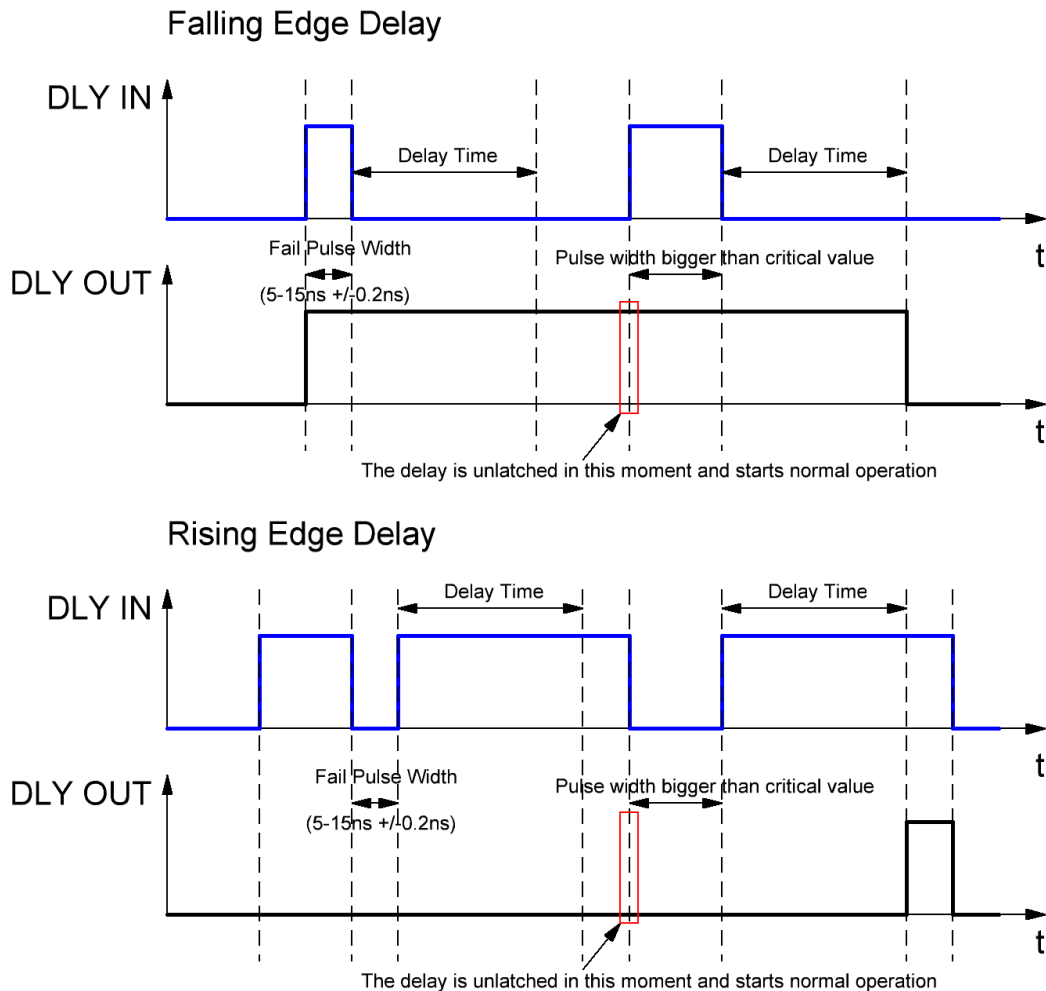
The delay output could be latched despite the input change when a short pulse is input. For example, if the delay cell is configured as a falling edge delay, the short pulse (see NOTE) appears on its input the delay cell output will switch from LOW to HIGH but may not switch from HIGH to LOW even after the delay time has passed.

NOTE: The pulse width varies from chip to chip and with different V_{DD} voltage. It is in range of 5-15ns and in the window ± 0.2 ns, so it should be very precise for issue happen.

Use P DLY/FILTER block configured as a both edge delay or FILTER.

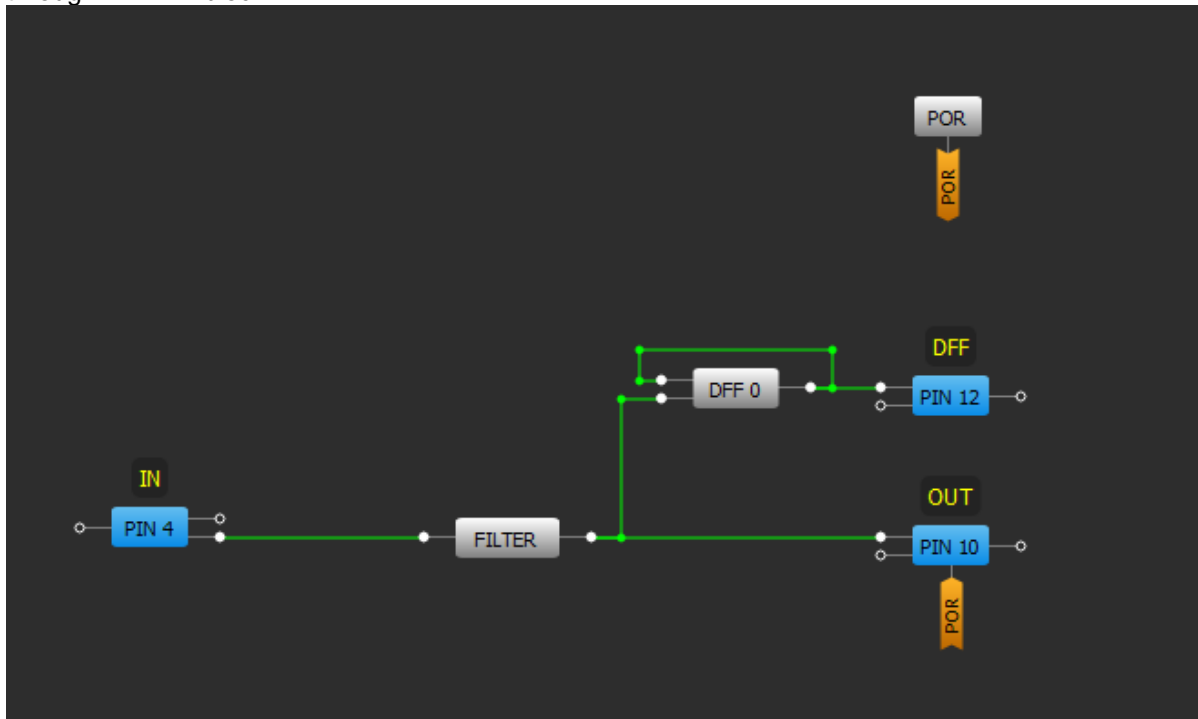
If clock type high frequency input comes in, the FILTER cell may not filter out it. There are several factors like input frequency, duty cycle and LOW duration in such signal that may lead to its passing through FILTER block.

Channel 1 (yellow/top line) – PIN#4 (IN)
 Channel 2 (light blue/2nd line) – PIN#10 (OUT)
 Channel 3 (magenta /3rd line) – PIN#12 (DFF)

Currently there is no workaround for this issue. Filter block is good at filtering short spontaneous glitches. It is intended to be used in series connection before the delay cell to avoid its latching (see issue #5).

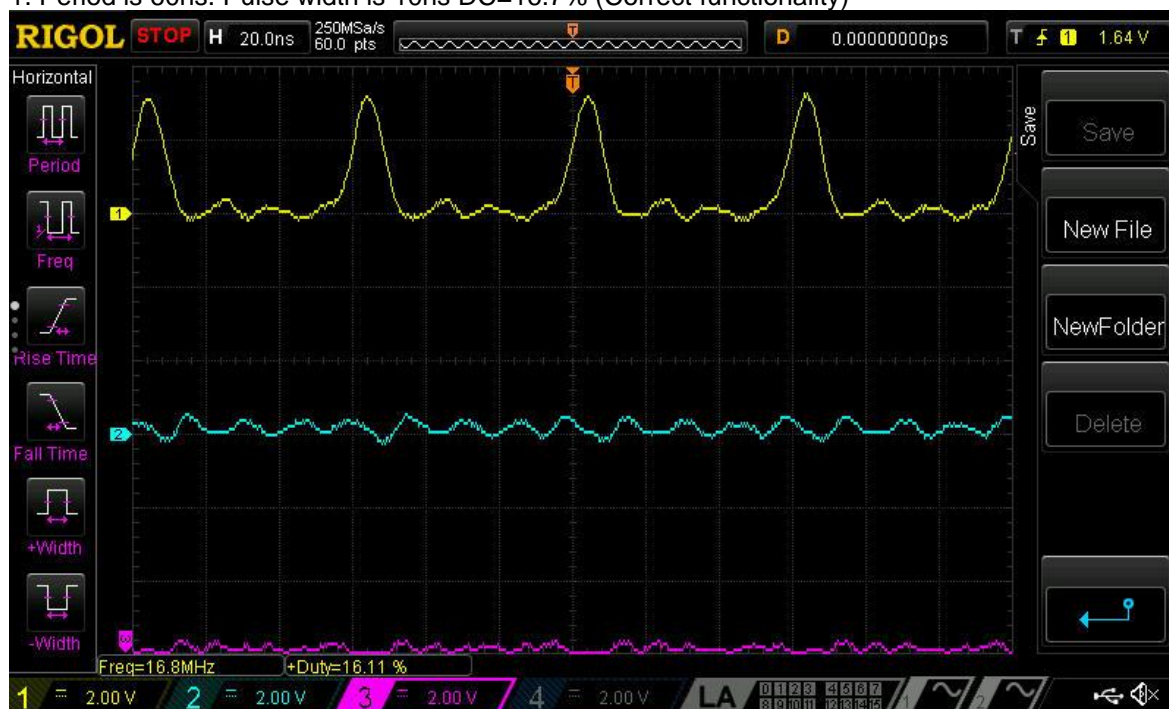
1. Period is 60ns. Pulse width is 10ns DC=16.7% (Correct functionality)

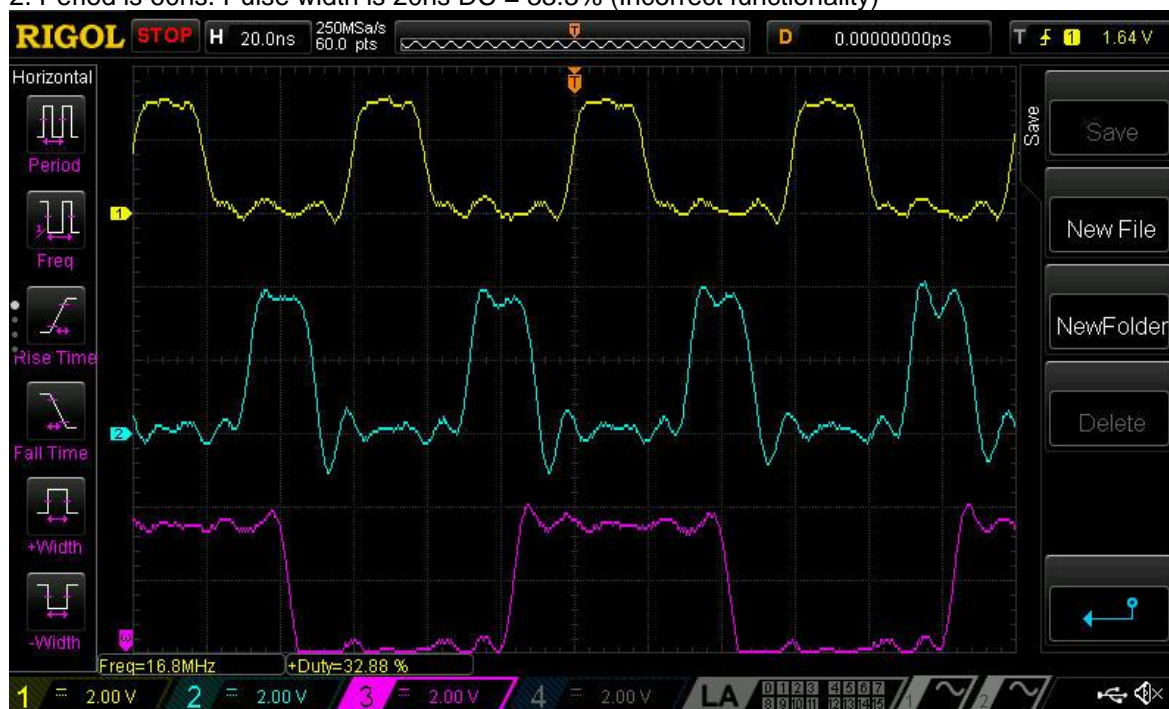
2. Period is 60ns. Pulse width is 20ns DC = 33.3% (Incorrect functionality)

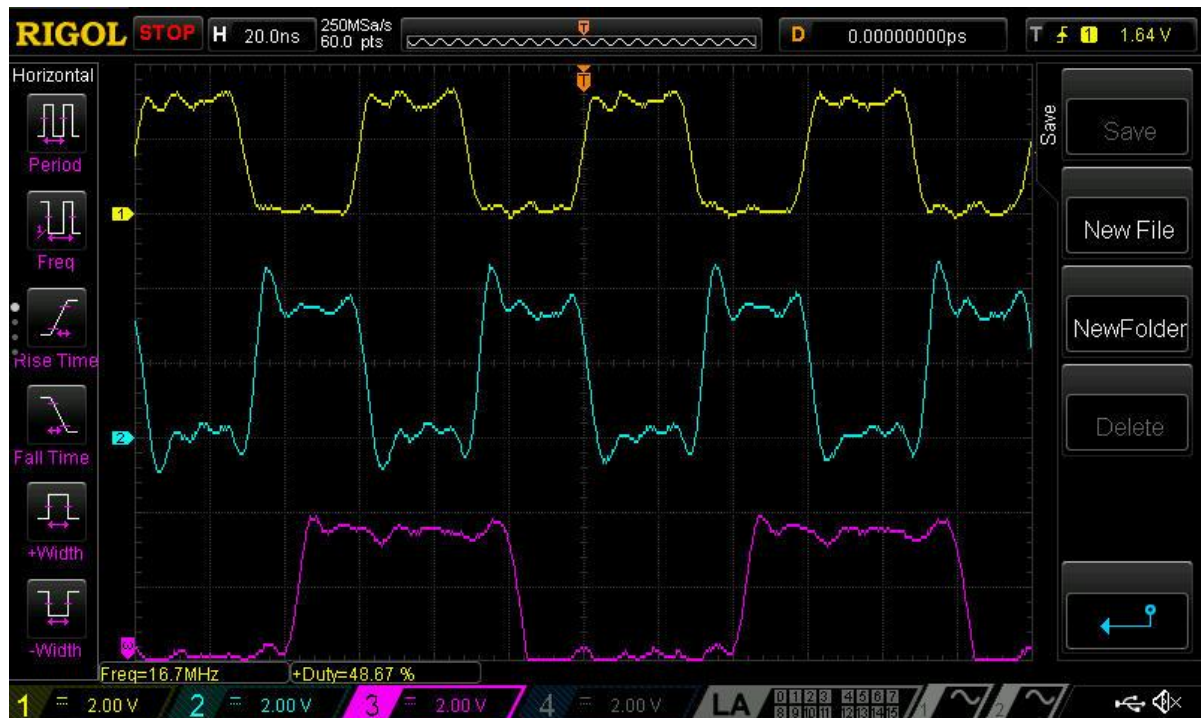
3. Period is 60ns. Pulse width is 30ns DC=50% (Incorrect functionality)

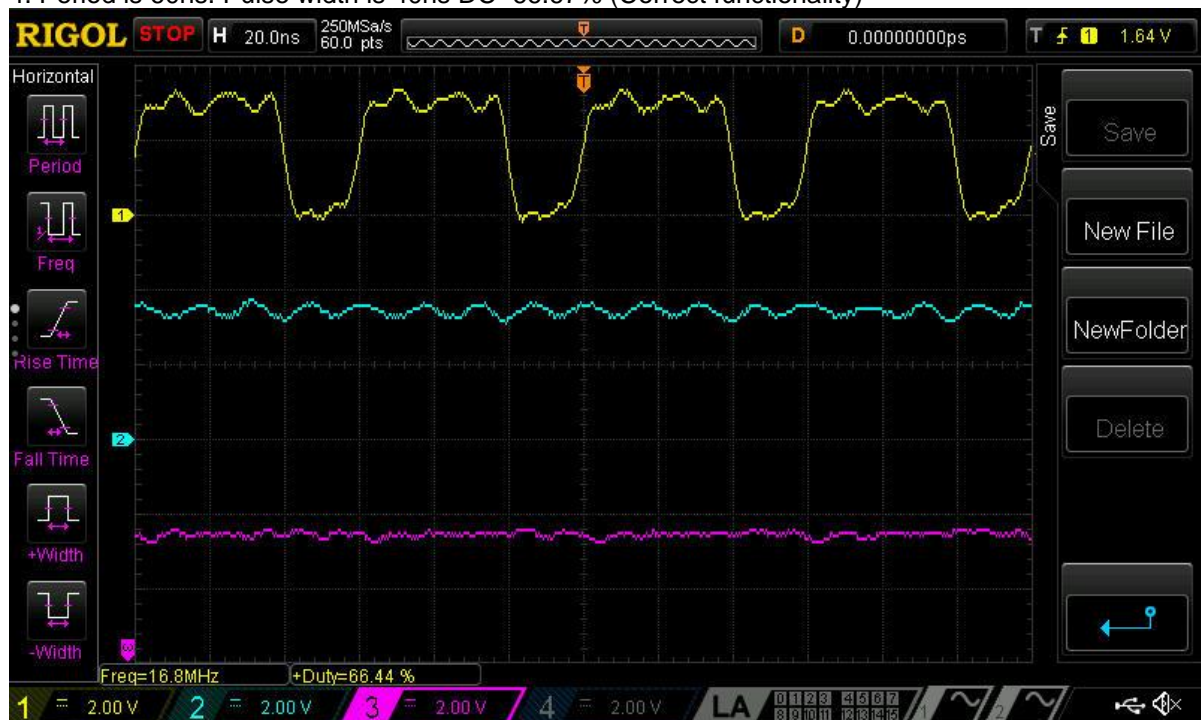
4. Period is 60ns. Pulse width is 40ns DC=66.67% (Correct functionality)

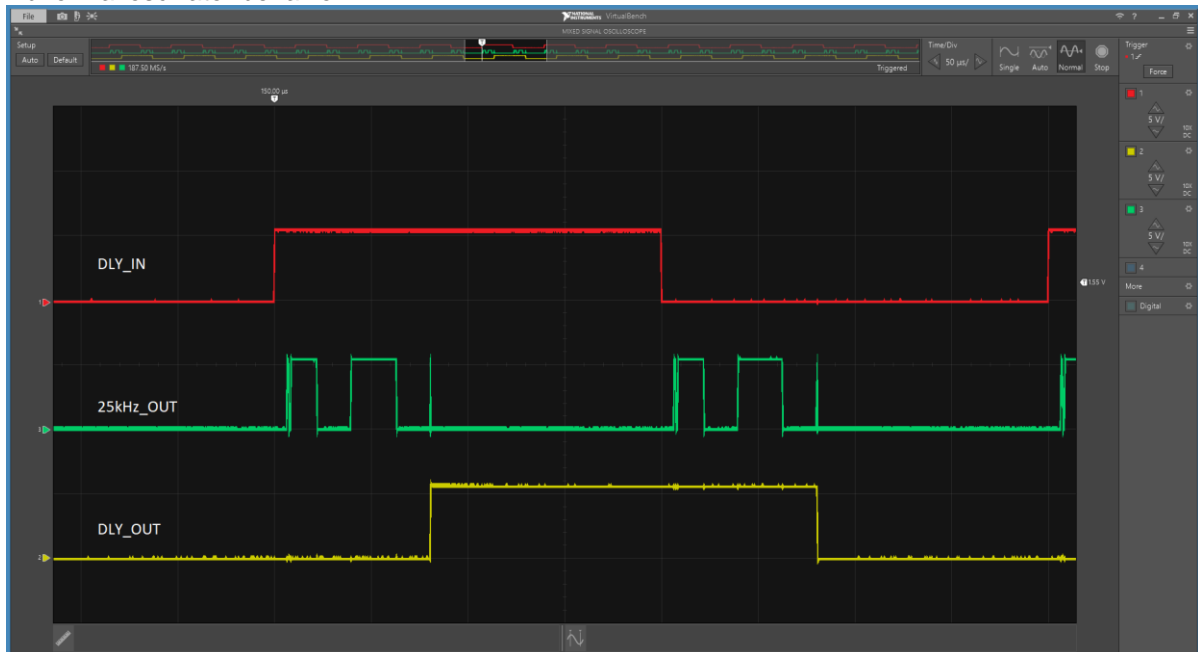
The first period of the RC OSC can be very short when OSC configured as 25 kHz with Auto Power On in the designs. This can be occurred when V_{DD} is above 4.0 V. Critical for CNT/DLY with a low counter data (less than 10) or if it is necessary to use the frequency of the OSC to clock external elements.

Abnormal oscillator behavior.

- Avoid V_{DD} higher than 4 V
- Force ON OSC

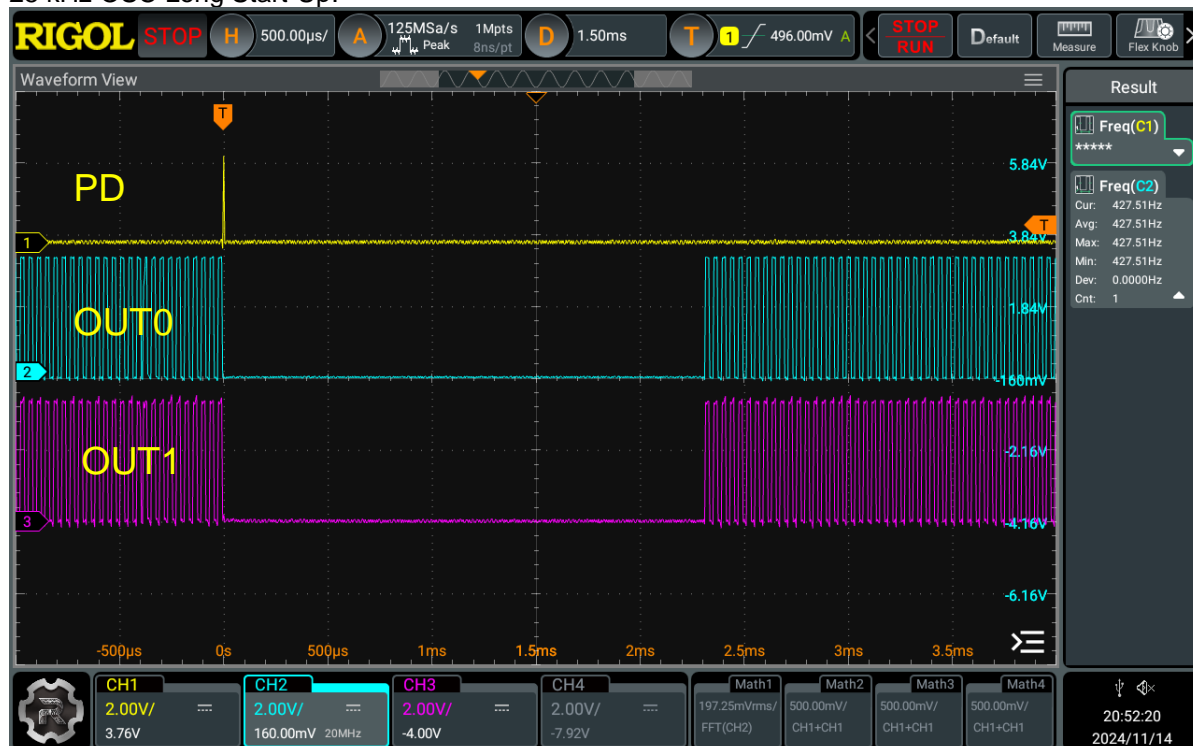
25 kHz OSC Long Start-Up:

If a pulse with a duration of less than ~40 ns is applied to the PWR DOWN input of the oscillator, the oscillator outputs remain stuck for milliseconds, as shown in figures below. This issue is observed for both 25 kHz and 2 MHz oscillators.

Change the Fast Start-up setting to "Enable" (see figure below) or avoid applying glitches to the PWR DOWN input of the oscillator.
