Errata SLG46127 CE-GP-024

This document contains the known errata for SLG46127 and the recommended workarounds.

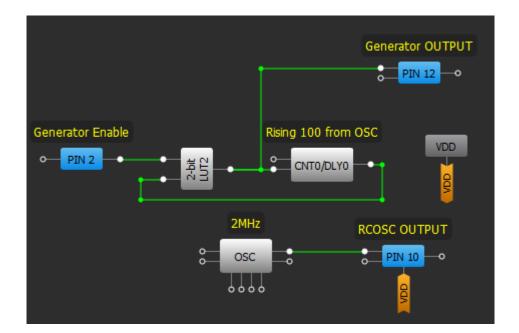
The RC OSC has a longer settling time when configured as 2 MHz with Auto Power On in the designs that have very short RC OSC disable time.

The configuration shown above generates a periodical signal with a frequency defined by the Delay cell and started by a HIGH signal on PIN2. The issue becomes apparent in a longer settling time when the scheme generates short pulses (Delay is configured as a rising edge delay only). See waveform below.

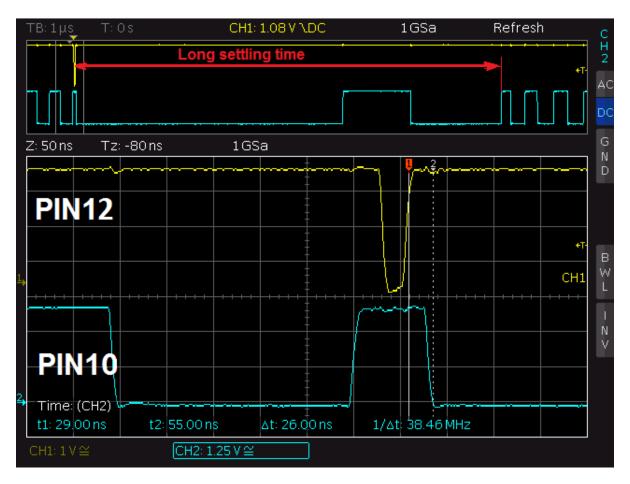
Channel 1 – 2-bit LUT0 output; Channel 2 – RC OSC output

Such behavior will lead to substantial error in period calculations if the delay time is relatively small.

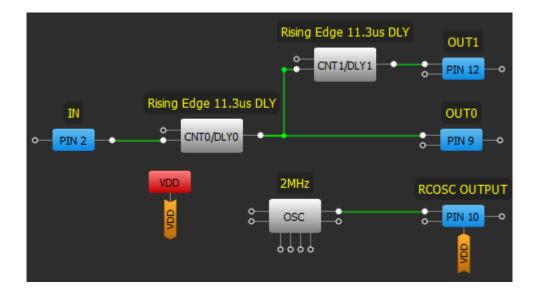
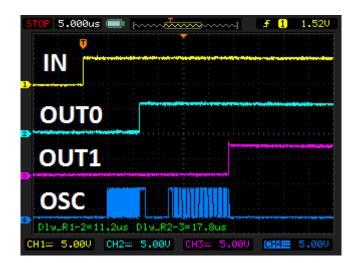
The same situation occurs while using two connected delays (all edge detect types except for a pair "Rising edge DLY – Falling edge DLY").

In the following example, Delay0 and Delay1 are configured in the same way. However, Delay1 time is 17.8us instead of expected 11.3us (Delay0 time).

- using two delays in series (except for a pair "Rising edge DLY – Falling edge DLY") use one Filter cell or P DLY between delay blocks. Using LUTs won't help in this case.

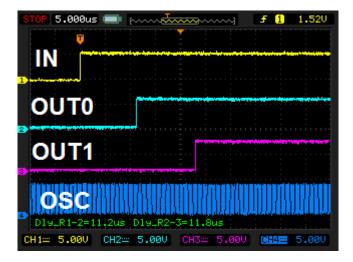
If there are some inner blocks which use RC OSC at the moment or RC OSC is forced power on when such error appears, RC OSC will be operational and delay value will be proper.

- use the "Force power on" RC OSC power control option to make the RC OSC operate at all times.

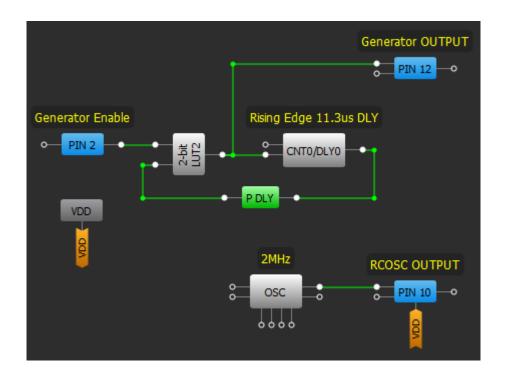
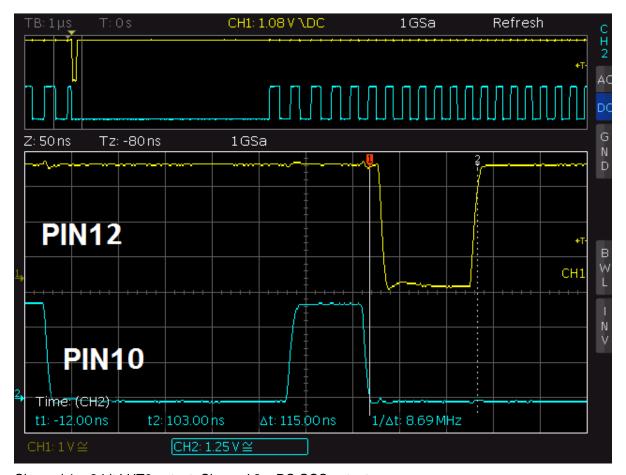
Channel 1 – 2-bit LUT0 output; Channel 2 – RC OSC output

- In first case use block with longer propagation time.

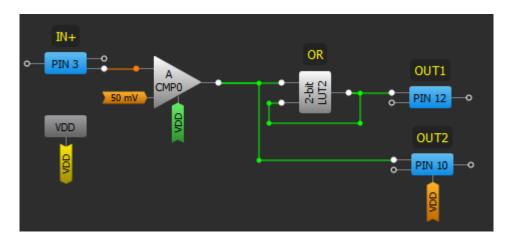
In some cases, ACMP may have short high-level glitches on its output (even if IN+ voltage is less than IN- voltage) after GreenPAK chip being powered up. Such cases may appear when using ACMP with Low Bandwidth mode enabled and Power Up is connected directly to the V_{DD}.

In order to detect such glitches, scheme with additional LUT was used. This LUT detects high level on ACMP output and stays high until chip powers down.

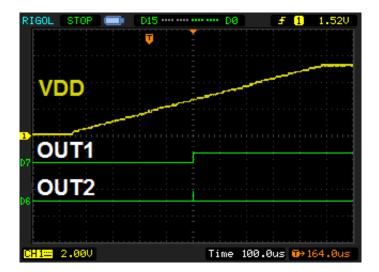
ACMP IN+ is connected to the Ground.

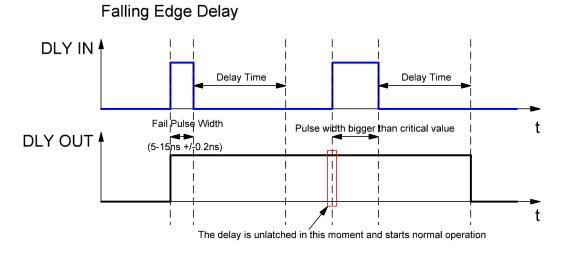
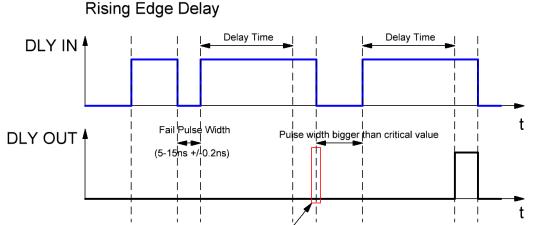
The delay output could be latched despite the input change when a short pulse is input. For example, if the delay cell is configured as a falling edge delay, the short pulse (see NOTE) appears on its input the delay cell output will switch from LOW to HIGH but may not switch from HIGH to LOW even after the delay time has passed.

The delay is unlatched in this moment and starts normal operation

Use P DLY/FILTER block configured as a both edge delay or FILTER.

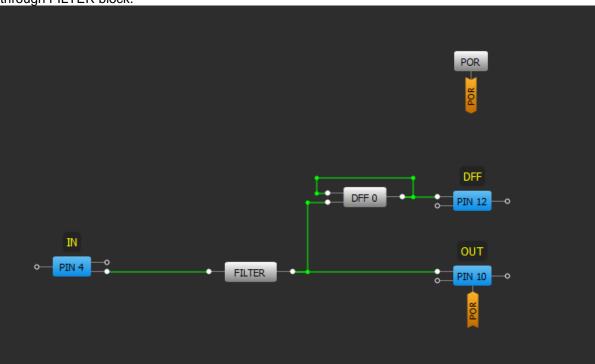
Channel 1 (yellow/top line) – PIN#4 (IN) Channel 2 (light blue/2nd line) – PIN#10 (OUT) Channel 3 (magenta /3rd line) – PIN#12 (DFF)

1. Period is 60ns. Pulse width is 10ns DC=16.7% (Correct functionality)

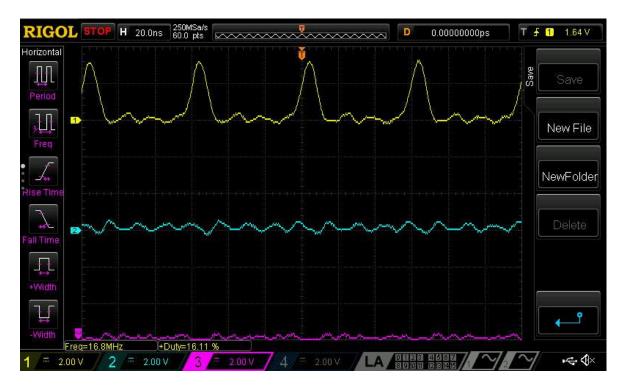
2. Period is 60ns. Pulse width is 20ns DC = 33.3% (Incorrect functionality)

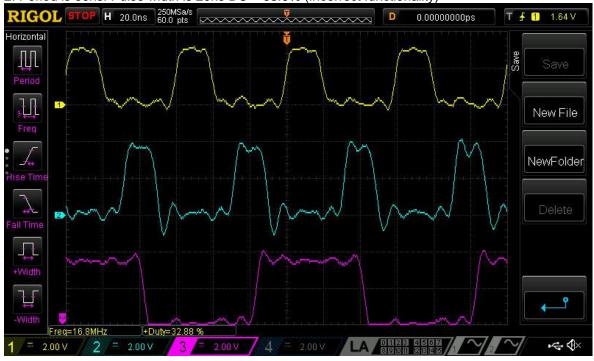
3. Period is 60ns. Pulse width is 30ns DC=50% (Incorrect functionality)

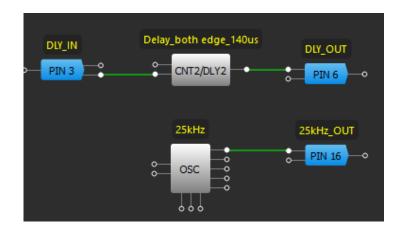
The first period of the RC OSC can be very short when OSC configured as 25 kHz with Auto Power On in the designs. This can be occured when V_{DD} is above 4.0 V. Critical for CNT/DLY with a low counter data (less than 10) or if it is necessary to use the frequency of the OSC to clock external elements.

- Avoid V_{DD} higher than 4 V
- Force ON OSC

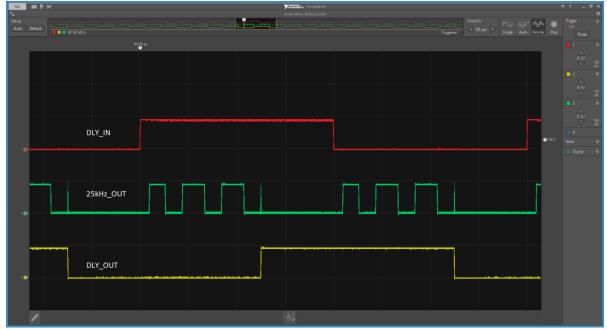
Normal oscillator behavior.

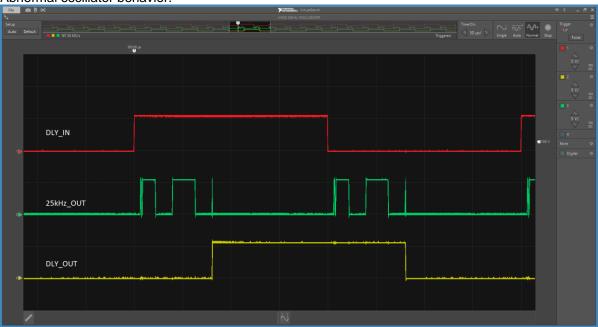
Abnormal oscillator behavior.

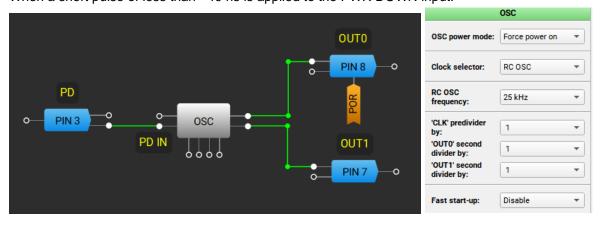
When a short pulse of less than ~40 ns is applied to the PWR DOWN input.

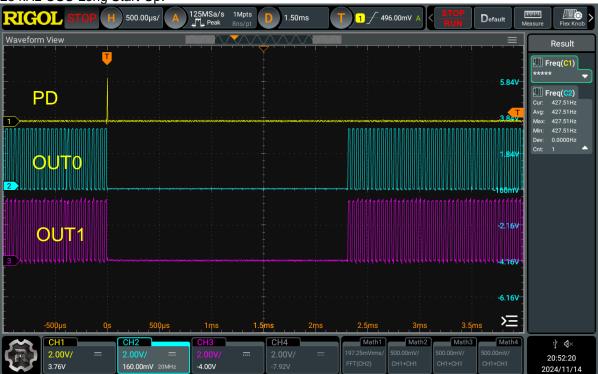
25 kHz OSC Long Start-Up:

If a pulse with a duration of less than ~40 ns is applied to the PWR DOWN input of the oscillator, the oscillator outputs remain stuck for milliseconds, as shown in figures below. This issue is observed for both 25 kHz and 2 MHz oscillators.

Change the Fast Start-up setting to "Enable" (see figure below) or avoid applying glitches to the PWR DOWN input of the oscillator.
