# Errata

## SLG4653x

### CE-GP-002

*This document contains the known errata for SLG46533, SLG46534, SLG46535, SLG46536, SLG46537, SLG46538 and the recommended workarounds.*

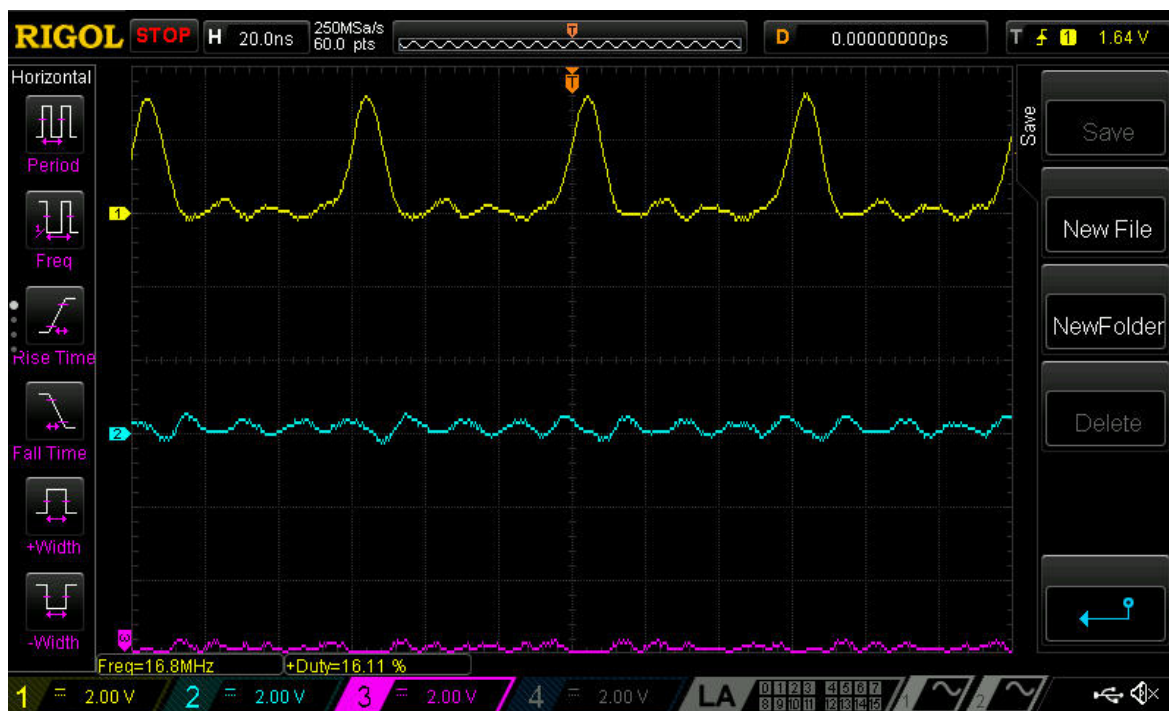
Figure 5

1. Period is 60ns. Pulse width is 10ns DC=16.7% (Correct functionality)

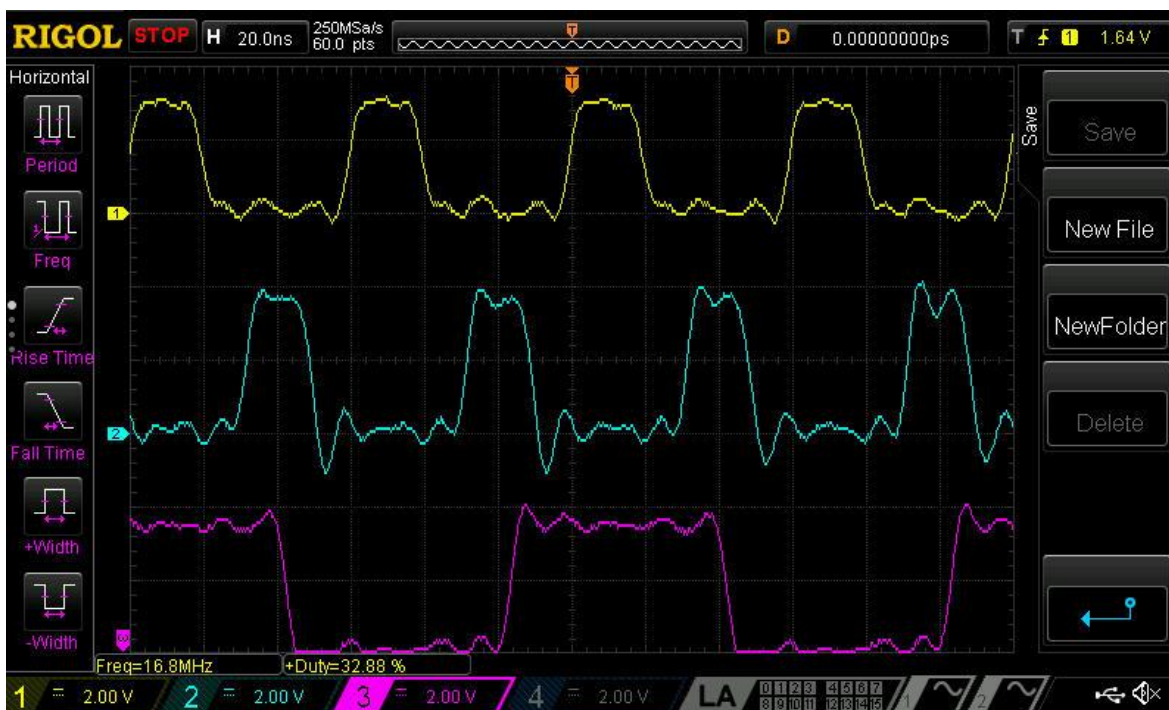
Figure 6

2. Period is 60ns. Pulse width is 20ns DC = 33.3% (Incorrect functionality)

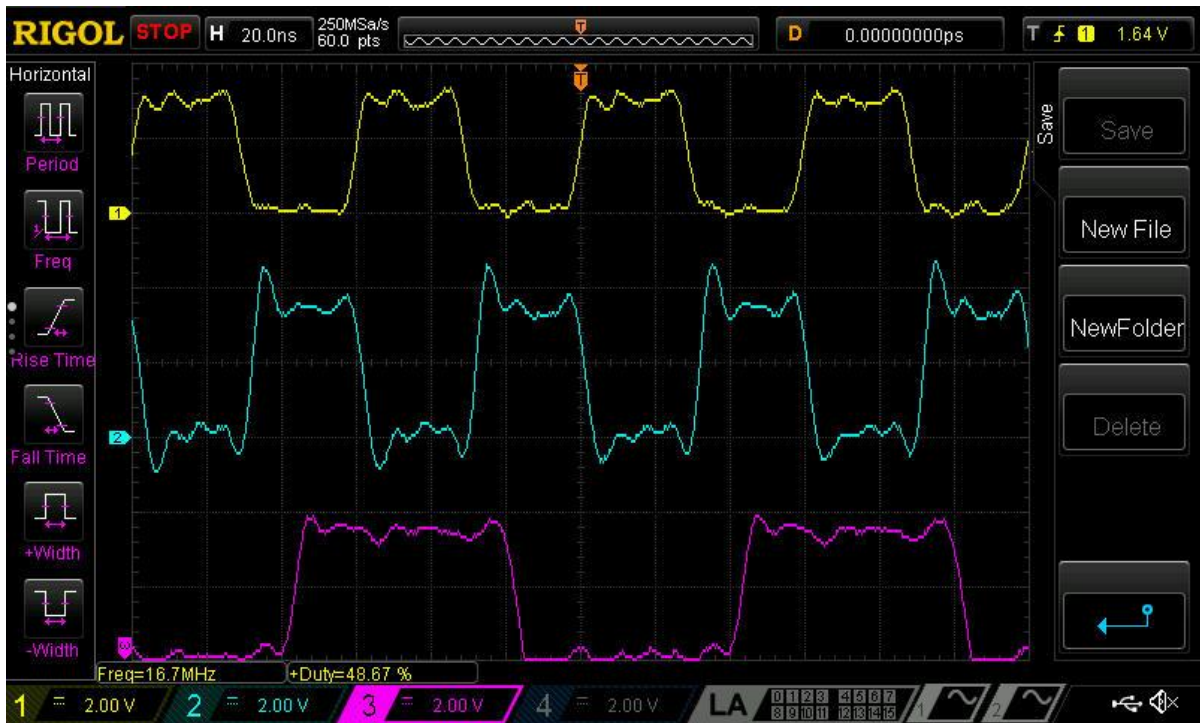
Figure 7

3. Period is 60ns. Pulse width is 30ns DC=50% (Incorrect functionality)

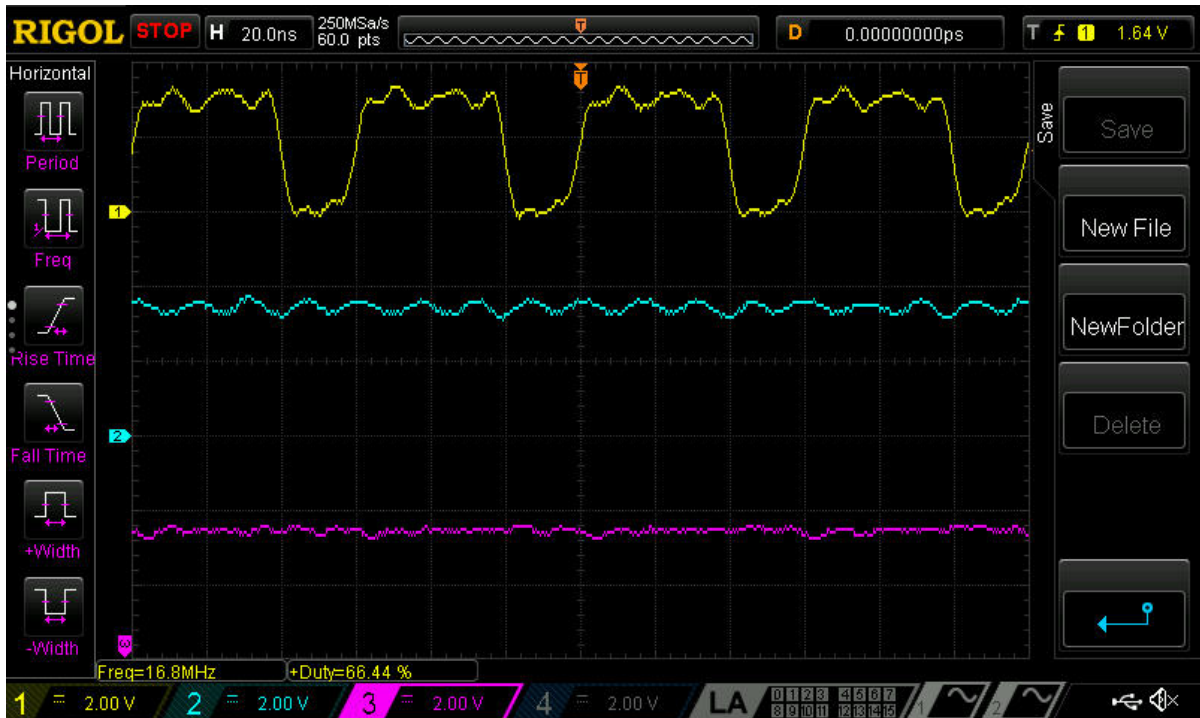
Figure 8

4. Period is 60ns. Pulse width is 40ns DC=66.67% (Correct functionality)

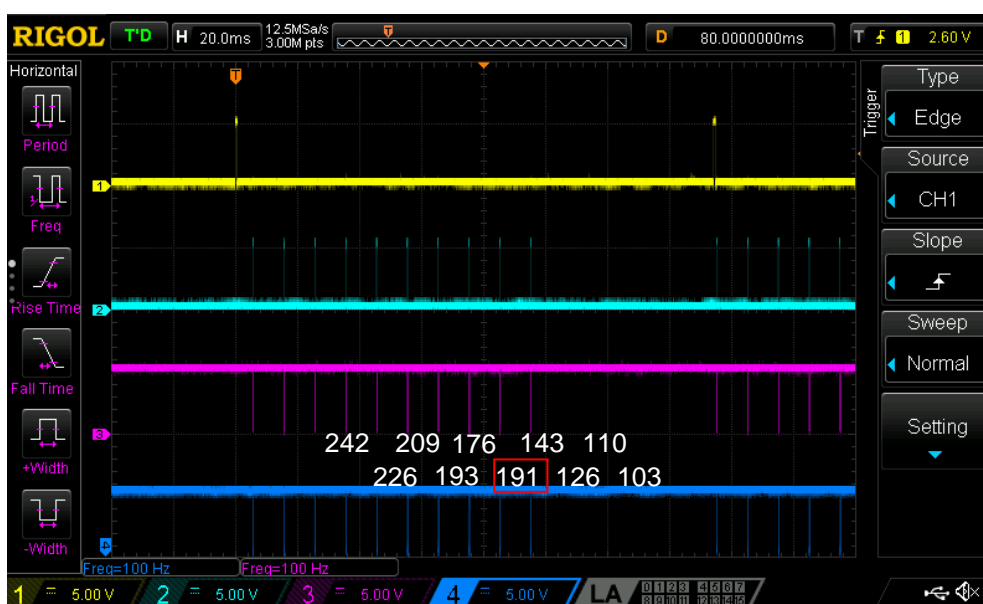
Figure 9

Asynchronous interaction between the CNT/DLY clock input and the I2C latch signal (generated by an I2C read command of the CNT/DLY block's count value) can result in an incorrect I2C data read. The CNT/DLY block will count accurately, but the count value transferred into the block's I2C read register might be loaded incompletely if the I2C latch signal and the clock input occur at about the same time.

The example data capture below shows ten periodic I2C reads of CNT2/DLY2 configured to count down at about 16 clocks per read. The sixth read sample erroneously shows a value greater than that of the fifth. The seventh sample reads as if the previous I2C error never occurred - the difference from the fifth sample (176) to the seventh (143) is 33 clocks or 16 clocks + 17 clocks as expected.

If the possibility of incorrect I2C data reads can't be accommodated for by external software checks, one can guarantee proper operation by stopping the CNT/DLY block's clock during I2C reads through one of the following methods: by disabling the oscillator block, by reconfiguring the CNT/DLY block's clock source, or by gating an external clock using a LUT (Look-up Table) in the signal matrix. After disabling the CNT/DLY block's clock, the count registers can be read without error. Please note that this workaround will add the I2C read and processing time to the counter's overall clock period.

The best workaround depends on the resource constraints of the application. If the oscillator block doesn't clock other logic elements within the design, a matrix output can be used to manually power down the oscillators for the I2C read. When the CNT/DLY block's clock source is routed internally from the oscillator block, I2C commands can temporarily reconfigure the CNT/DLY block's clock source registers to select "Ext. CLK. (From Matrix)." This action will disable the clock by connecting it to ground. If the CNT/DLY block is clocked from the signal matrix, a LUT can be used to gate the clock during an I2C read.

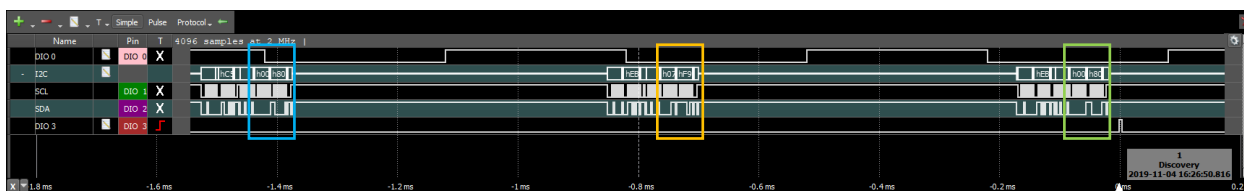
**Figure 12: Counter Behavior**

For the following condition, the Counter Data register contents are unexpectedly loaded into the counter's DFF chain. This behavior occurs when there is a falling edge on the counter block's clock input during the data return portion of an I2C read of the Counter Data registers. [Figure 10](#) shows this falling edge boxed in light blue followed by two I2C reads of the Current Count Value registers.

As you can see by the MCU data log below, the Current Count Value gradually increases from 0xF904 to 0xF907 but is unexpectedly reset to 0x8000. Please note that the colored HEX values in the MCU Log correspond to the boxed I2C read commands shown in the waveform above. As previously described, this reset occurs because there is a falling edge on the counter's clock input while the GreenPAK device is responding to an I2C read request to 0xC5 and 0xC6. (Note that 0xC5/0xC6 are the Counter Data registers and 0xEB/0xEC are the Current Count Value registers for CNT0.)

The reason that the counter isn't set to 0x8000 on the I2C read immediately following the Counter Data query is because the counter requires two rising edges on its clock input to load the data from the Counter Data registers into the DFF chain. Note that all rising edges during  $T_{stop}$  will be gated internally by the "Stop and Restart" feature.

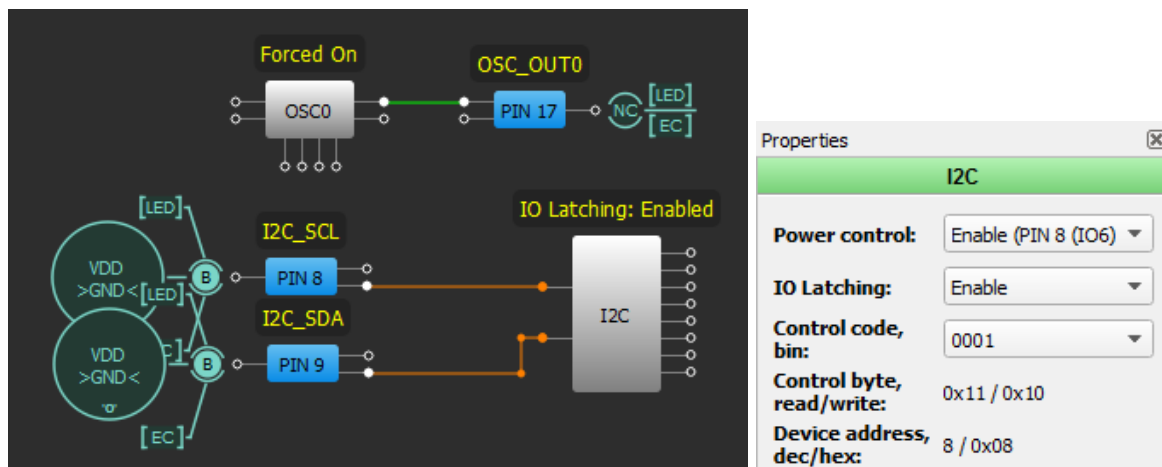
Figure 11

In the example below, we will be monitoring the OSC output, which is measured by a scope on Channel 3 via PIN17 (“OSC\_OUT0”). The I2C bus will be forced low to create a START bit.

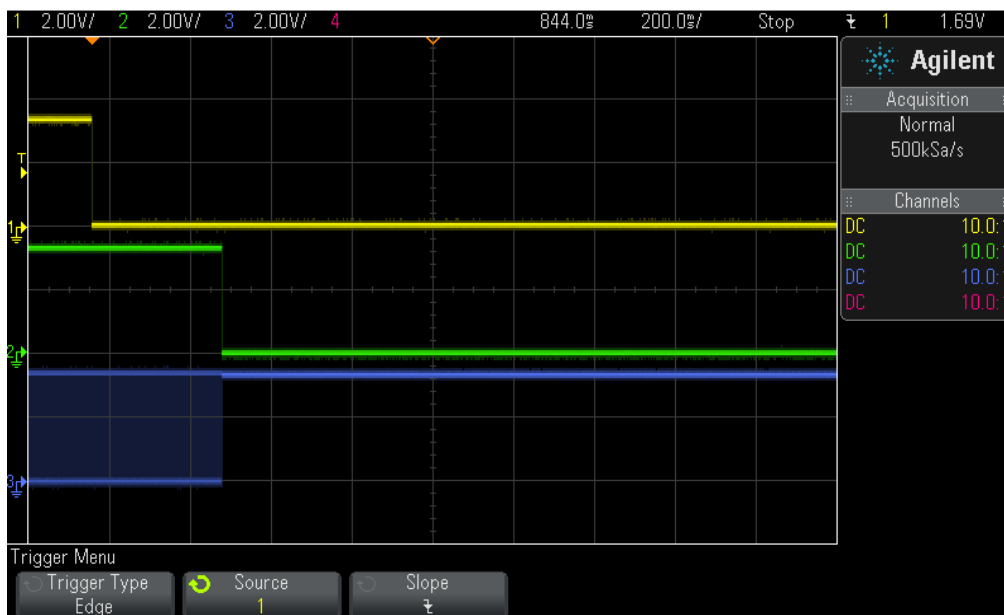
Figure 12

By toggling I2C\_SDA low and then I2C\_SCL low, the GreenPAK registers this as a start bit and latches all General Purpose Outputs such as PIN#17(“OSC\_OUT0”). In the Figure 12, notice that PIN#17 (OSC\_OUT0) stops toggling.

Disable IO Latching in programmed OTP. This register is I2C-write locked during normal operation and therefore should be disabled in configuration file.  
Do not share I2C bus with other devices and make sure the I2C bus is not powered down while the GreenPAK is still powered through VDD.

If the above cannot be satisfied, then consider using the SLG4658x devices, where this errata has been fixed.
