SLG46580

ISSUE 1: Long 2 MHz OSC Settling Time Functional Block Affected: OSC, Counter, Delay

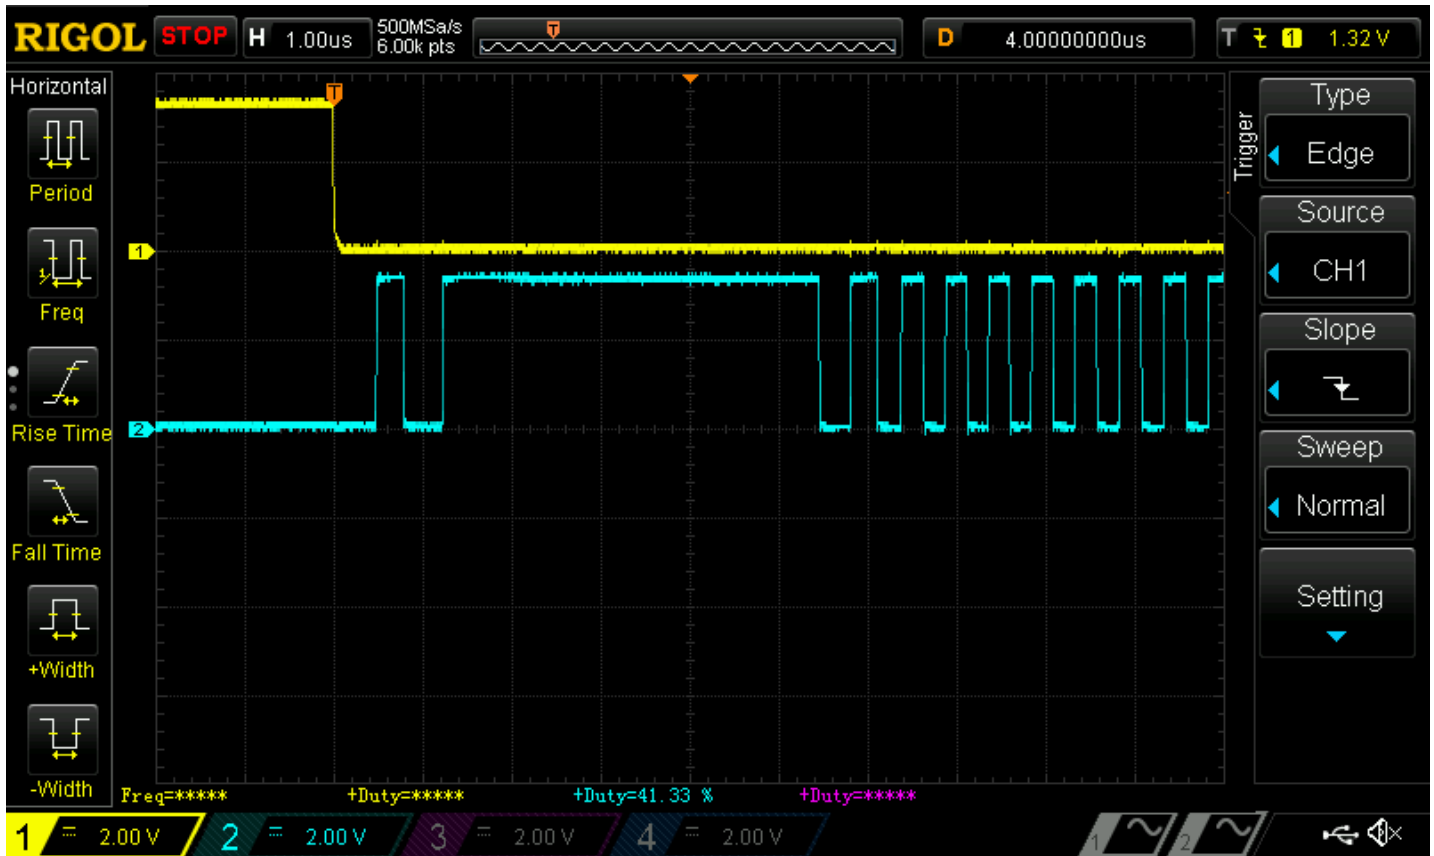
2MHz OSC has an additional ~ 9 cycles settling period. Higher VDD shows longer settling time.

Channel 1 – OSC Power Down; Channel 2 –OSC output

Such behavior will lead to substantial error in period calculations if the delay time is relatively small.

- Enable Fast Start-up option. Fast Start-up means forcing bias ready at the power-up instead of automatic enabling at OSC event. The standby current consumption difference between Fast start-up disabled and enabled is only an additional 300 nA.
- Use the “Force power on” OSC power control option to make the OSC operate at all times. However, this will cause increased constant current consumption.

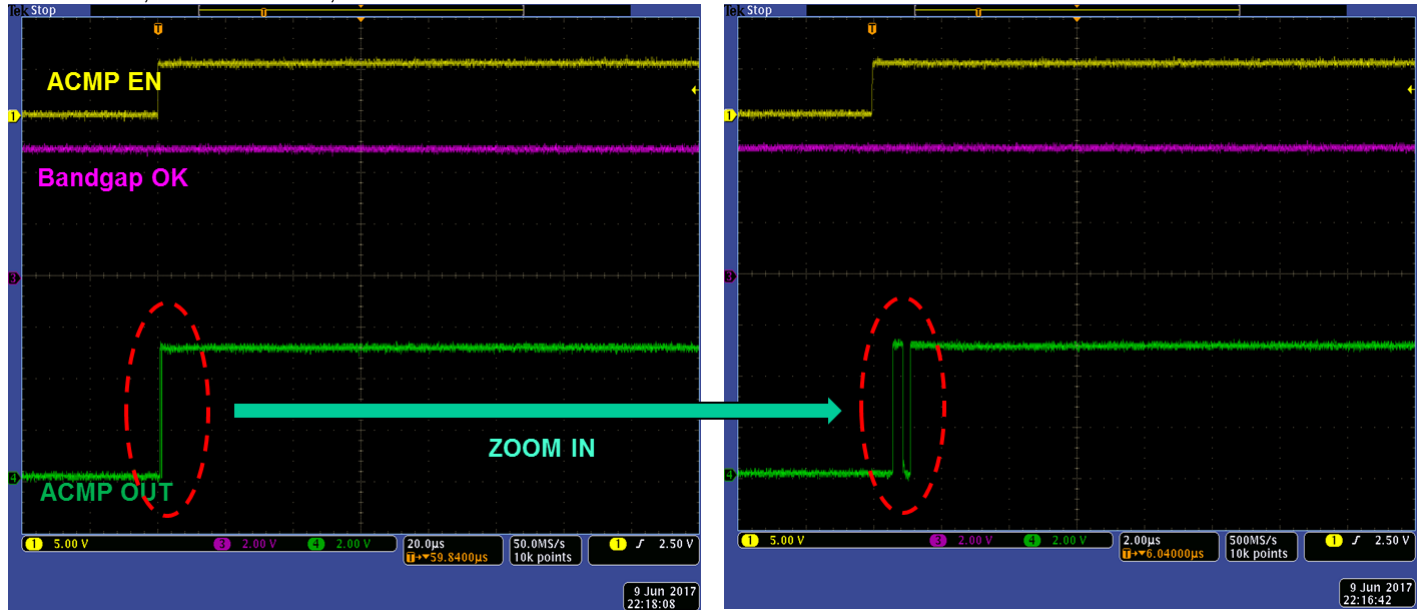
After power-up, if LDO is enabled earlier than ACMP, its output may generate a glitch.

VDD = 5.0 V, ACMP IN+ > IN-, One of LDOs enabled

Because BG_OK is already released by LDO, there is no gating signal. Depending on the ACMP VREF condition & the positive input value, it is possible for the ACMP to have a glitch. Subsequently, the other ACMP will not have an issue unless the customer repeats LDO enable first and ACMP later during power stable.

- Use both edge delay on the output to filter out the glitch.

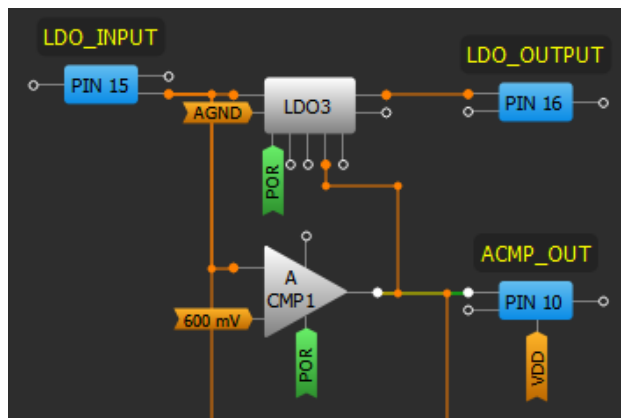
If an LDO's VIN pin (LDO_INPUT) has an internal connection (depicted with an orange wire) to the ACMP's IN+ port, the ACMP's output may give an erroneous result with respect to the LDO's input voltage. The switch between the LDO's VIN pin and the ACMP's IN+ port is implemented using an NMOS-only based transmission gate with its gate controlled by logic supplied from VDD. As a result, this switch is unable to pass LDO input voltages that are close to VDD. This can result in the ACMP's IN+ port seeing a lower voltage than the actual voltage present at LDO_INPUT. This lower input voltage may cause the output of the ACMP to behave unexpectedly.

If the LDO's UVLO feature is enabled, the ACMP's output will cause unexpected LDO behavior that results from the previously described transmission gate voltage drop.

Case 1: Proper Behavior at VDD = 5V;

With a 5V VDD, the NMOS transmission gate passes the 2.25 and 2.75V LDO_INPUT pin voltages to the ACMP's IN+ port. When the input voltage exceeds the 2.4V IN- threshold of the ACMP, the LDO is enabled.

Case 2: Erroneous Behavior at VDD = 2.75V;

When the VDD is reduced to 2.75V, the NMOS transmission gate is unable to pass LDO_INPUT's full magnitude to the ACMP's IN+ port. Since the IN+ port of the ACMP doesn't exceed the 2.4V IN- threshold, the ACMP's output stays low and keeps the LDO disabled.

- If the GreenPAK's VDD is always powered up before the LDO's VIN input, you can externally short the LDO's VIN to another dedicated analog input pin for the desired ACMP.

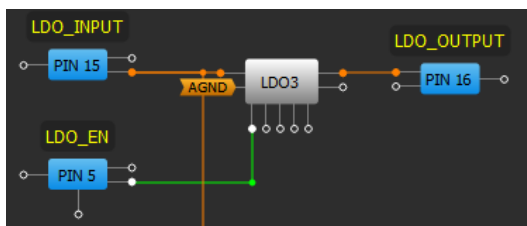
When a GreenPAK's first LDO is enabled, the LDO's VOUT will step to a non-zero voltage during its 500 μ s wait time. The magnitude of this step is directly proportional to the LDO's VIN and the GreenPAK's VDD. With a large LDO input voltage and VDD, this step can exceed 500mV.

VDD = 5.5V, LDO_INPUT = 5.5V, All other LDOs Disabled

- If your GreenPAK design has an unused LDO, you can reduce the magnitude of this voltage step by keeping an unused LDO enabled in high power mode.

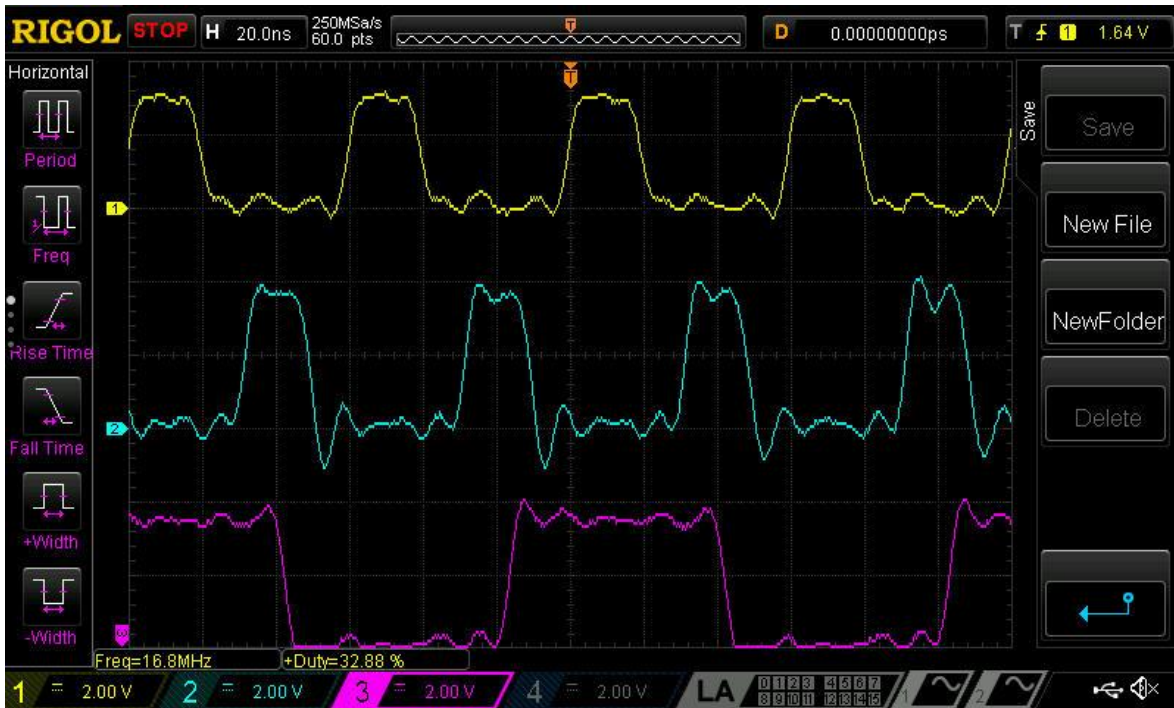
3. Period is 60ns. Pulse width is 30ns DC=50% (Incorrect functionality)

Currently, there is no workaround for this issue. The FILTER block correctly filters isolated glitches, but it shouldn't be used to filter repetitive, high frequency input signals.

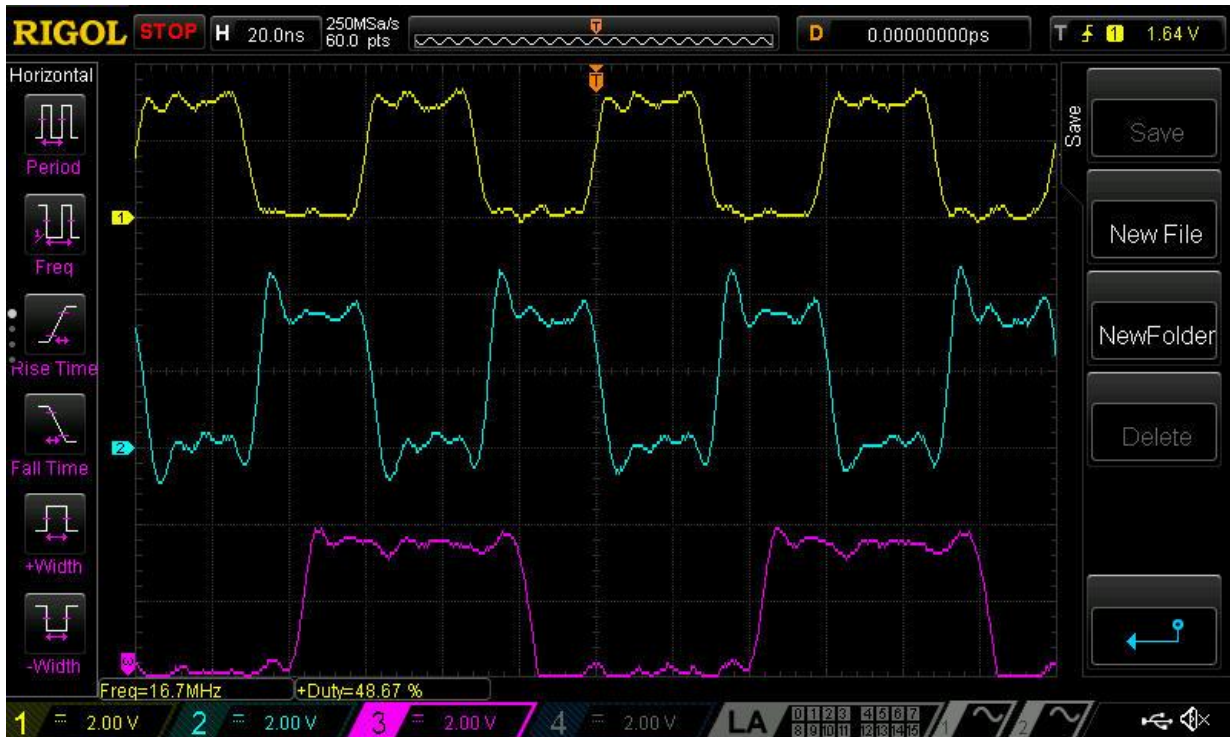
4. Period is 60ns. Pulse width is 40ns DC=66.67% (Correct functionality)

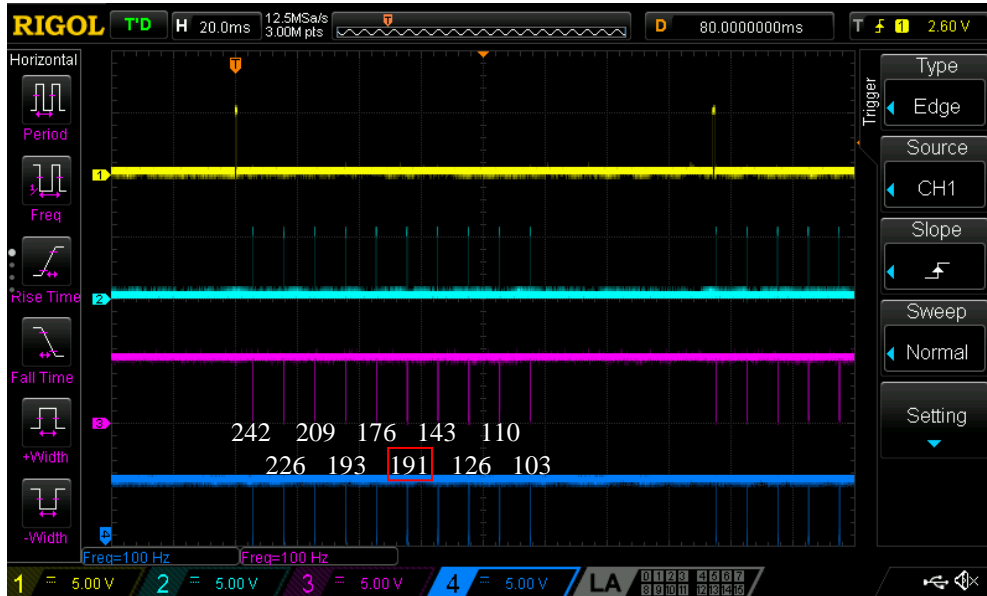
Asynchronous interaction between the CNT/DLY clock input and the I²C latch signal (generated by an I²C read command of the CNT/DLY block's count value) can result in an incorrect I²C data read. The CNT/DLY block will count accurately, but the count value transferred into the block's I²C read register might be loaded incompletely if the I²C latch signal and the clock input occur at about the same time.

The example data capture below shows ten periodic I²C reads of CNT2/DLY2 configured to count down at about 16 clocks per read. The sixth read sample erroneously shows a value greater than that of the fifth. The seventh sample reads as if the previous I²C error never occurred - the difference from the fifth sample (176) to the seventh (143) is 33 clocks or 16 clocks + 17 clocks as expected.

- Channel 1 (yellow/top line) – PIN#2 (CNT2/DLY2 Out)
- Channel 2 (light blue/2nd line) – PIN#1 (I²C Read Triggers)
- Channel 3 (magenta /3rd line) – PIN#8 (I²C SCL)
- Channel 3 (dark blue /4th line) – PIN#9 (I²C SDA)

If the possibility of incorrect I²C data reads can't be accommodated for by external software checks, one can guarantee proper operation by stopping the CNT/DLY block's clock during I²C reads through one of the following methods: by disabling the oscillator block, by reconfiguring the CNT/DLY block's clock source, or by gating an external clock using a LUT (Look-up Table) in the signal matrix. After disabling the CNT/DLY block's clock, the count registers can be read without error. Please note that this workaround will add the I²C read and processing time to the counter's overall clock period.

The best workaround depends on the resource constraints of the application. If the oscillator block doesn't clock other logic elements within the design, a matrix output can be used to manually power down the oscillators for the I²C read. When the CNT/DLY block's clock source is routed internally from the oscillator block, I²C commands can temporarily reconfigure the CNT/DLY block's clock source registers to select "Ext. CLK. (From Matrix)." This action will disable the clock by connecting it to ground. If the CNT/DLY block is clocked from the signal matrix, a LUT can be used to gate the clock during an I²C read.

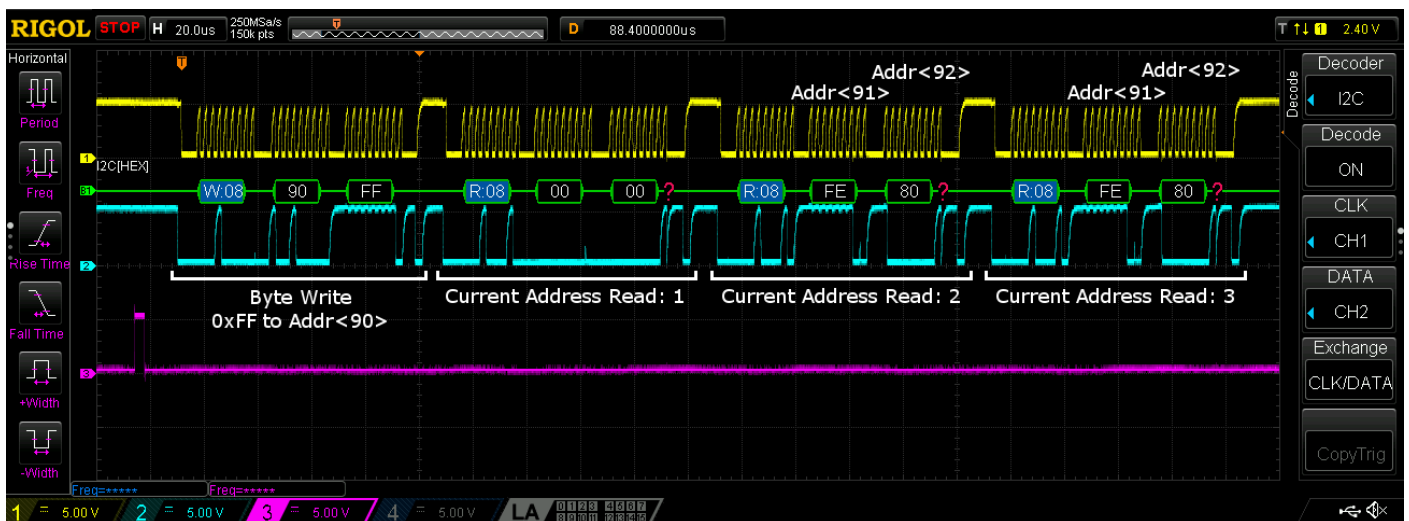
The first “Current Address Read” or “Sequential Read” command following an I²C “Byte Write” or a “Sequential Write” command will produce incorrect data. Additional read commands will return the expected data. See the waveform below for more information.

Channel 1 (yellow/top line) – PIN#8 (SCL)

Channel 2 (light blue/2nd line) – PIN#9 (SDA)

Channel 3 (magenta /3rd line) – I2C Software Trigger

Note: In the GreenPAK test design, Addr<91> and Addr<92> expect FE and 80 respectively.

If possible, use the “Random Read” command as described in the datasheet for SLG46580. This command will output the correct data.

If you expect consecutive reads of the same register, we recommend sending a “Random Read” command to the register preceding the register of interest. After the “Random Read” command finishes, the chip’s register pointer will increment to the desired register and the following “Current Address Read” or “Sequential Read” commands will produce the correct data. Note that the “Current Address Read” and “Sequential Read” commands don’t increment the GreenPAK’s register pointer.
