## SLG46583

### ISSUE 1: Long 2 MHz OSC Settling Time Functional Blocks Affected: OSC, Counter, Delay

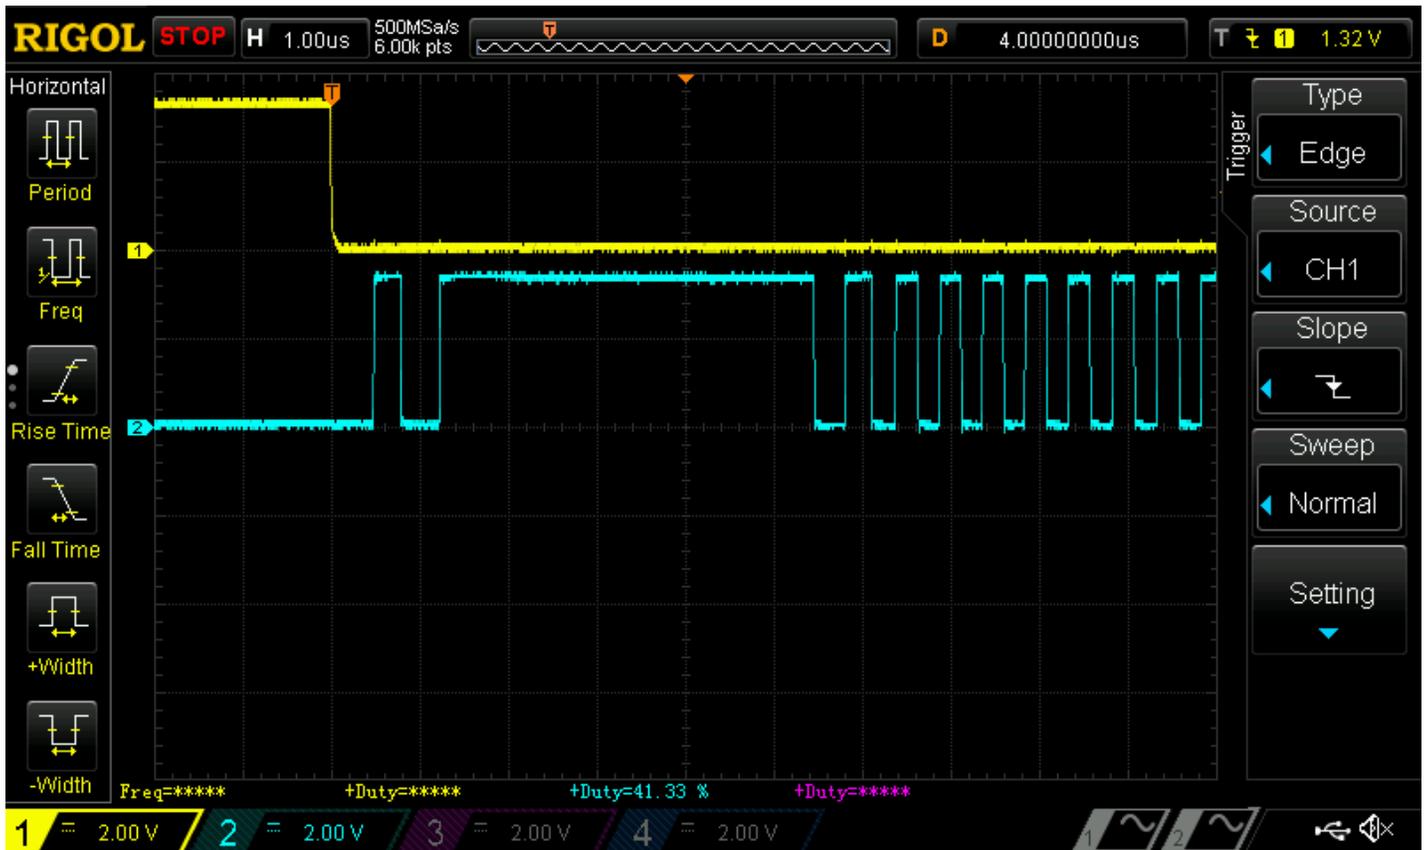
2 MHz OSC has an additional ~ 9 cycles settling period. Higher VDD shows longer settling time.

Channel 1 – OSC Power Down; Channel 2 –OSC output

Such behavior will lead to substantial error in period calculations if the delay time is relatively small.

- Enable Fast Start-up option. Fast Start-up means forcing bias ready at the power-up instead of automatic enabling at OSC event. The standby current consumption difference between Fast start-up disabled and enabled is only an additional 300 nA.
- Use the “Force power on” OSC power control option to make the OSC operate at all times. However, this will cause increased constant current consumption.

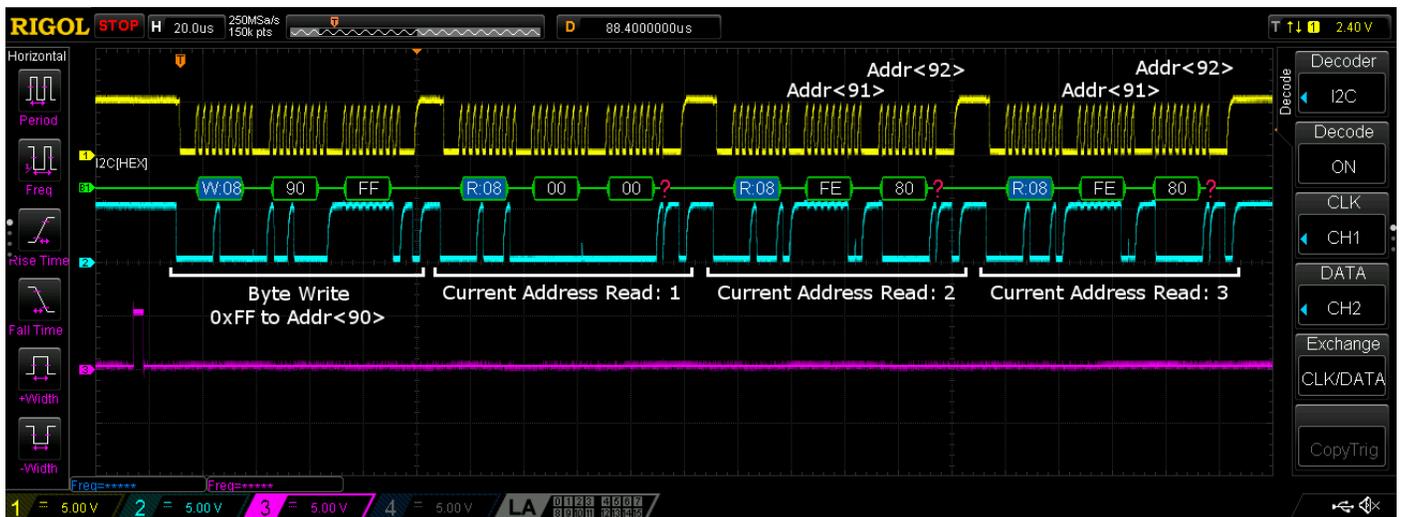
The first “Current Address Read” or “Sequential Read” command following an I<sup>2</sup>C “Byte Write” or a “Sequential Write” command will produce incorrect data. Additional read commands will return the expected data. See the waveform below for more information.

Channel 1 (yellow/top line) – PIN#8 (SCL).

Channel 2 (light blue/2nd line) – PIN#9 (SDA).

Channel 3 (magenta/3rd line) – I<sup>2</sup>C Software Trigger.

*Note: In the GreenPAK test design, Addr<91> and Addr<92> expect FE and 80 respectively.*

If possible, use the “Random Read” command as described in the datasheet for SLG46583. This command will output the correct data.

If you expect consecutive reads of the same register, we recommend sending a “Random Read” command to the register preceding the register of interest. After the “Random Read” command finishes, the chip’s register pointer will increment to the desired register and the following “Current Address Read” or “Sequential Read” commands will produce the correct data. Note that the “Current Address Read” and “Sequential Read” commands don’t increment the GreenPAK’s register pointer.

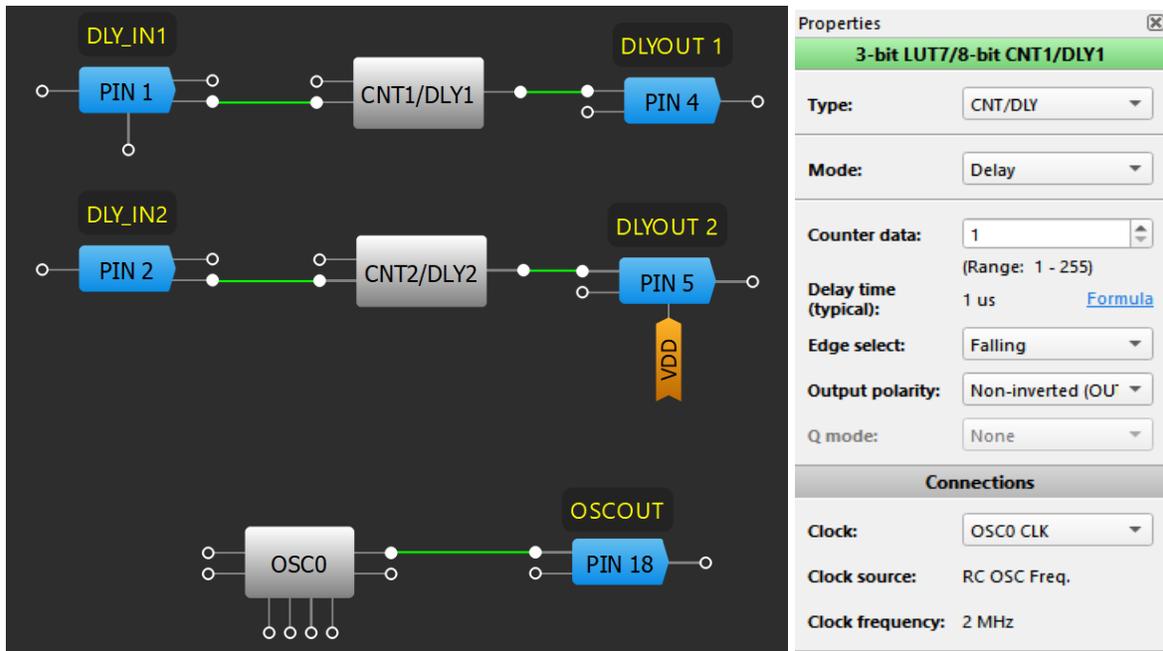
Figure 2: Test Circuit

The error is difficult to capture as the timing must be exact within ns, and short (ns) pulses are difficult to generate glitch precise enough to induce the problem. GPIO naturally filter out ns pulses, so for purposes of errata capture, two simultaneous falling-edge DLY circuits (as shown in Figure 2) were used. By lining up two delays precisely at a particular timing relationship, we can use the internal Auto Power On (OR logic) to generate the glitch pattern necessary to cause the error.
