ISSUE 1: Long Settling Time for Ring OSC

SLG46621

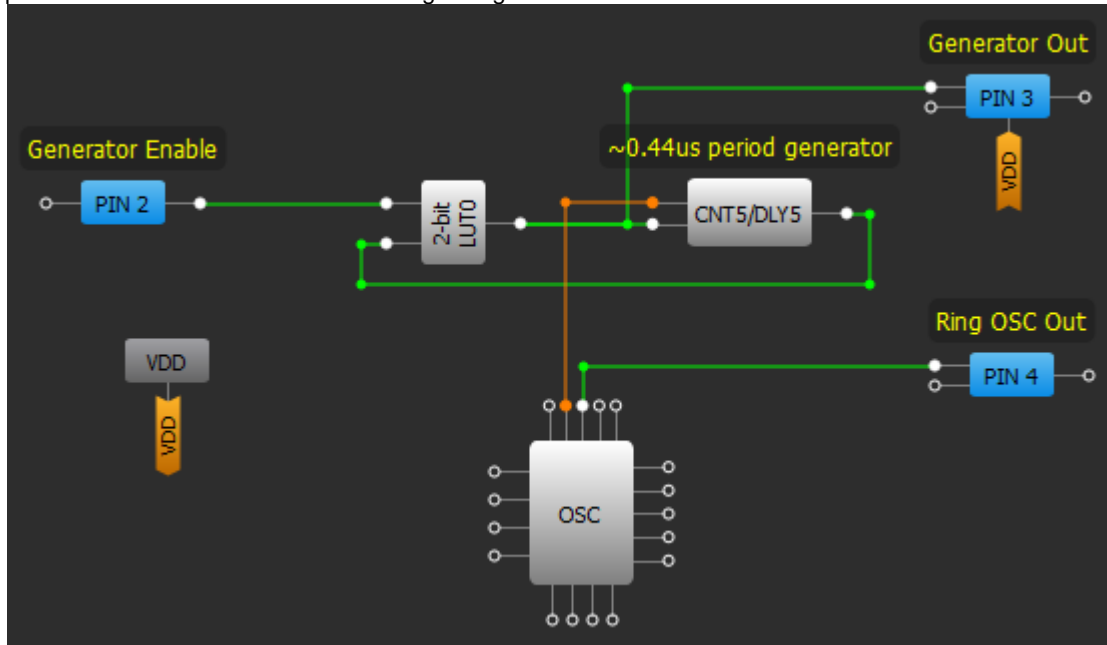
The Ring OSC has a longer settling time when configured as Auto Power On in the designs that have a very short Ring OSC disable time. An example of this issue is shown in the following configuration:

- Set Ring OSC power mode to “Force Power On”
- or, Set Turn on by register option in BG (Band Gap) block as “Enable”

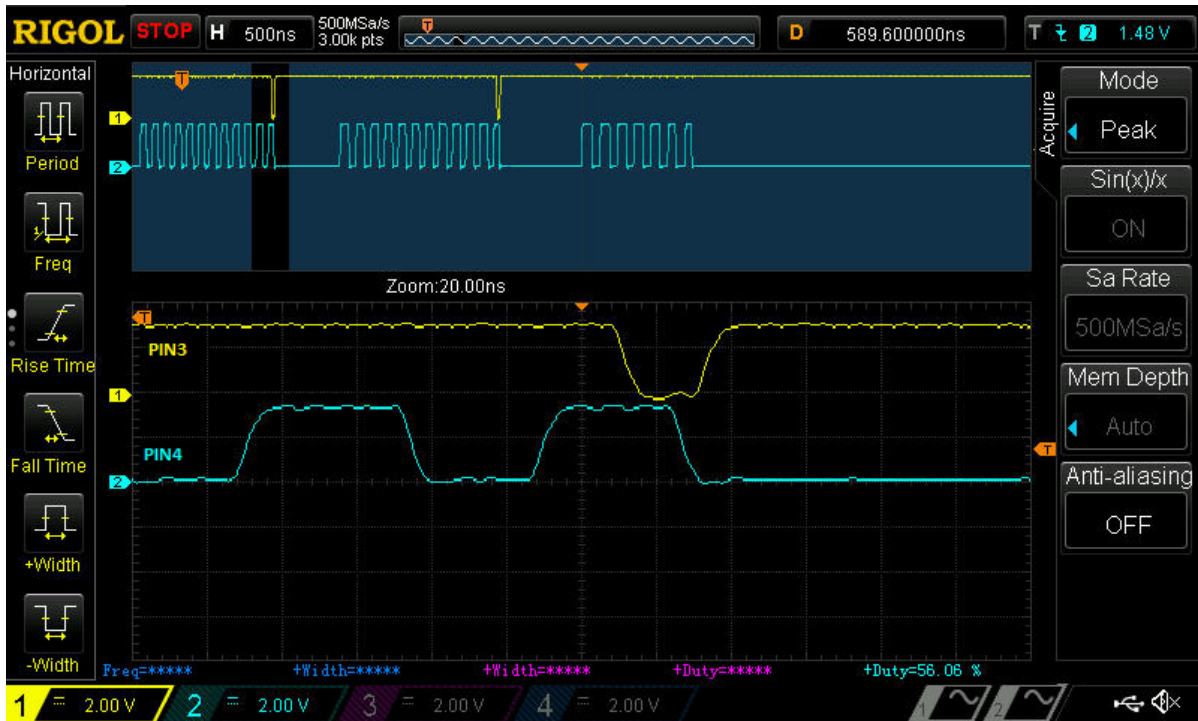
The configuration shown above generates a periodical signal with a frequency defined by the Delay cell and started by a high signal on PIN2. The issue becomes apparent in a longer settling time when the scheme generates short pulses (Delay is configured as a rising edge delay only). See waveform below.

Such behavior will lead to substantial error in period calculations if the delay time is relatively small.

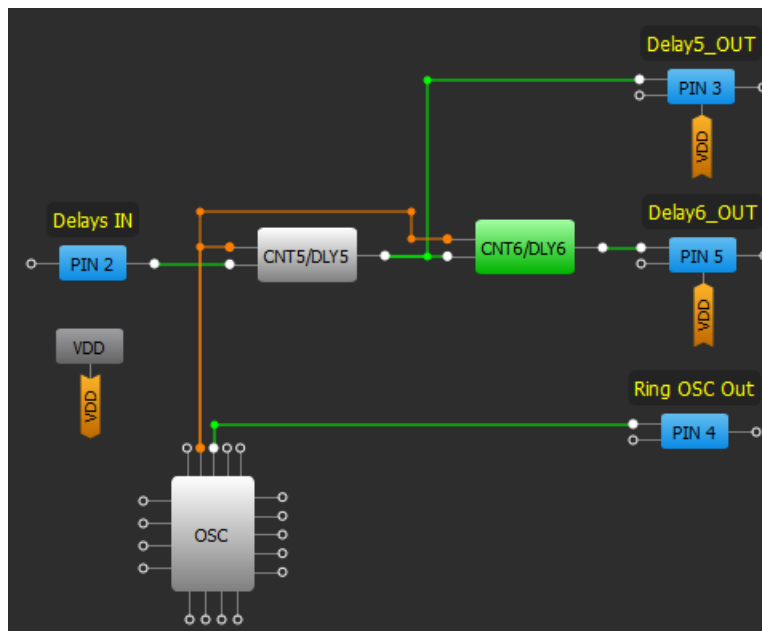
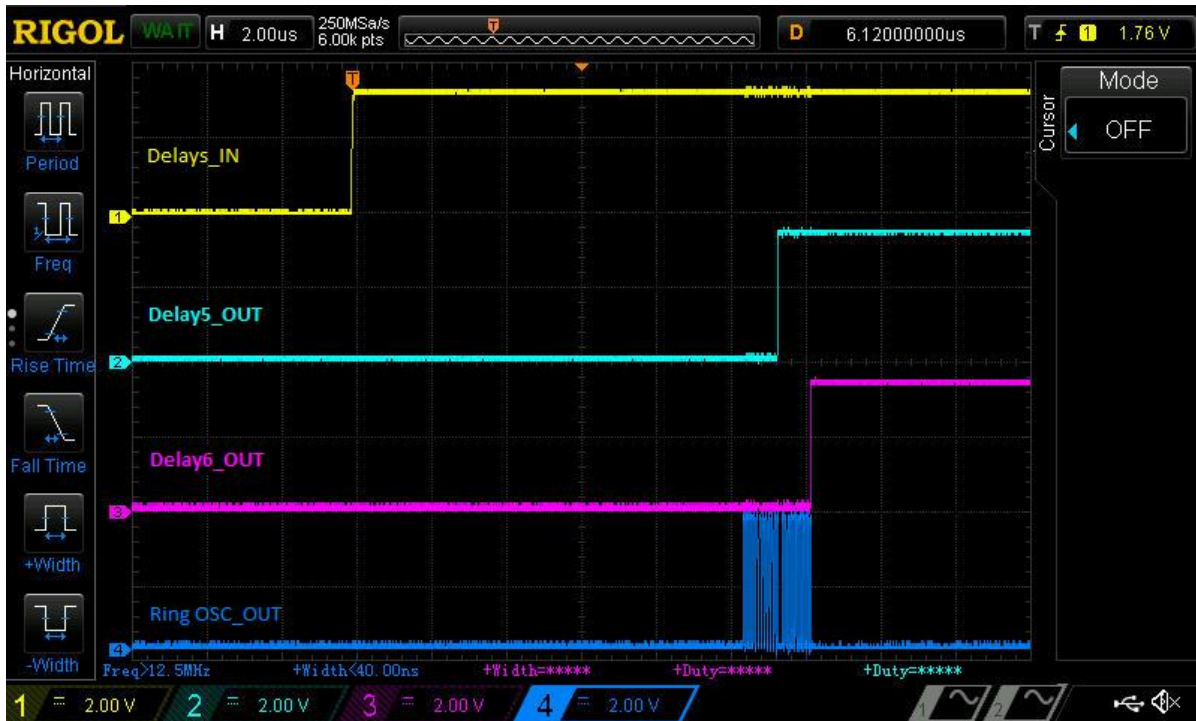
A similar situation can occur when using two connected delays (all edge detect types except when pairing “Rising edge DLY – Falling edge DLY”).

In the following example, Delay5 and Delay6 are configured in the same way. However, Delay5 time is 11.4us instead of expected 0.4us (Delay5 time).

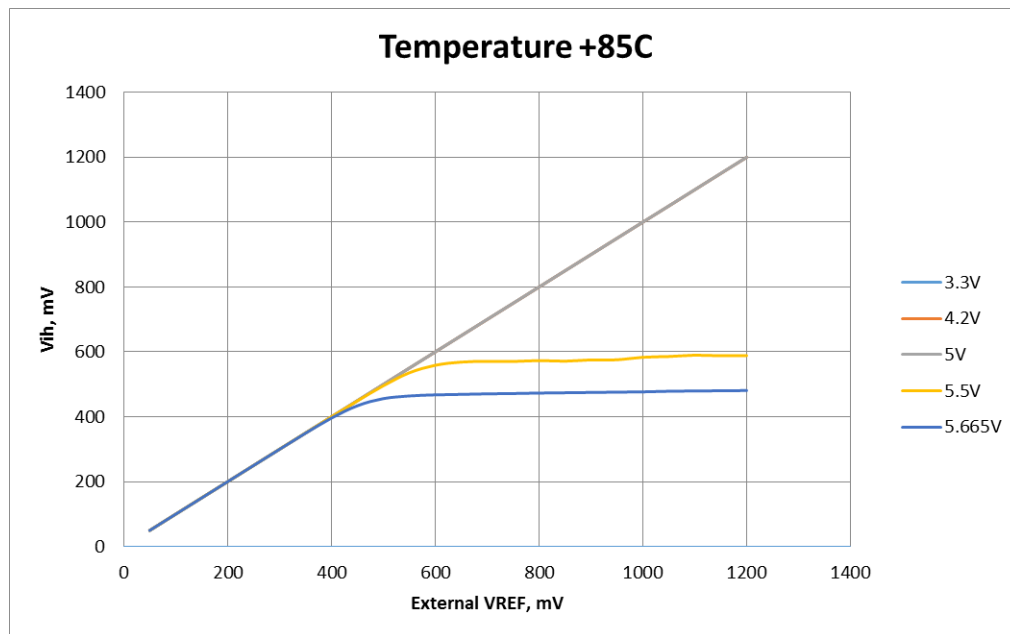
When using an external Vref source, the ACMP comparison may happen at the wrong threshold if the external Vref voltage is higher than a particular value (please see figure below) at high VDD values (> 5V) and high temperature.

- Avoid using ACMPs in such conditions.

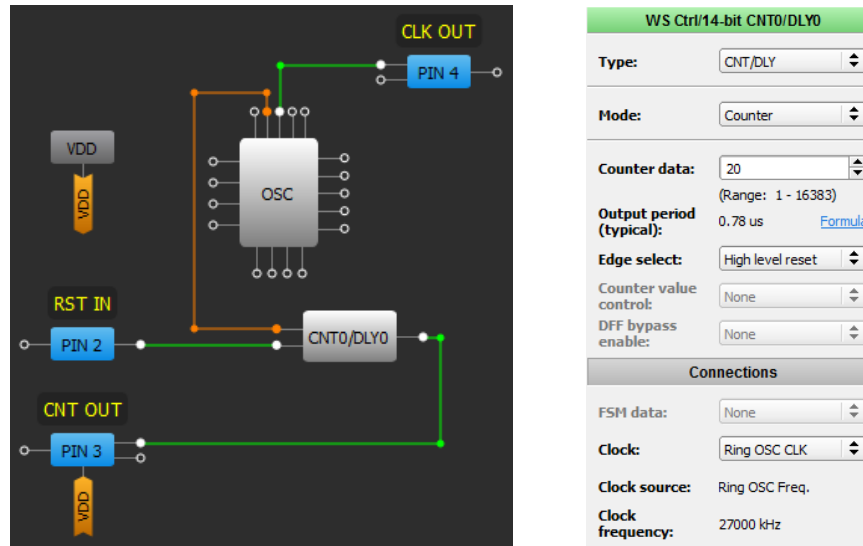
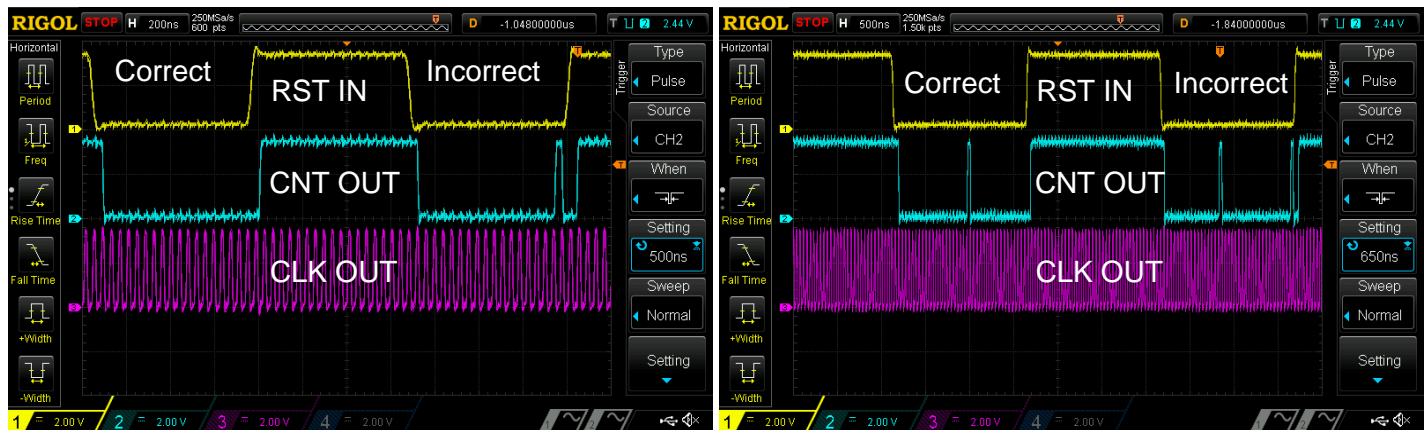
If the Counter Reset occurs at a time very close to a rising edge of the clock signal during clock signal generation (for example OSC operation), there is a possibility that the Counter Data of the Counter is reset incorrectly and the counter end signal (HIGH pulse) may appear faster than expected. This phenomena appears more frequently the higher the clock frequency is.

- Synchronize the RESET input of the Counter with its CLK using 2 DFF cells as shown in the image below.

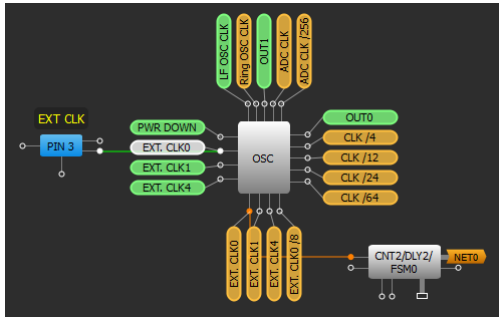
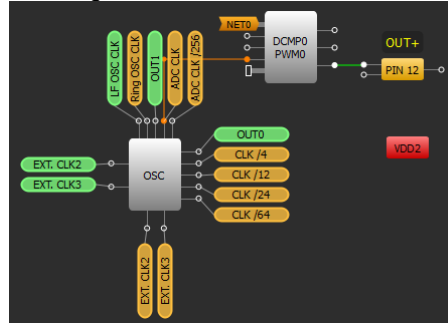
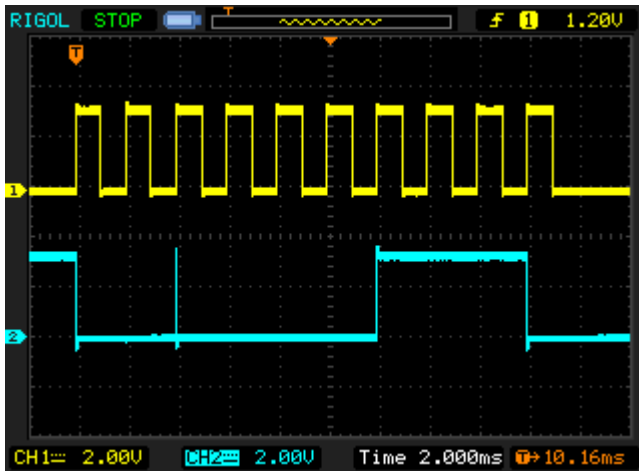
DCMP's OUT+ output may have a glitch when the input data is changed. This issue appears more frequently the higher DCMP clock is.

For example, DCMP IN+ sources from FSM0 and IN- from Register0. DCMP is clocked from the Ring OSC.

- Synchronize the data source clock with the DCMP clock source using 2 DFF cells as shown in the images below.

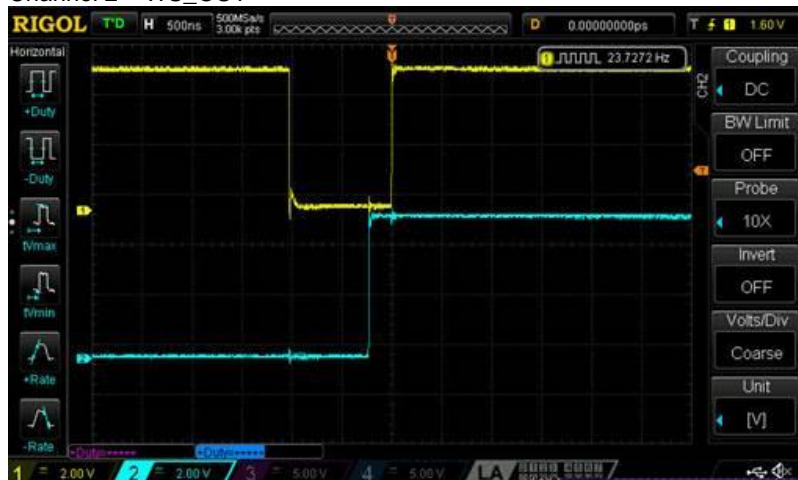
The output of the ACMP incorrectly goes low even when IN+ is greater than IN- if the RING OSC is active when the WS signal rises

Avoid using the RING OSC with the WS Controller, or add a filtering block on the ACMP output to filter out the glitch.

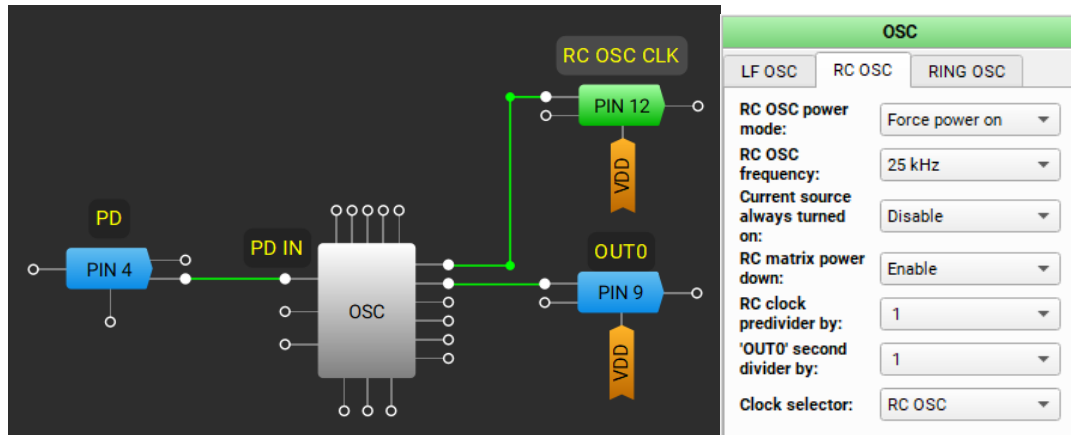
If a pulse with a duration of less than ~40 ns is applied to the PWR DOWN input of an oscillator, the oscillator outputs remain stuck for milliseconds.

Avoid applying glitches to the PWR DOWN input of an OSC.
