RENESAS TECHNICAL UPDATE

Product Category	MPU/MCU	Document No.	TN-RZ*-A043A/E	Rev.	1.00		
Title	Notes about SSCG		Information Category	Technical Notification			
Applicable Product	See following	Lot No.	Reference Document	See following

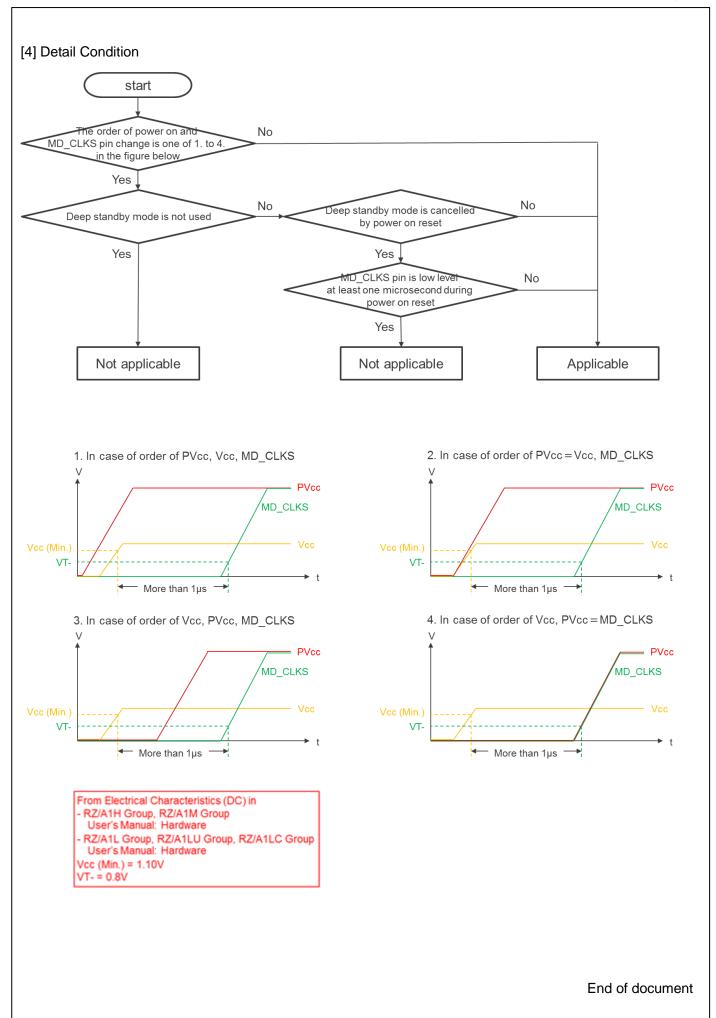
From Electrical Characteristics (DC) in
- RZ/A1H Group, RZ/A1M Group
User's Manual: Hardware
- RZ/A1L Group, RZ/A1LU Group, RZ/A1LC Group
User's Manual: Hardware
Vcc (Min.) = 1.10V
VT- = 0.8V

if PVcc power on timing is later than change timing of MD_CLKS pin to high level, it becomes absolute maximum rating violation.

- Please make more than one microsecond between Vcc power on and change timing of MD_CLKS pin to high level. (below figure)

PVcc power on timing should be at the same time as MD_CLKS pin or faster than MD_CLKS pin.
 (below figure)
