# RENESAS TECHNICAL UPDATE

Product Category	MPU&MCU		Document No.	TN-SH7-A551A/E	Rev.	1.0
Title	Restrictions on dead time of the motor management timer (MMT) in the SH7046 Series, SH7047 Series, SH7104, SH7105, SH7106, SH7107, SH7108, and SH7109		Information Category	Technical Notification		
Applicable Product	SH7046 Series, SH7047 Series, SH7104, SH7105, SH7106, SH7107, SH7108, and SH7109	Lot No.	Reference Document	SH7046 Series Hardware Manual (ADE-602-237B Rev. 3.0) SH-2 SH7047 Group Hardware Manual (REJ09B0020-0200Z Rev. 2.0)		
		All lots

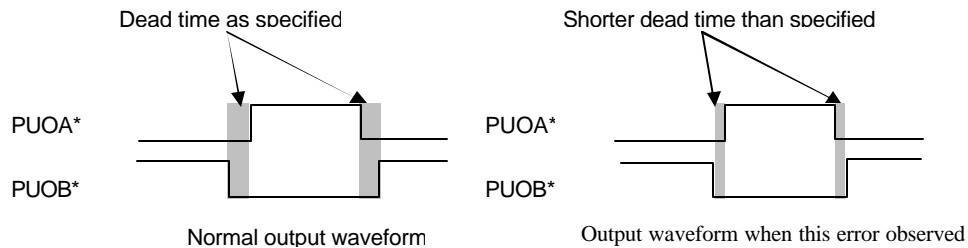
A PWM waveform output may have a shorter dead time (no n-overlap time) than the time specified by the timer dead time register (MMT\_TDDR) or may have no dead time (a dead time of 0).

Note:\* The same error is observed for the PVOA and PVOB pins or the PWOA and PWOB pins.

This error occurs when the counter is restarted (setting the CST bit in TCNR to 1) after the counter is stopped by clearing the CST bit in TCNR to 0 while the MMT repeats count up and count down.

The CST bit should not be cleared to 0 when the counter is restarted by setting the CST bit to 1. If the CST bit needs to be cleared, the CST bit should not be set to 1 after clearing.

1. Specify the PWM output pin as a general input port by the pin function controller (PFC).
2. Write H'0000 to free-operation addresses of all buffer registers (TBRU, TBRV, and TBRW).
3. After the specified dead time has elapsed, write H'00 to TCNR to clear the CST bit to 0.
4. Set the CST bit to 1 to restart the counter.

1. Stop the counter by clearing the CST bit in TCNR to 0.
2. Specify the PWM output pin as a general input port by the pin function controller (PFC).
3. Clear bit MSTP14 in the module standby control register 2 (MSTCR2) to 0 to enter the module standby mode. The internal states of the MMT is initialized.
4. Immediately, set bit MSTP14 to 1 to leave the module standby mode. Again, initialize the MMT and pin functions.
5. Set the CST bit to 1 to restart the counter.
