RENESAS TECHNICAL UPDATE

Product Category	MPU/MCU	Document No.	TN-RX*-A0242B/E	Rev.	2.00	
Title	RX21A Group, RX220 Group Errata to User's Manual: Hardware Regarding Realtime Clock (RTC)	Information Category	Technical Notification			
		Lot No. RX21A Group User's Manual: Hardy		lardware		
Applicable Product	RX21A Group, RX220 Group	All	Reference Document	Rev.1.10 (R01UH0251EJ0110) RX220 Group User's Manual: Hardwork Rev.1.10 (R01UH0292EJ0110)		lardware

This document describes corrections to the "Realtime Clock (RTC)" chapter in User's Manual: Hardware for the applicable products.

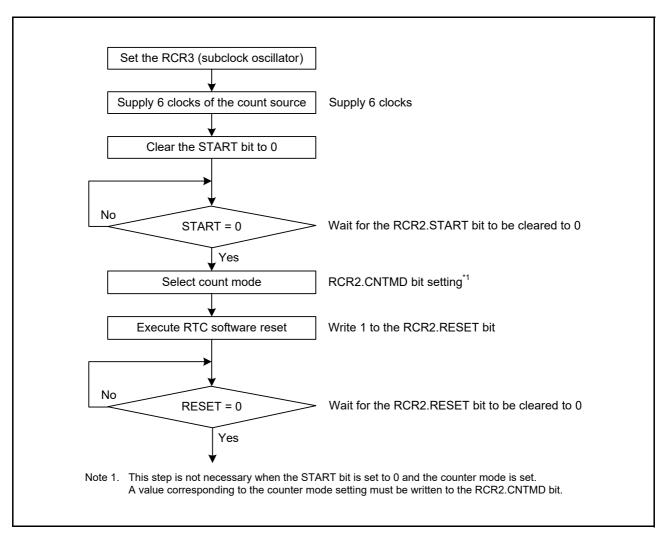
Figure 26.3 Clock and Count Mode Setting Procedure

The setting procedure described in Figure 26.3, Clock and Count Mode Setting Procedure is corrected as follows.

Before correction

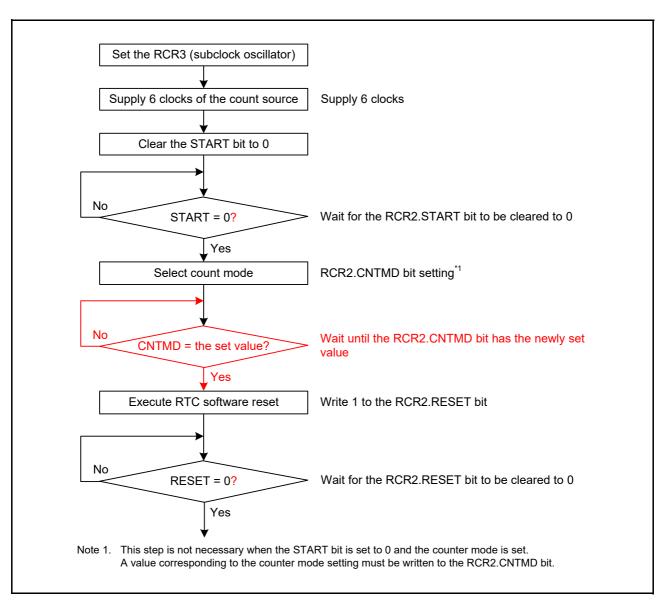
Figure 26.3 Clock and Count Mode Setting Procedure

After correction

This bit specifies whether the RTC count mode is operated in calendar count mode or in binary count mode. After setting the count mode, execute an RTC software reset and start again from the initial settings.

The CNTMD bit is updated in synchronization with the count source, so when the value of the CNTMD bit has been changed, check that the value of the bit has actually been updated before applying the RTC software reset. The count mode changes to that which was specified beforehand in the CNTMD bit after the RTC software reset is applied. For details on initial settings, refer to section 26.3.1, Outline of Initial Settings of Registers after Power-On.
