## Outline

When using Smart Configurator for RH850, note the following points.

## 1. Notes on using T&H path self-diagnosis function of A/D Converter

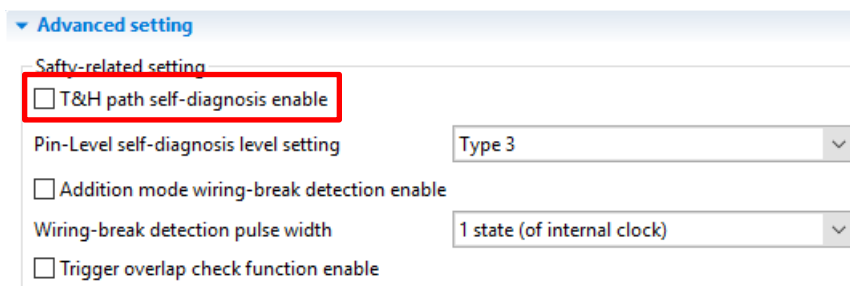
Figure 1-1 T&H path self-diagnosis setting

When using T&H path self-diagnosis function of A/D Converter (refer to Figure1-1) on the following peripherals, the function can't be enabled/disabled correctly even if the T&H path self-diagnosis function is already selected/unselected on GUI. The actual generated code is the opposite of the GUI setting.

- RH850/U2A16 (516-pin product, 292-pin product)  
ADCJ0, ADCJ1, ADCJ2
- RH850/U2A8 (292-pin product)  
ADCJ0, ADCJ1, ADCJ2

Manually modify the code in the following source file

- Source file: "r\_cg\_ad.h".
- Macro value: `_ADC_TH_PATH_SELF_DIAGNOSIS_ENABLE`,  
`_ADC_TH_PATH_SELF_DIAGNOSIS_DISABLE`

Note: If code is generated again, the previous state will be restored. Modification is necessary each time after performing code generation.

This is an example of the required modification. Manually change the macro values in “r\_cg\_ad.h”. In the following example, the code in red color is wrong code before modification, while the code in blue color is correct code after modification.
