# RENESAS TECHNICAL UPDATE

Product Category	MPU&MCU		Document No.	TN-H8*-A386A/E	Rev.	1.00
Title	Notes on Rewriting DTC Enable Registers (DTCER)		Information Category	Technical Notification		
Applicable Product	H8SX/1622 group, H8SX/1638 group H8SX/1648 group, H8SX/1650 group H8SX/1651 group, H8SX/1653 group H8SX/1657 group, H8SX/1658R group H8SX/1663 group, H8SX/1668R group	Lot No.	Reference Document	See below.		
		All lots

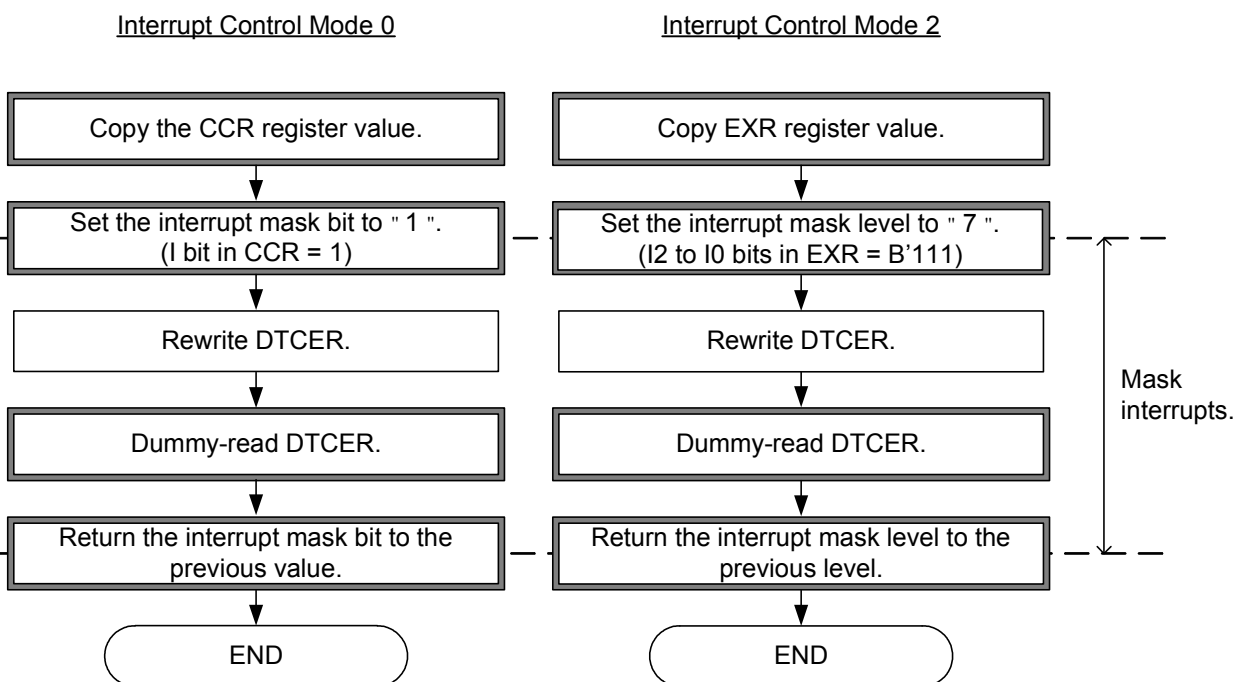
Figure 1 Recommended DTCER Rewriting Procedures

The following DTCER rewriting procedures can prevent a conflict between rewriting the DTCER and a DTC activation source interrupt from causing execution of both DTC activation and CPU interrupt exception handling. The DTCER rewriting procedure depends on the interrupt control mode: set the I bit in CCR to "1" in interrupt control mode 0, and set the interrupt mask level to "7" (I2 to I0 bits in EXR = B'111) in interrupt control mode 2. This masks an interrupt to the CPU thus preventing execution of interrupt exception handling by the CPU.

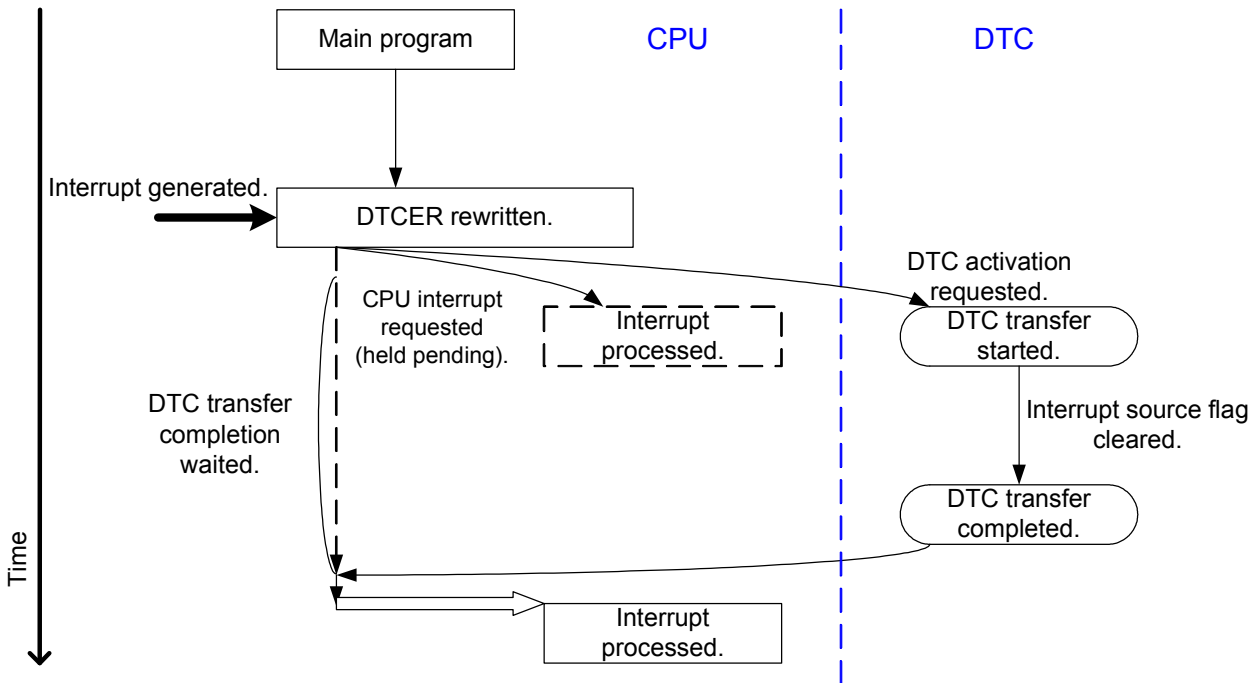
Figure 2 Execution of Both DTC Activation and CPU Interrupt Exception Handling

If the above preventive measure is not taken, both DTC activation and CPU interrupt exception handling may be executed when rewriting the DTC enable registers (DTCER) conflicts with generation of a DTC activation source interrupt.

If the above preventive measure is taken, CPU interrupt exception handling is not executed.

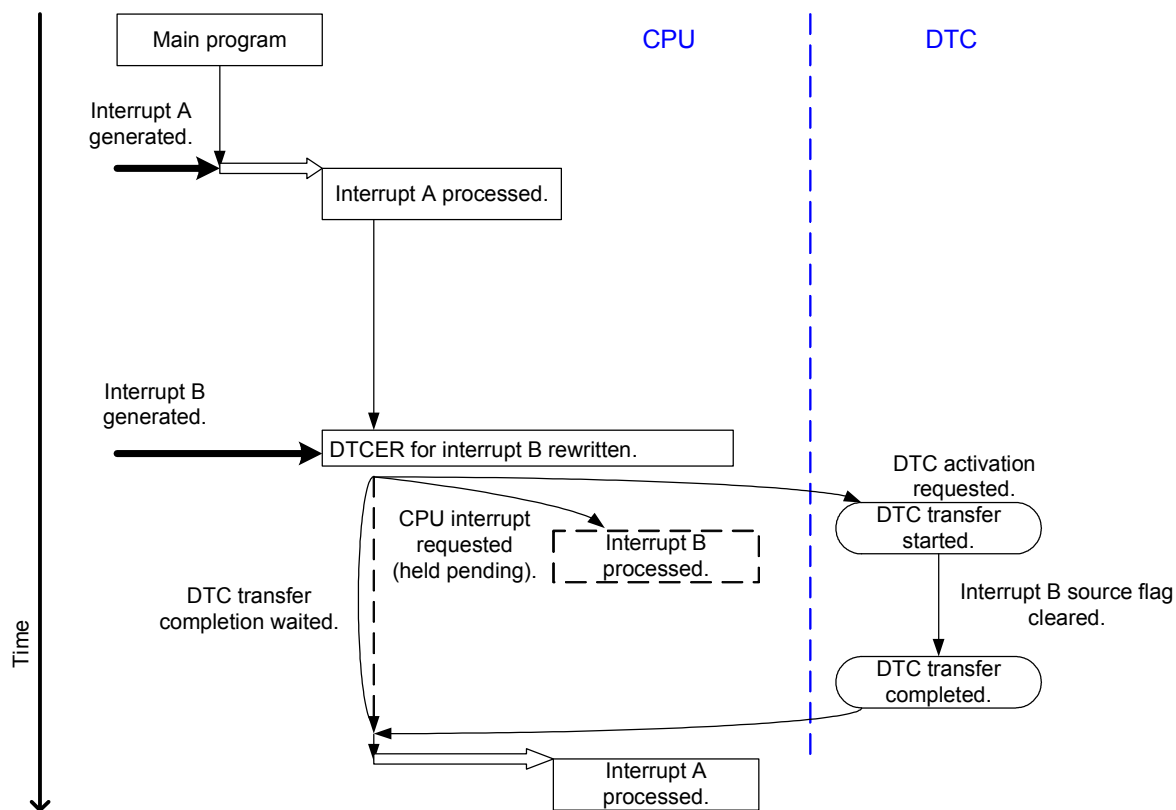
Figure 3 Double Processing Example of Interrupt A

When all the above conditions are satisfied and rewriting the DTC enable register conflicts with generation of a DTC activation source interrupt B, double exception handling of interrupt A may be caused.

When such a conflict occurs, both a DTC transfer request and a CPU interrupt request may be generated. When both the requests are generated and the DTC transfer request priority is higher than the CPU interrupt request priority, the DTC transfer request is processed first, holding the CPU interrupt request pending.

After the DTC transfer is completed, the interrupt B source flag is cleared by the DTC. Due to this, exception handling of interrupt A, whose interrupt source flag has not been cleared, is erroneously executed again instead (double processing of interrupt A).

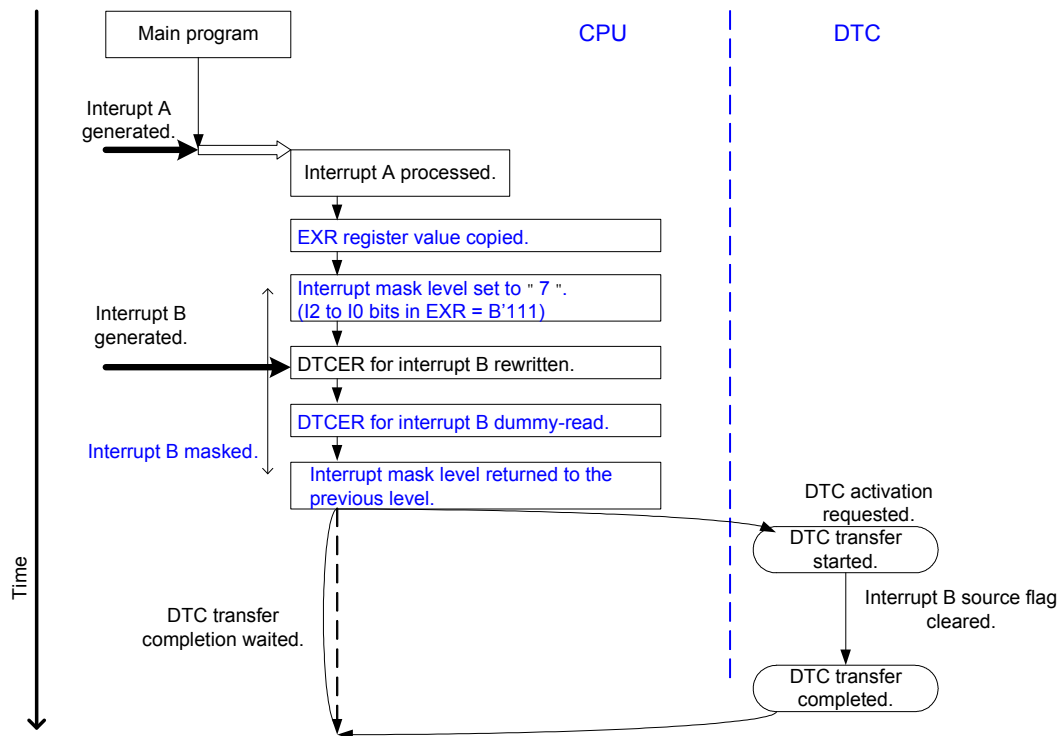
Figure 4 Operation Example when a Preventive Measure is Taken

Figure 3 shows a double processing example of interrupt A and figure 4 shows an operation example when a preventive measure is taken.
