R20TS0752ES0100

RX Family

SCI Module Firmware Integration Technology,

1. Notes on possible junk byte being transmitted while using asynchronous mode

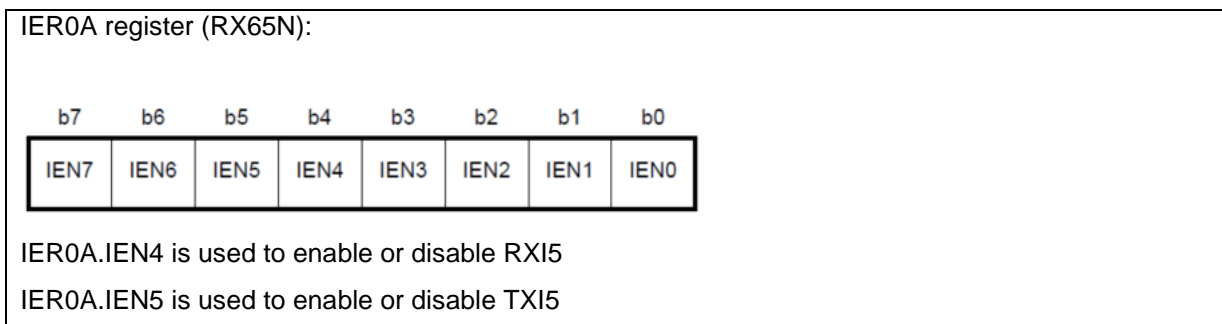
We have also identified the root cause as the IENx bit is corrupted due to non-atomic macros DISABLE\_RXI\_INT and ENABLE\_RXI\_INT; which are called in an asynchronous receive routine.

Interrupt request enable bit for RXI5 and TXI5 are IER0A.IEN4 and IER0A.IEN5 respectively. Located in the same register means potential of corruption (due to read-modify-write) if the operation on the register is not atomic

Make the following macros atomic (note that RX65N is used as example):

```
#define ENABLE_RXI_INT      (R_BSP_BIT_SET(hdl->rom->icu_rxi, hdl->rom->rx_i_bit_num))
#define DISABLE_RXI_INT    (R_BSP_BIT_CLEAR(hdl->rom->icu_rxi, hdl->rom->rx_i_bit_num))
```
