RX Family

R20TS0875EJ0100 Rev.1.00 Sep. 16, 2022

Notes on Performing Firmware Update Over-The-Air on AWS FreeRTOS

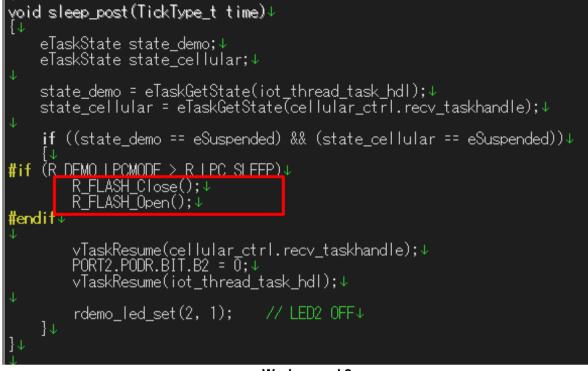
Workaround 2

After recovering from software standby, if OTA is initialized and then performed, the flash module Firmware Integration Technology (flash memory programming driver) returns an error.

Workaround 2:

Before performing OTA or after recovering from software standby, call the flash module function "R_FLASH_Close" and then "R_FLASH_Open".
